EFFECTS OF ARTIFICIAL LANDFORM CHANGE TO WATER PIPELINE DAMAGE IN SENDAI CITY DURING THE 2011 TOHOKU OFFSHORE JAPAN EARTHQUAKE

Kazue Wakamatsu¹, Shigeru Nagata², and Yoshihisa Maruyama³

Abstract. *Sendai City was severely affected by the Mw9.0 Tohoku Offshore Earthquake of March 11th, 2011. A system of 4458-km water supply network in the city had extensive damage, with 1064 locations seriously affected, resulting in cuts off water supply of 2.3 hundred thousand houses just after the earthquake. About 60 percent of locations of the damaged pipelines were found to be located not on low-lying land consisting of soft soils but on hilly residential lands developed by cutting and leveling the hills and then filling the valleys for the past several ten years. In this study, the old topographic maps surveyed before the land development were digitized and normalized for superimposing on locations of pipeline damage to analyze the effects of landform change to pipelines damage. As a result, the followings were reached: more than a half of pipe breaks in the developed areas occurred in the former hillside slope and one third of the breaks occurred in the former valleys in the hill; The heav

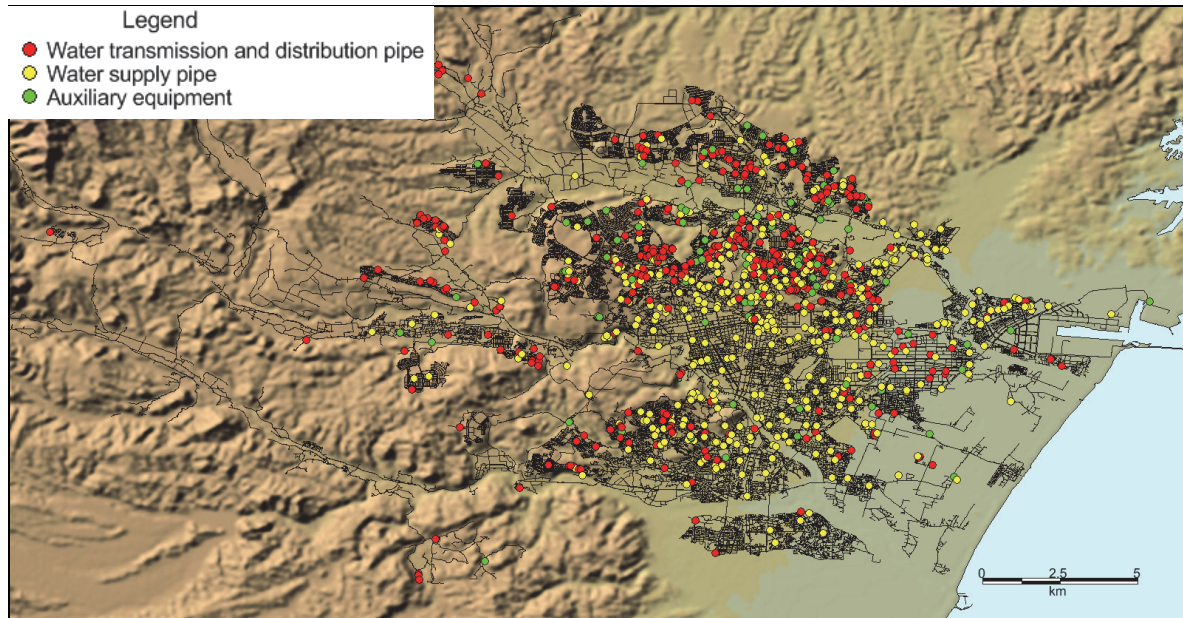
In contrast, there was significant damage to water distribution pipelines. Figure 1 shows the locations of water pipe breaks in Sendai following the 2011 Tohoku Offshore Japan Earthquake, which is overlaid to the map of the water distribution network. A system of 4458-km water pipeline network in the city had extensive damage, with 1064 locations seriously affected: the damage to the pipeline network includes 437 of transmission and distribution pipes

Figure 1: Locations of water pipeline breaks in Sendai following the March 11th 2011 Tohoku Offshore Japan Earthquake

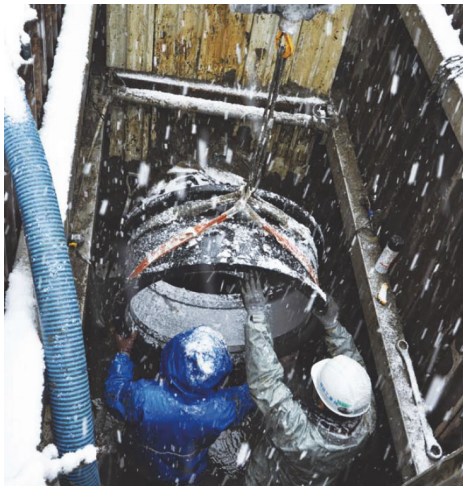
(Photo 1), 522 of water supply pipes, and 105 of auxiliary equipment. No damage was found in ductile cast-iron: pipes with earthquake-proofing joint (Photo 2).

Photo 1: Repair of water distribution pipe with a diameter of 800mm [4]

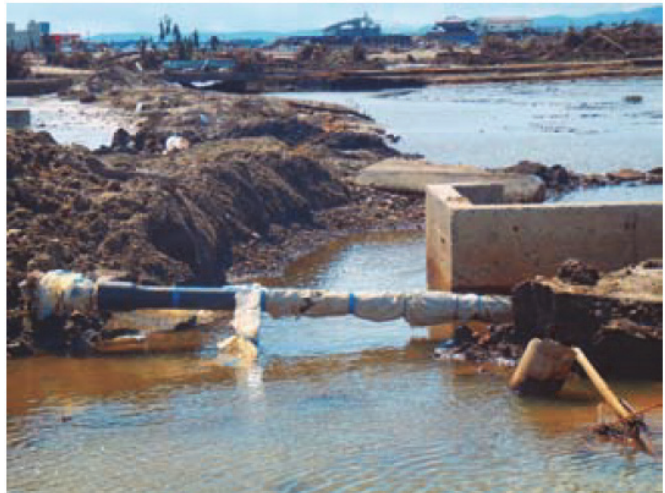
Photo 2: Earthquake-proofing water pipe with a diameter of 150 mm survived the tsunami [4]

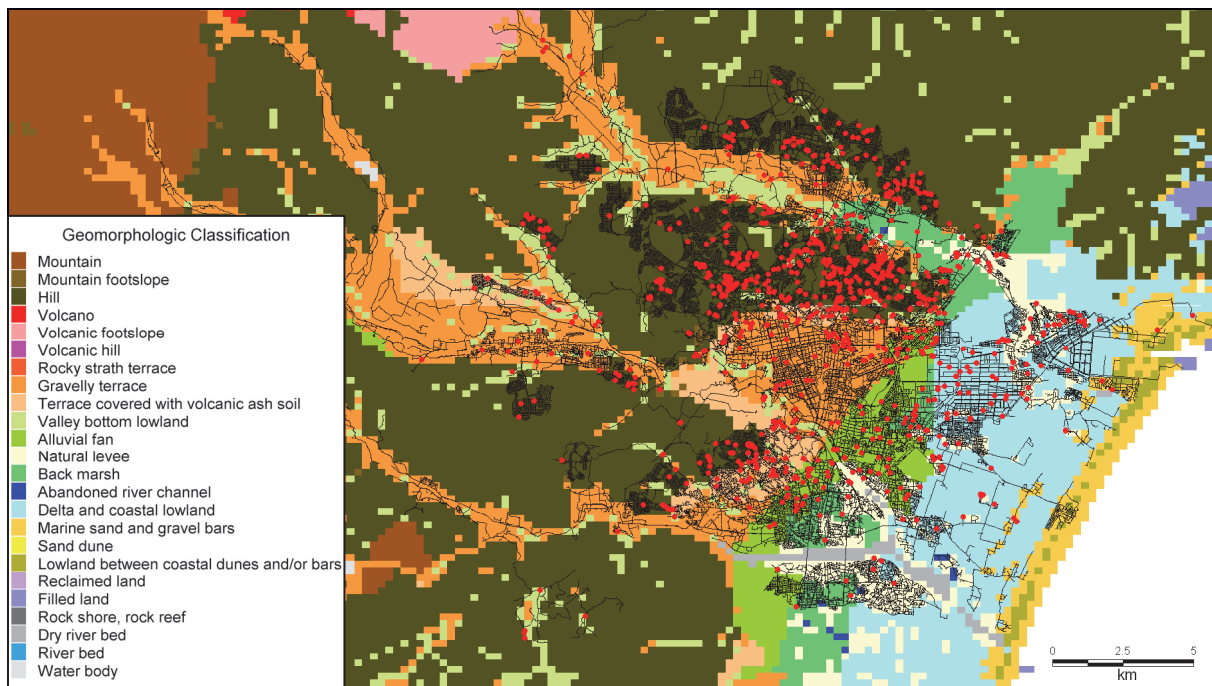
Figure 3 shows locations of pipe breaks and the water distribution network superimposed on the 7.5-sec Japan Engineering Geomorphologic Land Classification Map (JEGM) which is a nationwide site-condition map based on geomorphologic classification for various kinds of hazard mapping [5]. The damage to pipes was spread across hill (moss green), gravelly terrace (orange) and lowlands such as alluvial fan (yellow-green), delta and coastal lowlands (sky blue).

Figure 3: Locations of pipe breaks (red dots) and the water distribution network (black lines) superimposed on the 7.5-sec Japan Engineering Geomorphologic Classification Map

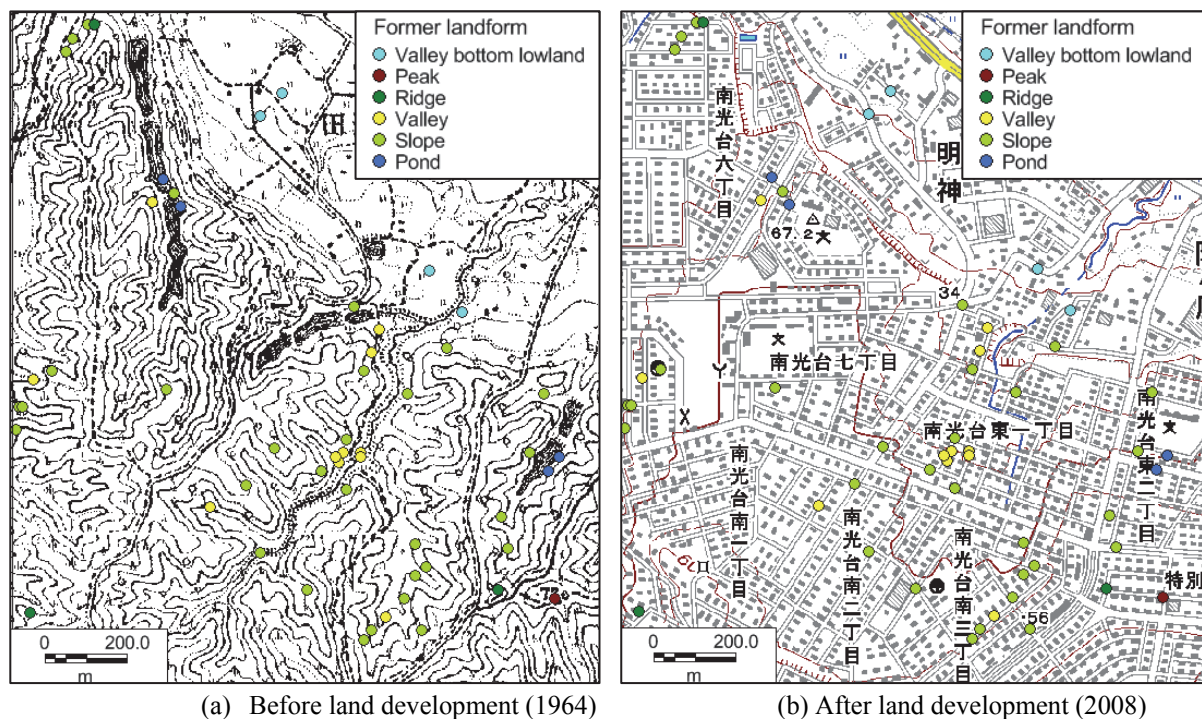
Figure 5(a) is an old topographic map surveyed in 1928. It should be noted that the hill is dissected by many small valleys and streams in the hill. The development of the hills started in the early 1950s and gradually extended toward surrounding areas of the old urban district of Sendai. Figure 5(b) shows the topographic map after the land development for housing. The area was developed typically by cutting and leveling the hill and then filling the valleys with soils from the excavated areas in the hill. Therefore there are two general types of sub-surface conditions in hilly land in Sendai: 1) natural soils of the original or excavated surface of the hill; it associated with the volcanic pumice flow deposit overlying Neocene sedimentary or volcanic bedrocks and 2) fills consisting mainly with the volcanic pumice flow deposit placed on the valleys and hollow parts in the hill. Areas underlain by these different profiles might to behave differently during the earthquakes.

Figure 5: Locations of pipe breaks (red dot) superimposed on 1:25,000-scale topographic map set surveyed before and after land development in Sendai

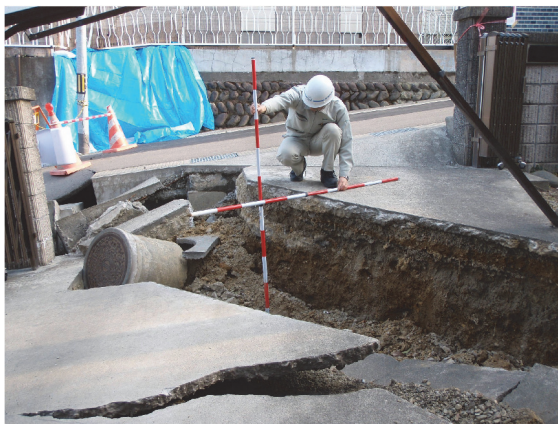
Significant ground failures occurred in many place in developed areas in hilly land in Sendai: ground failures include landslide, slope failure, collapse of retaining wall and liquefaction-induced lateral spreading (Photos 3 and 4). The number of damaged lots due to ground failures reached 5080 [7]. Figure 14 shows the locations of water pipeline breaks and superimposed on a map of ground failures. The higher concentration of pipe breaks is found in the area of ground failures but the greater numbers of breaks are also plotted outside of the areas.

Photo 3 Large crack due to landslide in Midorigaoka (courtesy of Sendai City) Photo 4 Collapse of retaining wall in Asahigaoka
