POST-EARTHQUAKE ASSESSMENT OF A MASONRY TOWER BY ON-SITE INSPECTION AND OPERATIONAL MODAL TESTING

Abstract. *The paper describes the methodology applied to assess the state of preservation of the tallest historic tower in Mantua, the "Gabbia" tower, after the earthquakes of May 2012. An extensive investigation programme – including visual inspection, sonic and flat jack tests, operational modal testing and structural modelling – has been planned to support the future preservation actions of the tower. The paper focuses especially on the information collected during on-site survey and dynamic tests and describes how these results can be employed and cross-correlated to assess the structural condition and seismic vulnerability of the tower.*

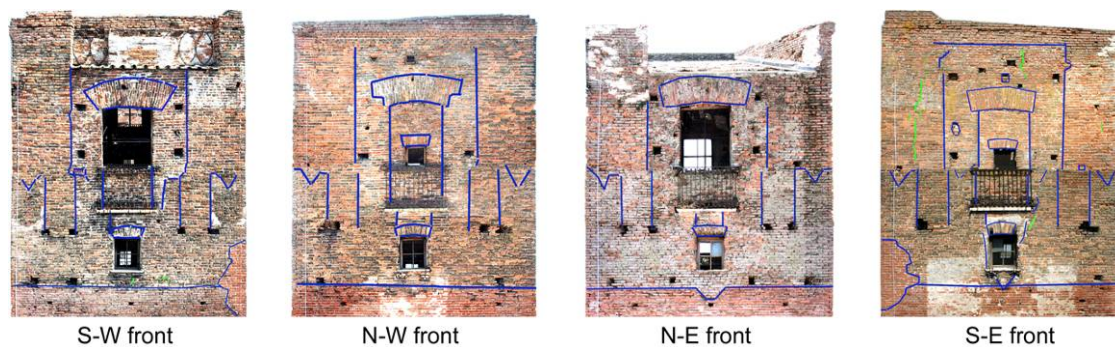
Figure 4: Map of the discontinuities on top of the tower.

On the contrary, the top of the tower (i.e. the upper portion about 8.0 m high, Fig. 3) shows damage related to the detachment of the several construction phases, worsened by the natural decay (Fig. 4). In fact, settlement of the interventions and of the opening infillings coupled

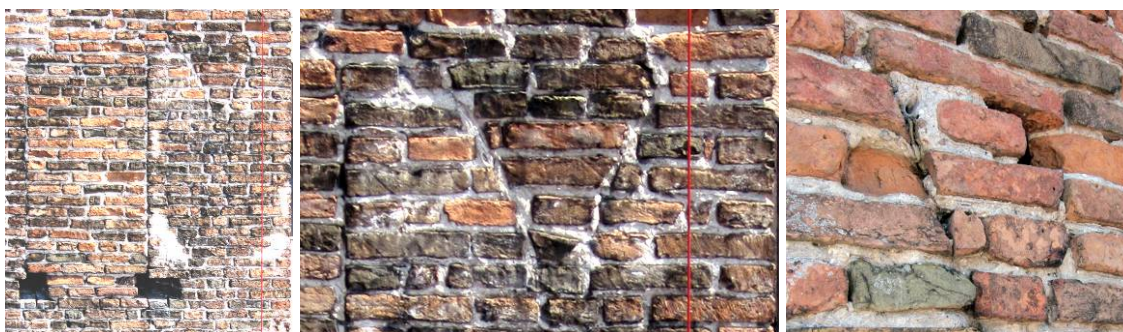
Figure 5: Probable merlons embedded in the masonry texture.

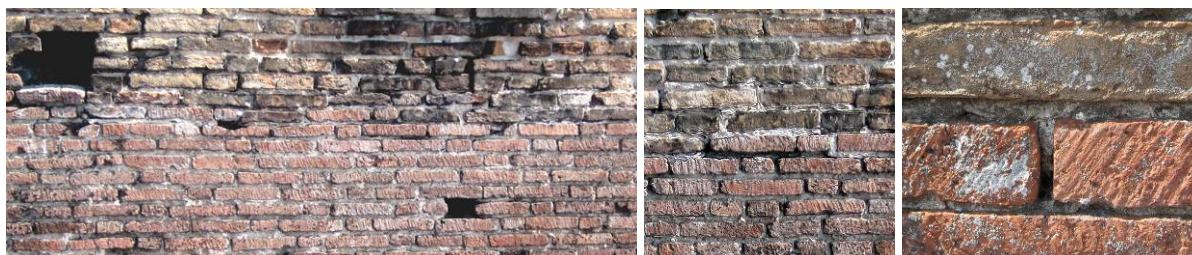
In the XVI century, the *Gabbia* tower was used as open-air jail, hosting a hanged dock on the S-W front (Figs. 1 and 3). Few information is available on the building evolution but the observation of the masonry texture reveals passing-through discontinuities at the top. Traces of past structures are visible on all fronts (Fig. 4) and the presence of merlon-shaped discontinuities (Figs. 4 and 5) suggests modifications and further adding at the top of the tower. Moreover, at about 8.0 m from the top, a clear change of the brick surface workmanship (the bricks of the lower part are superficially scratched) could reveal a first addition (Fig. 6); in the same region concentrated changes of the masonry texture reveal local repair.

Figure 6: Change of the surface workmanship at about 8.0 m from the top (the bricks of the lower portion are superficially scratched).

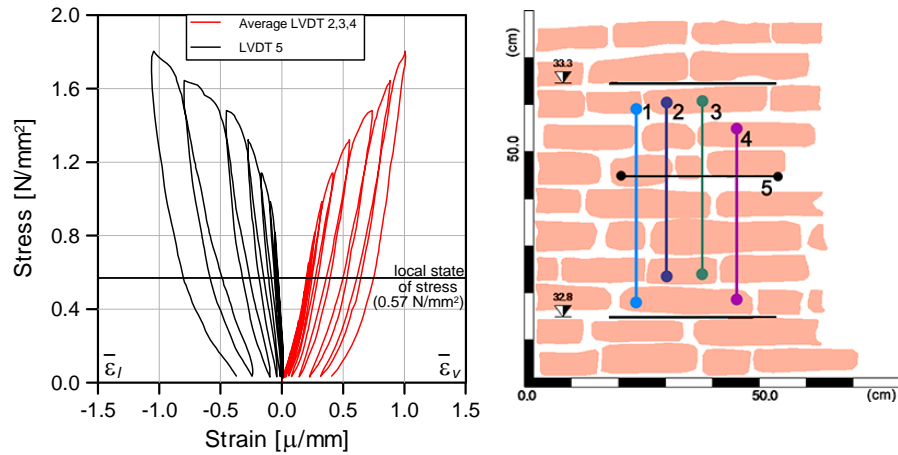
Excepting the upper part of the tower, visual inspection did not reveal evident structural damage but only superficial decay of the materials (mainly of the mortars, due to the natural ageing and the lack of maintenance). In the lower part of the tower, the corners exhibit rare thin cracks and the masonry section appears of solid bricks and lime mortars. Subsequent pulse sonic tests and double flat jacks confirm the soundness and the compactness of the masonry of such building portion. Results from pulse sonic tests suggest solid brick section, with high velocity values, ranging between 1100 m/s to 1600 m/s. Double flat jack test carried out on the N-E side at about 32.8 m from the ground level (Fig. 7) revealed that the Young's modulus is larger than 3.00 GPa. Similar information result from the laboratory tests on sampled bricks and mortars.

Figure 7: Results of the double flat jack test and superficial texture of the investigated area.

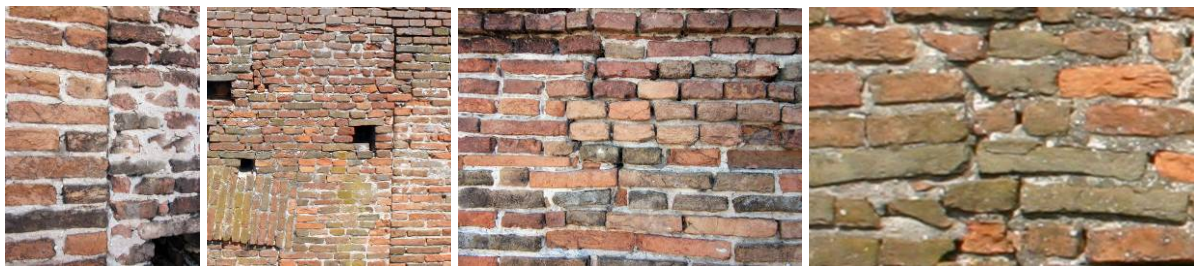
Figure 8: Typical discontinuities on top of the tower and lack of horizontality of the masonry courses.

with the highly disordered masonry and mortar erosion causes lack of horizontality of the joints of the crowing and the development of cracks as well (Fig. 8).

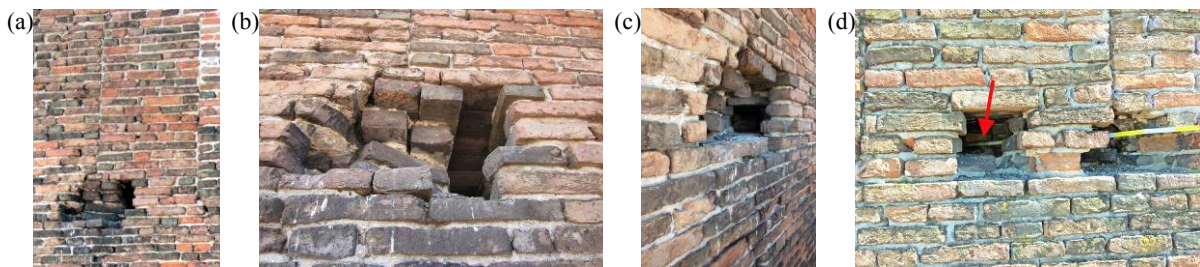
Figure 9: Details of the infillings between the supposed merlons on the N-W front: (a), (b), (c) left side infilling; (d) right side infilling.

Critical areas are the infillings between merlons (Figs. 4 and 9), supported only by few courses of thin masonry due to the unusual layout of the scaffolding holes. The extension of the scaffolding holes beside the base of the infillings weakens the local and overall stability (Fig. 9) so that the prevention of local instability of such masonry portions should be one of the intervention priority on the tower.

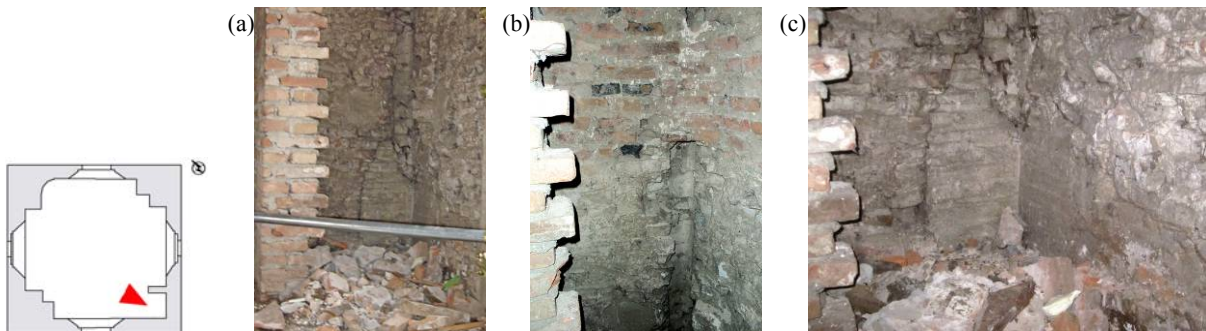
Figure 10: Details of the South corner at level 4: (a) the corner is partially dismantled, (b) with an embedded pipe at the edge and (c) a probable merlon.

It is important to remark the change of the masonry sections and of the plan layout in the upper part (Levels 3 and 4 in Fig. 3), where the nearly squared plan turns into corner masonry piers and un-toothed infillings. The decrease of resisting section is especially significant for the piers on North and South corners at level 4. As shown in Fig. 10, the corner pier at South is partially dismantled, showing an embedded pipe at the edge and the merlon shape. The lack of any mortar encrustation in the merlon surface suggests a weak connection in the other piers at the same level, as well.

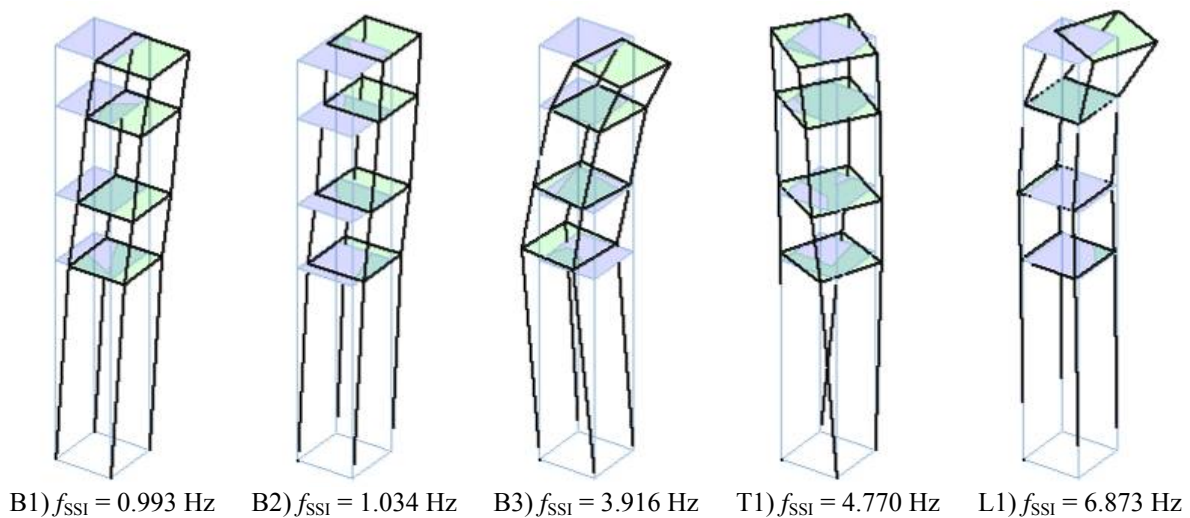
Figure 13: Vibration modes generally identified from ambient vibration measurements (SSI, July 31st 2013, 16:00-17:00).

- two closely spaced modes were identified around 1.0 Hz. These modes are dominant bending (B) and involve flexure in the two main planes of the tower, respectively: the mode B1 (Fig. 13B1) is dominant bending in the N-E/S-W plane whereas the modal deflections of B2 (Fig. 13B2) belong to the orthogonal N-W/S-E plane;
- the third mode B3 (Fig. 13B3) involves bending in the N-E/S-W plane, with slight (but not negligible) components in the orthogonal plane;
- just one torsion mode (T) was identified (Fig. 13T1) and the corresponding natural frequency was 4.77 Hz (in the examined time window);
- the last identified mode is local (L) and only involves deflections of the upper portion of

the tower (Fig. 13L1). The mode shapes seems dominant bending, with significant components along the two main planes of the tower. The presence (and generalized detection) of a local vibration mode provides further evidence of the structural effect of the change in the masonry quality and morphology (including un-toothed opening infillings and discontinuities) observed on top of the tower during the preliminary visual inspection. On the other hand, both visual inspection and OMA confirm the concerns about the seismic vulnerability of the buildings and explains the fall of small masonry pieces from the upper part of the tower, reported during the earthquake of May 29th 2013.

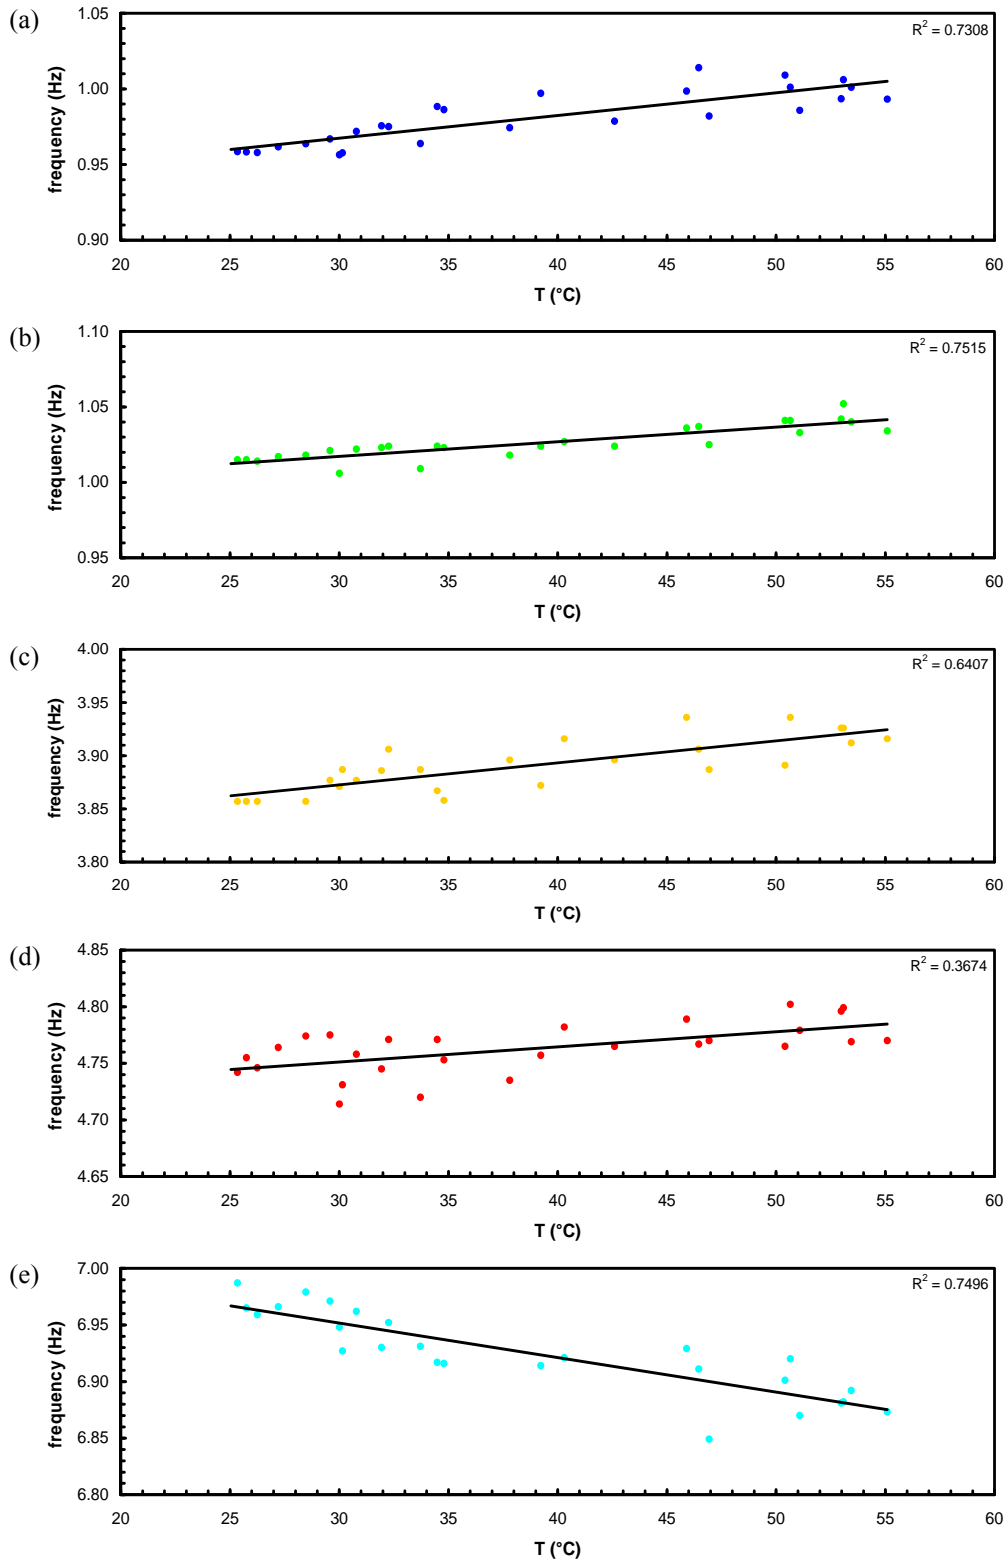
Figure 15: Frequency (SSI) variation versus measured outdoor temperature (S-W front):
(a) mode B1; (b) mode B2; (c) mode B3; (d) mode T1; (e) mode L1.

Figures 15a-c confirm that the natural frequencies of bending modes B1-B3 increase as temperature increases and exhibit an almost linear correlation with the temperature, with R^2 ranging between 0.64 (mode B3, Fig. 15c) and 0.75 (mode B2, Fig. 15b).

The frequency-temperature correlation seems less strong for the torsion mode T1 (Fig. 15d) since R^2 is quite low (0.37) in comparison with the values of the other modes.

Unlike the global modes, the natural frequency of the local mode L1 (Figure 15e) decreases as the temperature increases and the coefficient of determination assumes a high value ($R^2 \cong 0.75$). This result suggests that the thermal expansion of materials in a very inhomogeneous area of the structure causes a general worsening of the connection between the masonry portions; hence, further evidence seems to be provided, again in agreement with the main observation of the visual inspection, of the poor state of preservation of the upper part of the tower.
