## EARTHQUAKE EXPERIENCE OF TURKISH PRECAST INDUSTRY

**Abstract.** *The high seismic activity of the three fault zones in Turkey developed damaging earthquakes in the last five decades that affected the precast-concrete building structures in the region. Among others, the 1998 Adana, 1999 Kocaeli, 2003 Bingöl and 2011 Van earthquakes are considerably important regarding the seismic performance of the precast structures. Earthquake performance of frame structures in the form of industrial-halls, shopping malls, multi-storey residential buildings and gymnasiums along with the wall structures mainly in the form of residential housing, under these seismic actions, revealed valuable information on the effectiveness of the prevailing technology and the design practice. The quality control system, inherently developed within the member companies of the Turkish Precast Concrete Association, TPCA, resulted better performance of the precast structures. The structural system of the multi-storey residential buildings in Bingöl, Kocaeli and Van, regardless of the structural system, were in the state of immediate occupancy, while the cast-in-place buildings in the vicinity experienced damage ra

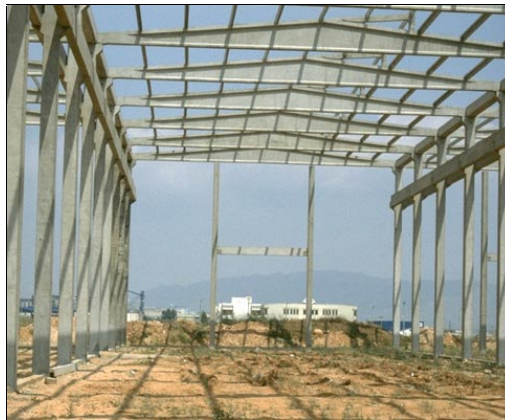
Figure 2 – Industrial Building under Construction in Adana in 1998 [6]

Adana (on EAF), Kocaeli and Sakarya (on NAF) are the industrial heartlands of Turkey and hit by two devastating earthquakes in the year 1998 and 1999 respectively. The precast construction in Adana was mainly in the form of single storey industrial buildings, while multi-storey industrial buildings also exist in the Kocaeli region. The structural system of single storey industrial buildings consists of cantilever columns, fixed at the base and pin connected to the roof beams at the top. It is reported that the workmanship and the material quality of the precast concrete elements in Adana were significantly over those of the cast in place residential buildings (Fig.2). It is also reported that the Schmidt hammer measurements of the concrete elements yielded a mean value for the compressive strength of  $f_c = 60 \text{ N/mm}^2$  while the yield strength of the reinforcement steel is assumed to be  $f_y = 420 \text{ N/mm}^2$  [6]. The local damage of such buildings were confined to the connections where roof beams were pin con-

nected to the columns. The structures conforming to the Turkish Earthquake Code experienced minimal damage confined to the partition walls and some connections, while the ones not conforming to the code experienced local failures. The column dimensions played an important role on the damage distribution in such buildings.

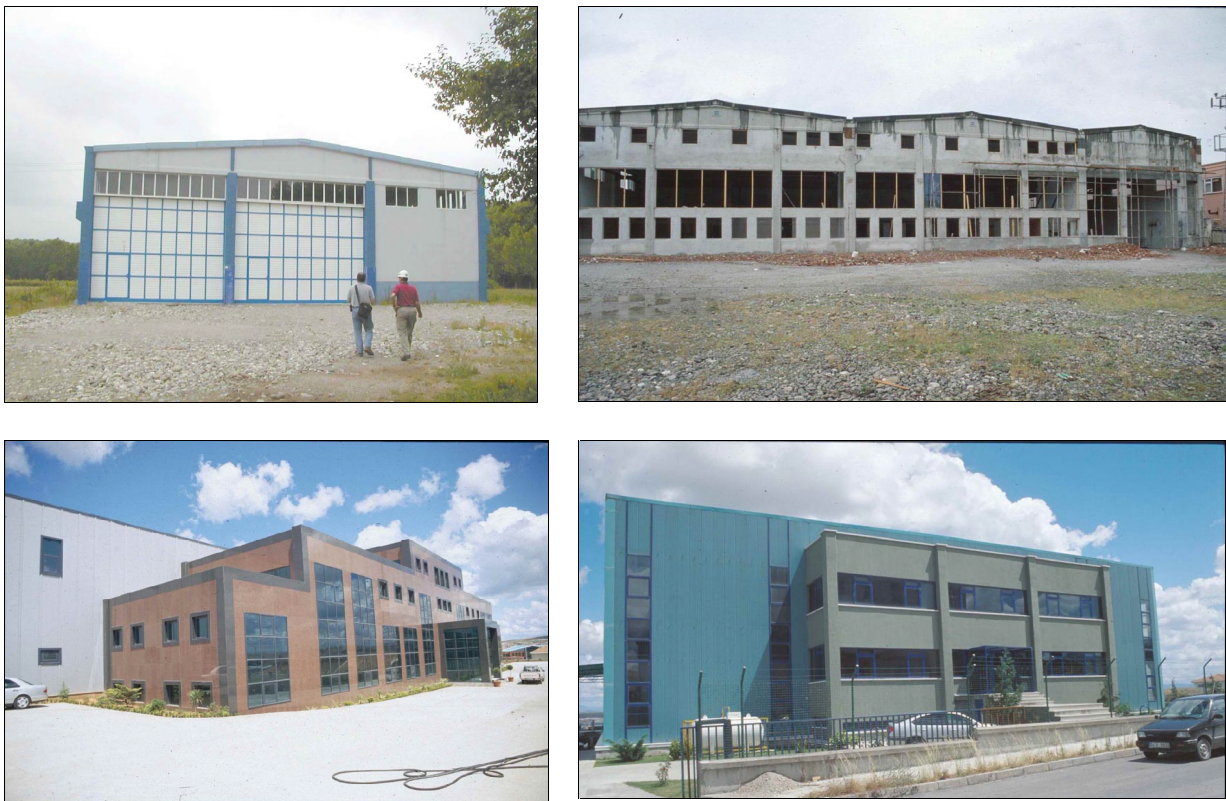
One year after Adana earthquake, Posada and Wood [5] reported similar results for the industrial buildings. Authors investigated the industrial buildings in Sakarya, Kocaeli, and Gebze. It is reported that the damage level of the industrial buildings are mainly influenced by the drift demand and the drift capacity of the buildings. The damage of precast structures in Sakarya was more pronounced due to the drift demand invoked by the soft soil conditions, as compared to the no damage in Gebze where the soil is basically stiff clay to rock. It is also reported that the buildings with larger column sizes, in other words the buildings conforming the Turkish Earthquake Code (TEC) performed well [5] (Fig.3). The site investigations and elaborations on the structural design calculations revealed that most of the damaged buildings were not conforming to the drift limits of TEC. Besides, the design was made only in the frame direction, and the earthquake loading is not made in the transverse direction. The damage of precast concrete industrial buildings conforming to the TEC drift limits on both orthogonal directions, even in the vicinity of the epicenter, were in the range of immediate occupancy to life safety [7].

Figure 3 – Typical Single- and Multi-Storey Warehouses after Kocaeli Earthquake [5]

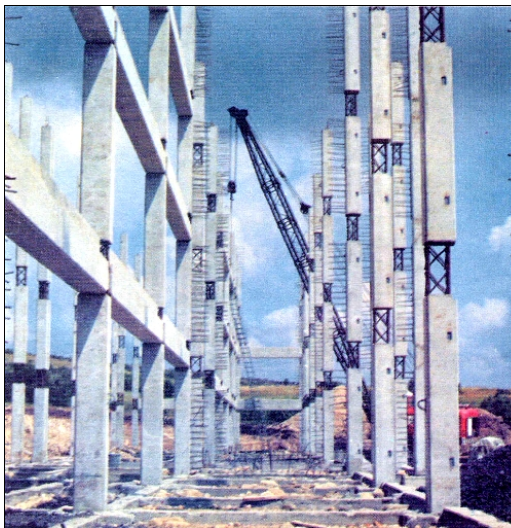
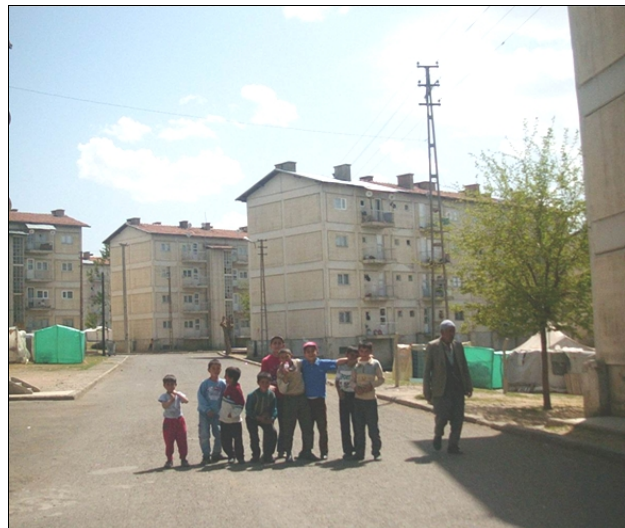
Figure 5 – Precast Multi-Storey Building during Construction and After 2003 Bingol Earthquake [9]

Post Earthquake investigation (Bingol-2003) on the Genc-Bingol housing complex revealed that the buildings were in the performance state of immediate occupancy, although the surrounding cast-in-place reinforced concrete structures underwent damages ranging from life safety to collapse.

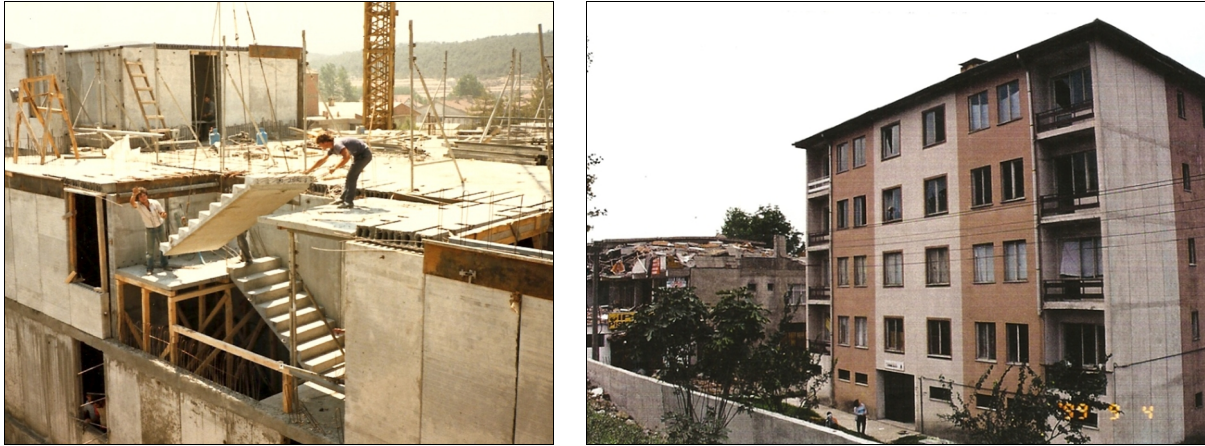
In 1999, a devastating earthquake hit the city of Kocaeli leaving thousands of casualties and a considerable economic loss both due to the damage in infrastructure and due to the industrial production losses (Table 1). The spread of damage was more pronounced in the sediment basins such as Adapazarı, and in the regions close to the East bound of the Kocaeli Gulf such as Golcuk and Kavaklı. The displacement demand due to the soft sub-layers caused many buildings to collapse, left many beyond the life safety performance limit. The precast wall type of 5 storey residential construction at Golcuk, which was constructed in 1991 experienced no damage (immediate occupancy performance level) while all the surrounding buildings were collapsed. The walls and the slabs of the building complex with 2

Figure 6 – Precast Multi-Storey Wall System Building during Construction and After 1999 Kocaeli EQ. [10]

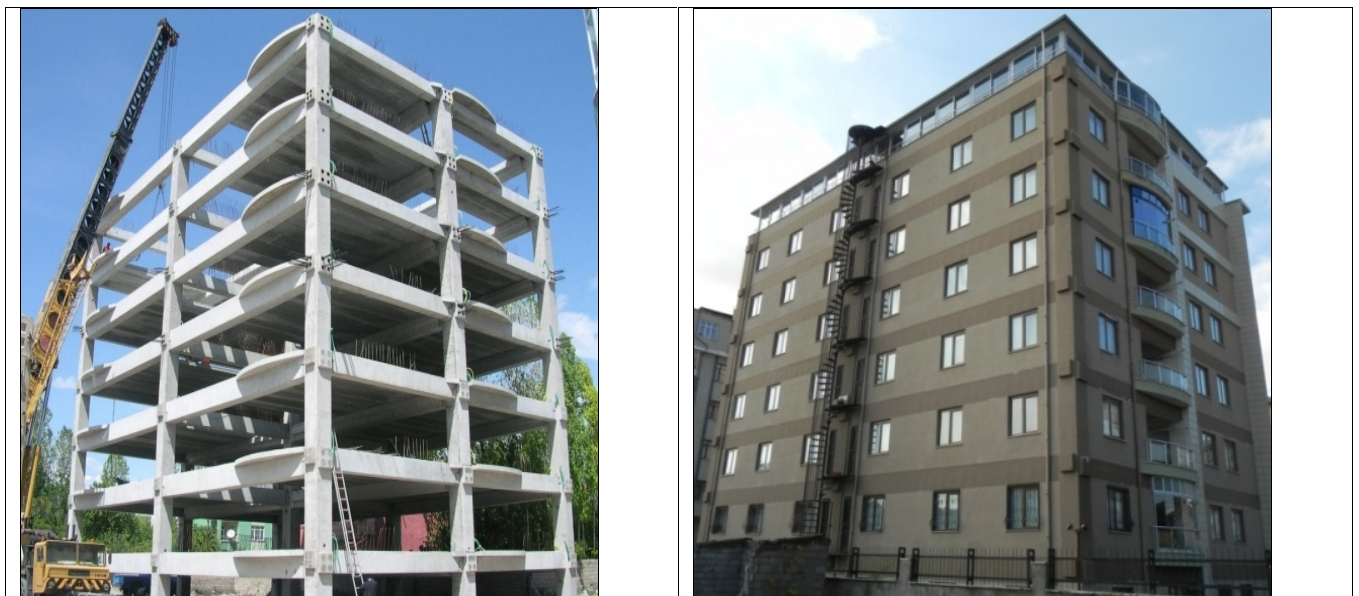
Figure 8 – Frame Building with Post Tensioned Connections, and the Performance after 2011 Van EQ. [11]

Post-earthquake damage investigation on that specific building revealed no structural damage on neither pre-cast, pre-tensioned members, nor the post-tensioned connections, and post-tensioning ducts. The column to foundation connections were carefully investigated and no flexural or shear cracking was observed. The frame performance during the Van Earthquake of October 2011 was immediate occupancy. However, some the dry partition walls experienced minimal damage.

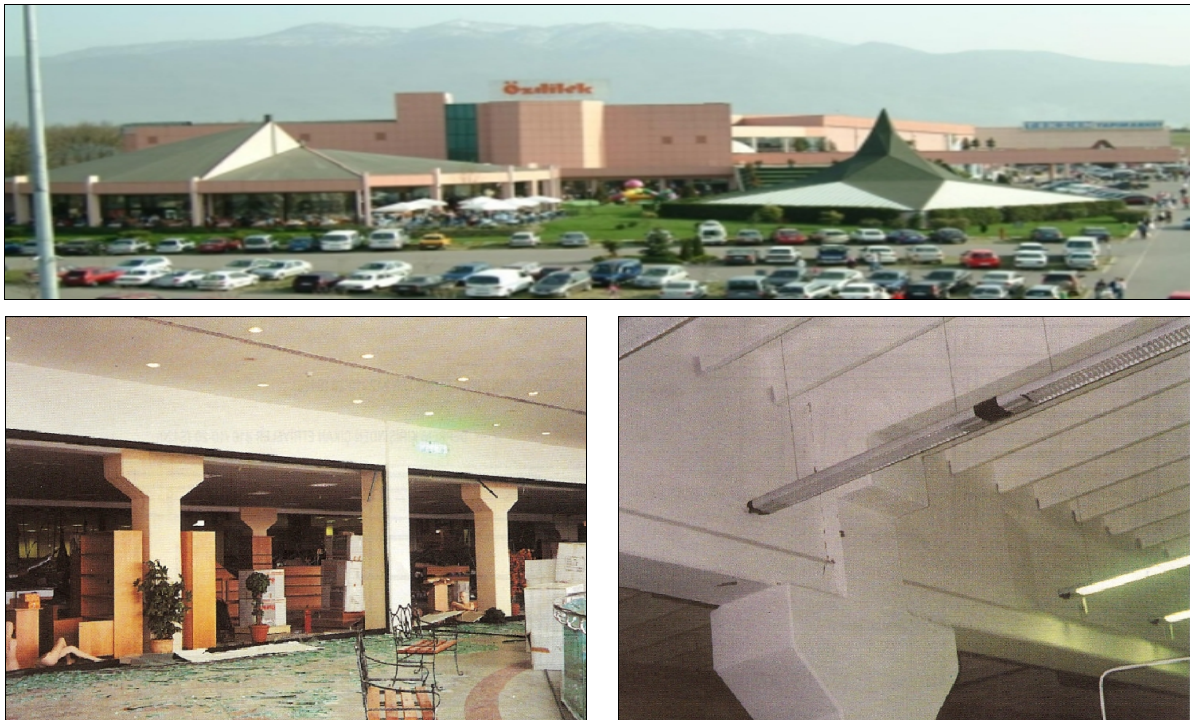
Figure 9 – Performance of a Shopping Mall after 1999 Kocaeli Earthquake [12]

frames were three storey height. The frame connections were cast-in-place. The structural system was in the immediate occupancy performance level. However, the false ceilings and the material racks toppled and service of the mall suspended for a while.
