A CASE STUDY OF COLLAPSE DURING THE 2009 L'AQUILA (ITALY) EARTHQUAKE

Keywords: case study; soft-story mechanism; partial collapse; non-ductile reinforced concrete frame; captive-beam mechanism.

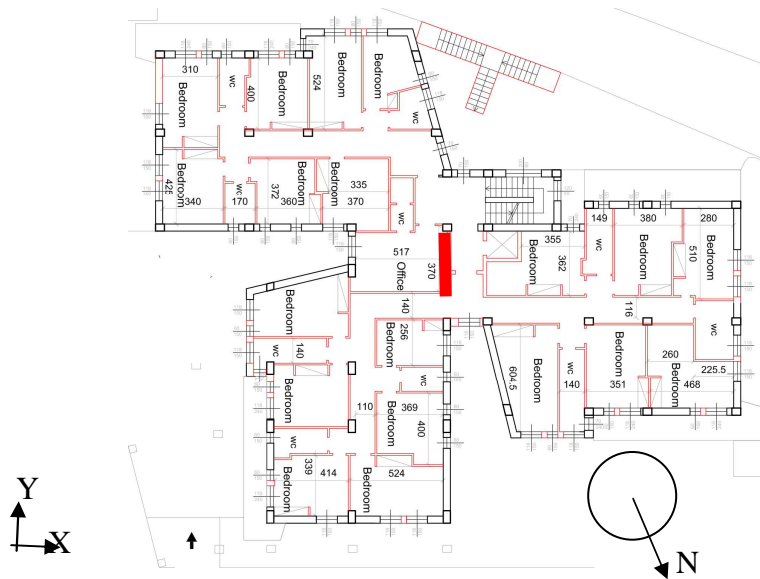
Figure 2. Plan of the typical building floor after refurbishment in 2000. The thick line marks the position of a fire resistant wall on Beam 18-29 which triggered the collapse of this beam at several levels.

A wide refurbishment intervention, not covering the structural system, was performed during the years 1999-2002. The layout of the internal partitions was changed to better adapt the building to its use as a university dormitory (Figure 2). To comply with fire safety regulations, a fire resistant wall (denoted, from the French acronym, as “REI wall” in the following) composed of lightweight concrete hollow blocks, 20 cm thick, was placed at floors from the first to the fourth (thick red line in Figure 2), supported by but not connected to the underlying beam. This wall spans from column 18 on roughly half of the beam 18-29, that in turn is part of the beam that connects columns 18, 29, 30, and the corner column 31 (beam 18-29-30-31).

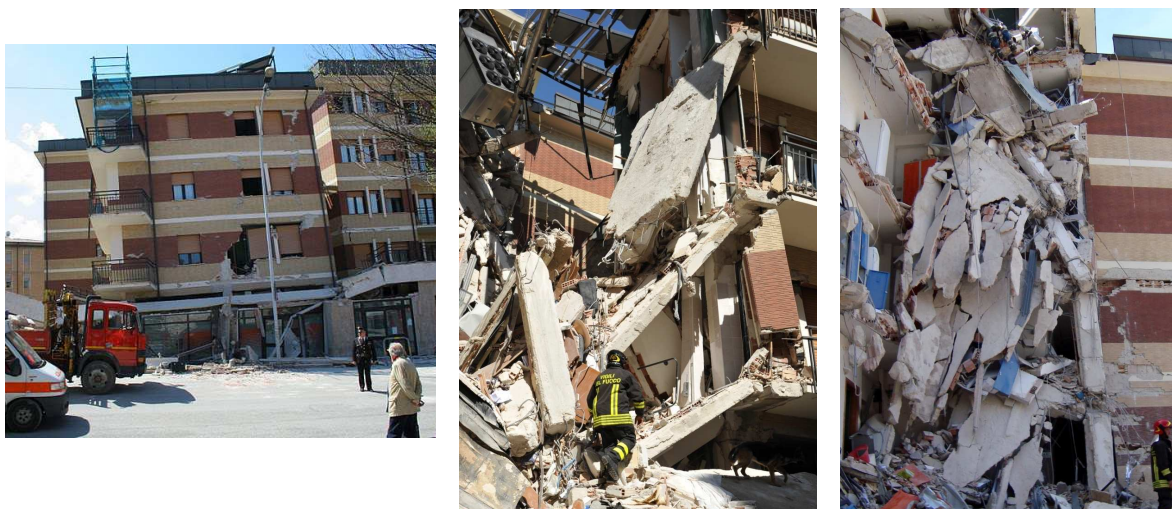
The partial collapse of the building was limited to the North wing (see Figure 1). Within this wing two distinct collapse zones were detected, from both pictures of the collapsed part (Figure 3) and on-site observations: the failure of all the columns at the ground floor, with a

Figure 3. The partial collapse of the building. Left, the soft story of North wing, view from XX September Street. Center, the collapse of the columns at the interface between the North wing and the remaining wings. Right, the remaining of column 29 after demolition of the collapsed region

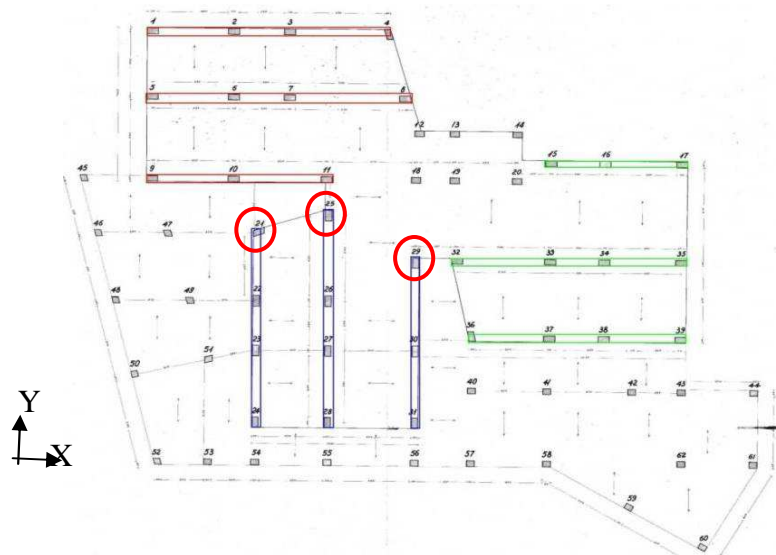
soft/weak story mechanism, and that of three columns (21, 25 and 29, see Figure 4) along the height of the building, at the interface between the North wing and the remaining ones. Previous studies, reported in [3, 4], performed for legal reasons, showed that neither the poor quality of material properties nor the ground motion at the building site could be considered – from the Italian laws viewpoint – among the causes of the collapse. The most likely collapse sequence was established by crossing the design criteria adopted in 1965, the results of modal analyses of the building in its original configuration and after refurbishment, and all the experimental data coming from the analysis of damage in the part of building that survived the earthquake. The lack of flexural strength of ground story columns was detected as the main mechanical cause of the collapse itself.

Figure 4. Layout of the vertical members. The colored lines highlight the positions of the main frames within the three wings; circles show the collapsed columns # 21, 25 and 29.

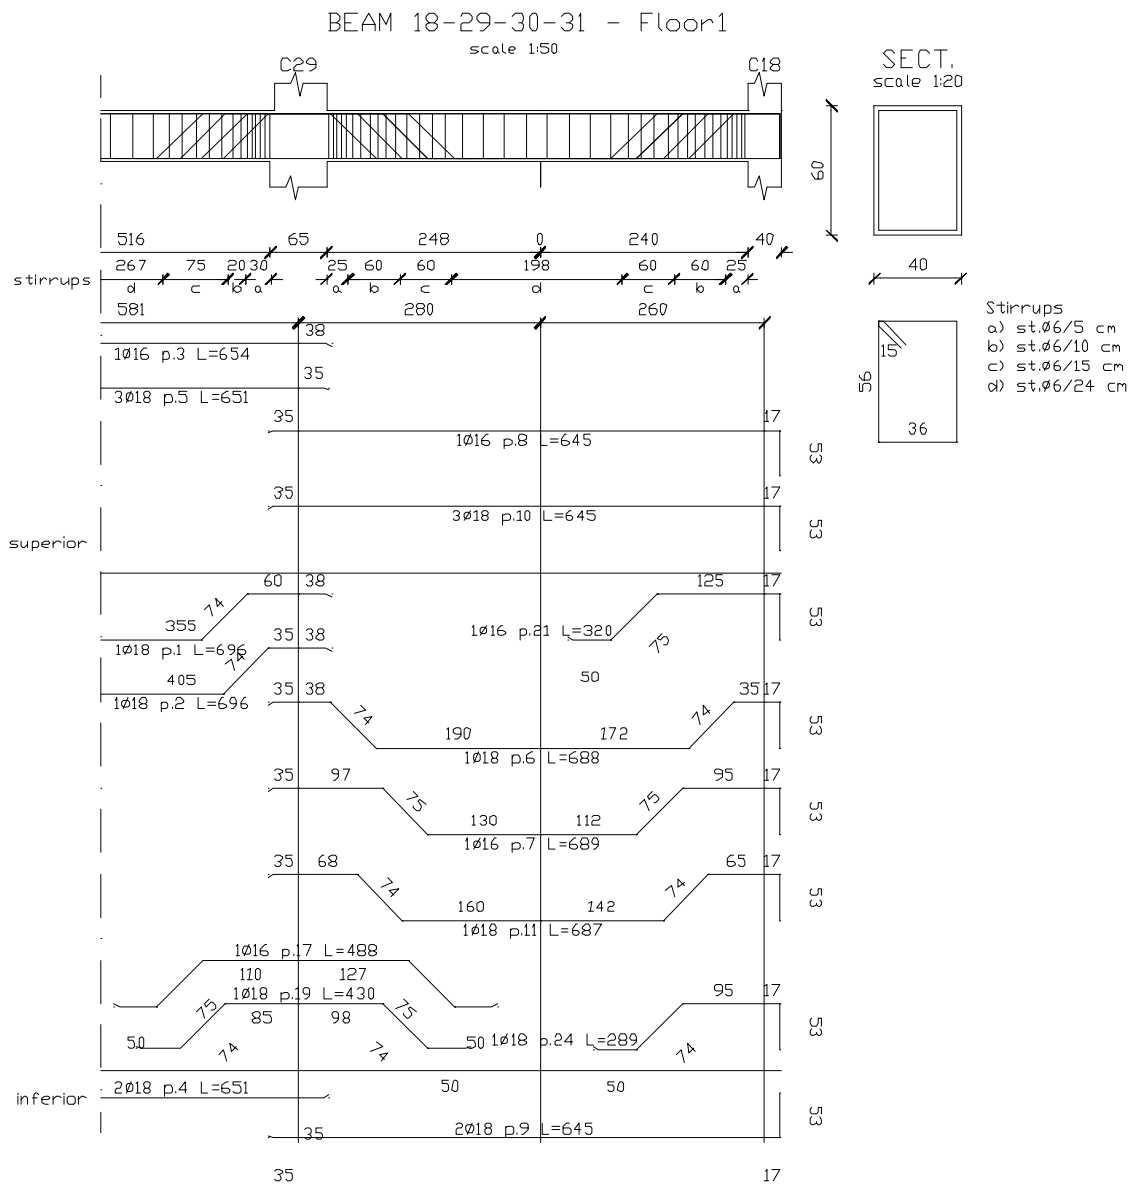
As an example of the level of detail with which the reinforcement has been described inside the numerical code, Figure 9 depicts the reinforcement considered for the critical beam 18-31 in the span that supports the REI wall. This span failed in shear at the location of the REI wall.

Bending reinforcement at mid-span is $4\phi 18 \text{ mm} + 1\phi 16 \text{ mm}$ in the lower part of the cross-section, $3\phi 18 + 1\phi 6$ in the upper part. In these indications, the symbol ϕ denotes the bar diameter, the first number denotes the number of equal diameter bars, the second number the diameter of the bar in mm. At the supports the upper bending reinforcement is $6\phi 18 + 3\phi 16$ while the lower one is $2\phi 18$. Shear reinforcement is provided by $\phi 6$ stirrups at a variable spacing: 240 mm in the central part of the beam and in between 50 to 75 mm at the supports.

Figure 9. Detail of the reinforcement in beam 18-31 at first floor.

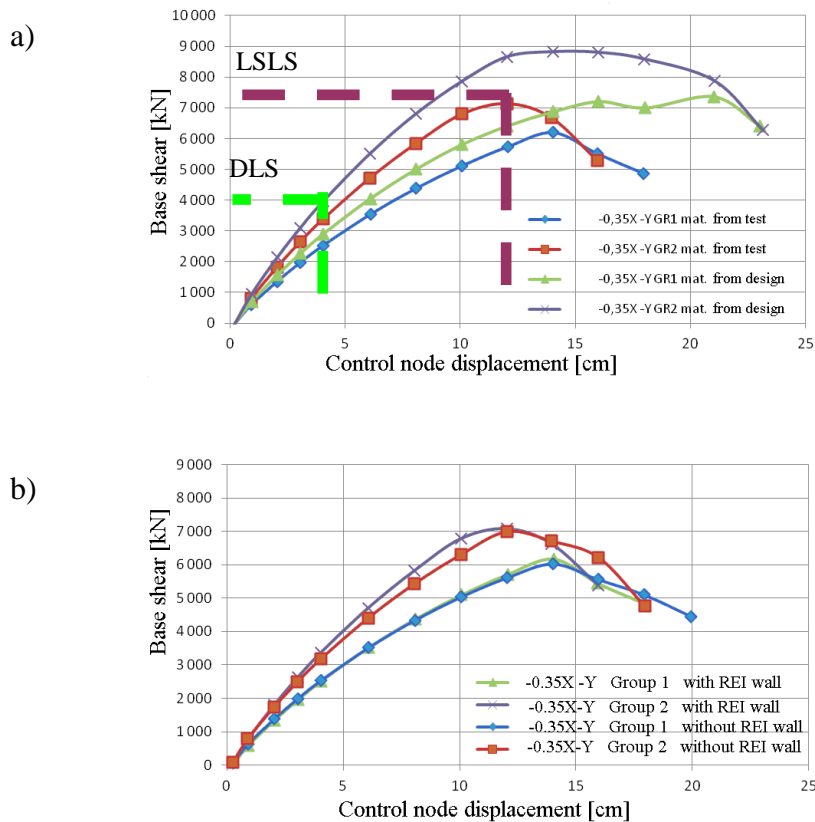
The estimated displacement demands in Figure 10 (4.0 cm at the DLS, 11.8 cm at the LSLS obtained with the response spectrum in [7] evaluated at the CdS) clearly highlight that also the original configuration, without the REI wall, would probably have collapsed under the earthquake of April 6th, 2009. The activation of a soft/weak-story mechanism is clearly visible in both the original and renovated configuration. In the second configuration the mechanism is more apparent, so that it would seem the insertion of the REI wall has adversely affected also the ground-story performance.

Figure 10. Capacity curves for Group 1 and Group 2 forces distributions: (a) REI wall included and material parameters from design and from tests; (b) with and without the REI wall, material parameters from tests.

The effect of the material properties is investigated in Figure 10a, where the results for the different materials are compared for the two force distributions considered. The poor quality of the materials affects more the base shear capacity of the structure than its ductility. The final value of the displacement under GR1 force distribution is practically the same, regardless the material properties adopted.

The effect of the REI wall is investigated in the Fig. 10b. The wall tends to exacerbate formation of a soft story at the ground floor and induces early failure in shear of beam 18-29. The failure of this beam accounts for the collapse of portion of the floor system in the zone from the end of the REI wall to column #29. This failure can be clearly detected at several floor in the pictures taken immediately after the seismic event of April 6th, before the remains of the North wing were taken down (see for example Figure 3 right). The collapse of column #29 can be ascribed to the increased shear force at the beam interface, causing ultimately the collapse of the column joints in shear and the loss of support of the beam 29-30. The wall plays an adverse role for this column too.

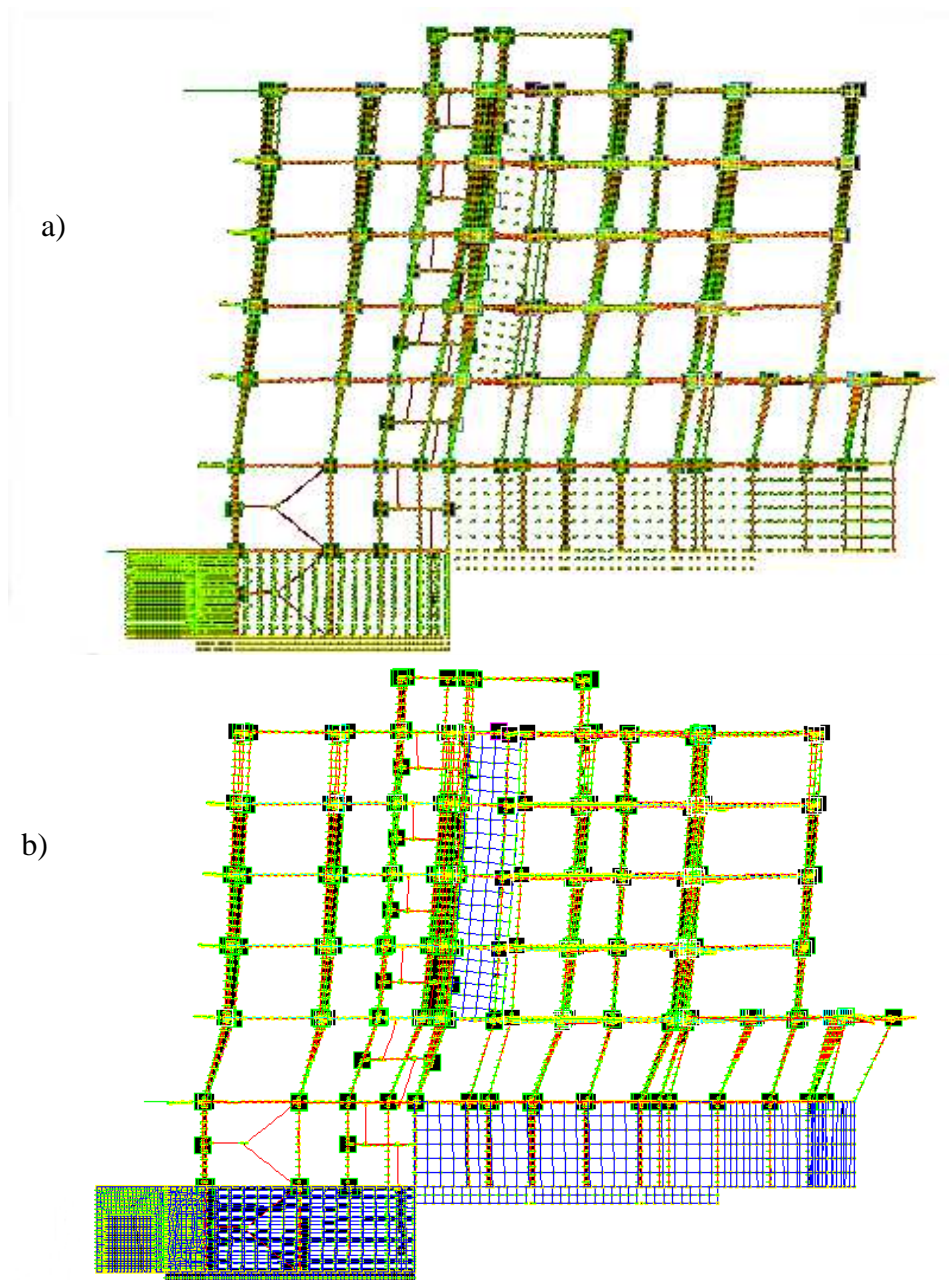
From the analysis of the sequence of local collapses, it can be observed that, when the REI wall is included, the beam 18-29 fails in shear at the first floor for a displacement of the control node $3 \leq d_c \leq 4$ cm, then at the upper stories for $4 \leq d_c \leq 6$ cm. The collapse of the North wing columns at ground floor starts at $4 \leq d_c \leq 6$ cm with failure in shear of column #29. The structural configuration without the REI wall sees the first collapse at a larger value of the displacement of the control node, $6 \leq d_c \leq 8$ cm, when some of the North wing columns at ground floor fail in shear. Whatever the material properties, the force distribution and the con-

Figure 11. Displaced structure for Group 1 forces distribution and seismic action $-0.35X-1.0Y$ (a) without the REI wall (b) with the REI wall. The control node displacement is 23 cm in both cases.
