REHABILITATION OF A PARTIALLY COLLAPSED MASONRY TRADITIONAL TOBACCO WAREHOUSE OF THE LATE 19TH CENTURY

Constantin E. Chalioris¹, Maria J. Favvata¹, Venetia G. Alexandri¹, and
Chris G. Karayannis¹

¹Democritus University of Thrace, School of Engineering, Department of Civil Engineering
Xanthi 67100, Greece
e-mail: chaliori@civil.duth.gr

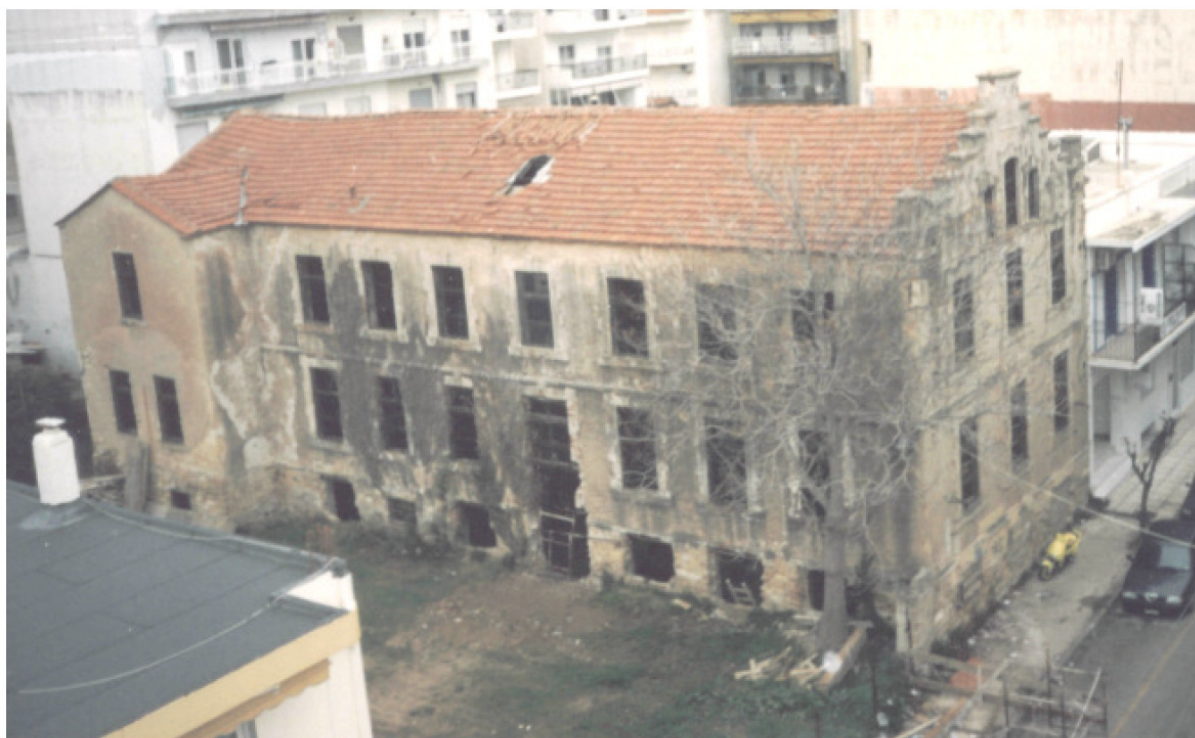
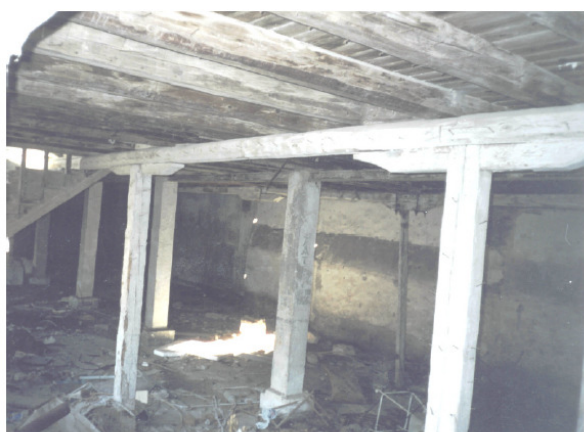
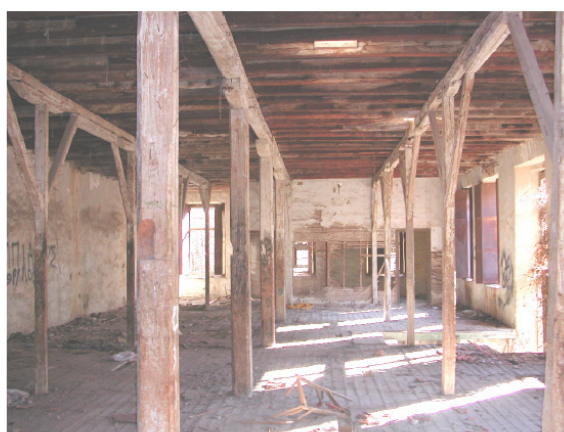
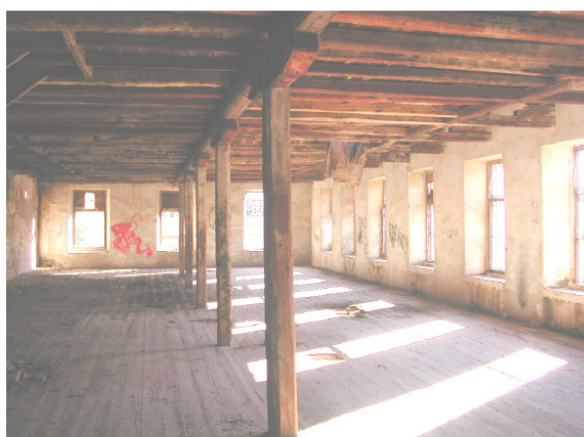
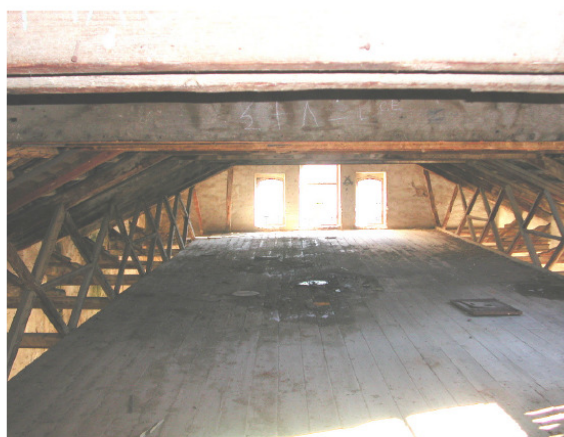
Figure 2: Outside south-western view and inside views of each floor of the tobacco warehouse (the photos were taken in 2003, before the intervention works of 2004-05).

Recently, the building was bought by the municipality with the purpose of its future use as the Municipal Library. At that time despite the large extent of the damages due to the forlornness and the thieveries the building was a stable structure as it can be observed in the photographs of Figure 2. The wooden diaphragms of the basement, the ground floor, the first floor and the attic were intact and in a relatively good condition. These diaphragms and the roof connected the opposite perimetric masonry walls and maintained this way a stable equilibrium for the whole structure.

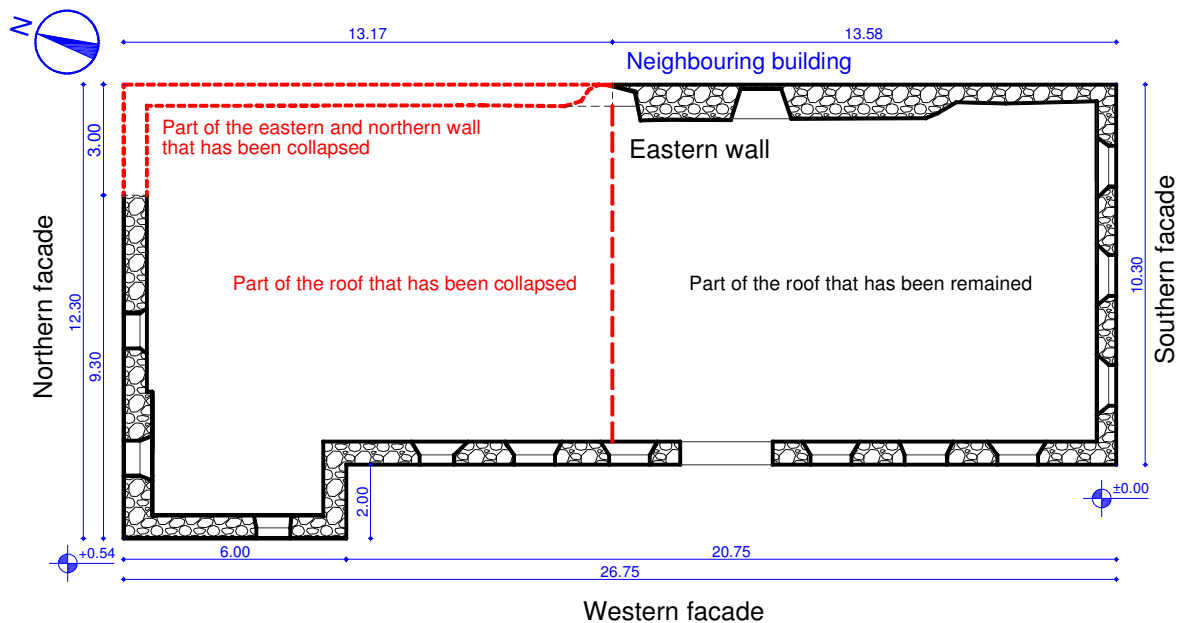
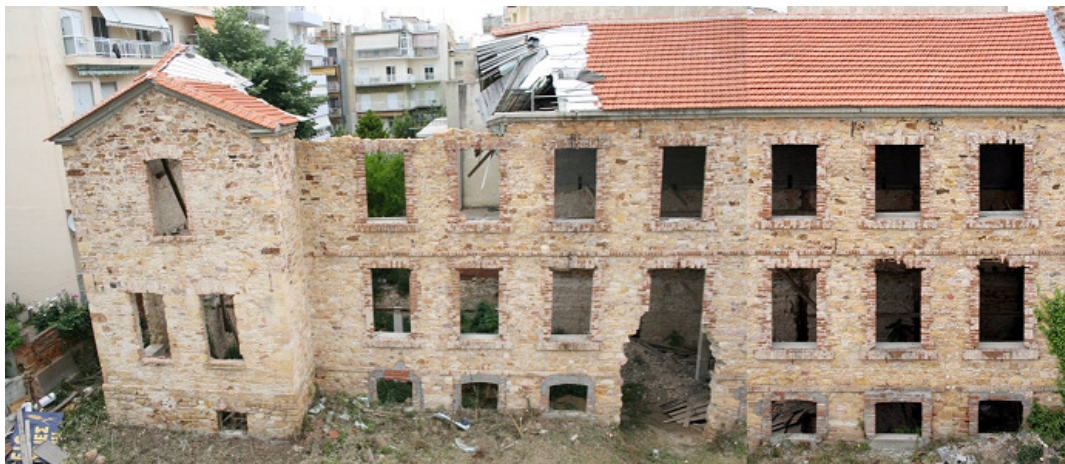
Thus, in the year 2004 the intervention works for the rehabilitation of the building and the forthcoming re-use as the Municipal Library began. However, these works during the years 2004-05 proved to be inappropriate and catastrophic for the building because the removal of all the interior old structural members without the proper shoring of the perimetric walls and the roof had as a result the sudden partial collapse of the building; part of the eastern and northern wall along with part of the roof collapsed, as displayed in Figures 3a & b. After that incident the works stopped and the building has remained heavily damaged, partially-collapsed, unsafe and apparently unapproachable to anyone due to the immediate danger of further collapsing.

Figure 3: (a) Plan view and (b) external view (western façade) of the building after the partial-collapse of 2005.

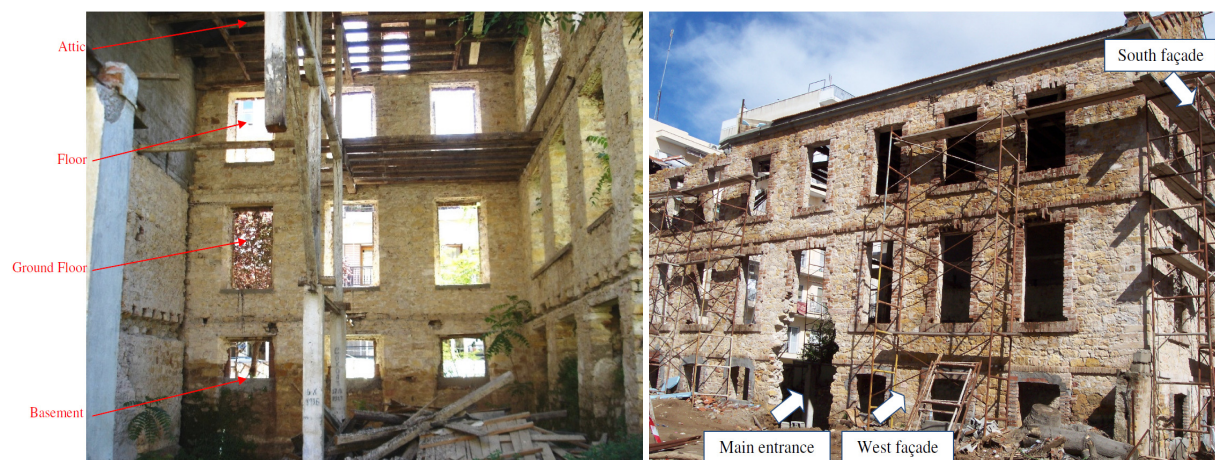
According to the approved restoration plan of 2004-05 almost all the wooden floors and columns of the building were removed (see also Figure 4a) without shoring the walls or any other safety measures, although it is well known that floors of multi-storey bearing masonry buildings are very important structural components since they form horizontal diaphragms that connect and restrain the perimetric masonry walls of the building. After the partial collapsing the few remained columns can hardly bear any loads and even more some remained parts of wooden columns are literally hanging from the roof making the working environment quite risky and dangerous.

After the collapse the building consisted of the perimetric masonry walls (except for parts of the eastern and northern walls that have fallen), two columns per floor and part of the roof. The masonry walls sustained ageing, damages and cracks. The main entrance at the west façade has become a very dangerous point for anyone who wants to enter the building due to its inappropriate widening of the opening during the intervention works (Figure 4b). Further, the eaves of the walls (the ridge was made of concrete) sustained serious damages and cracks, whereas at some parts they have been destroyed by the fallen parts of the roof. Figures 5a & b shows the partially-collapsed masonry walls (northern and eastern walls). The masonry wall that sustained the greater damage is the eastern one. Further there are three vertical and one horizontal deep grooves on the internal side of the eastern wall (Figure 5c).

Figure 4: (a) Inside and (b) outside views of the building after the partial-collapse of 2005.

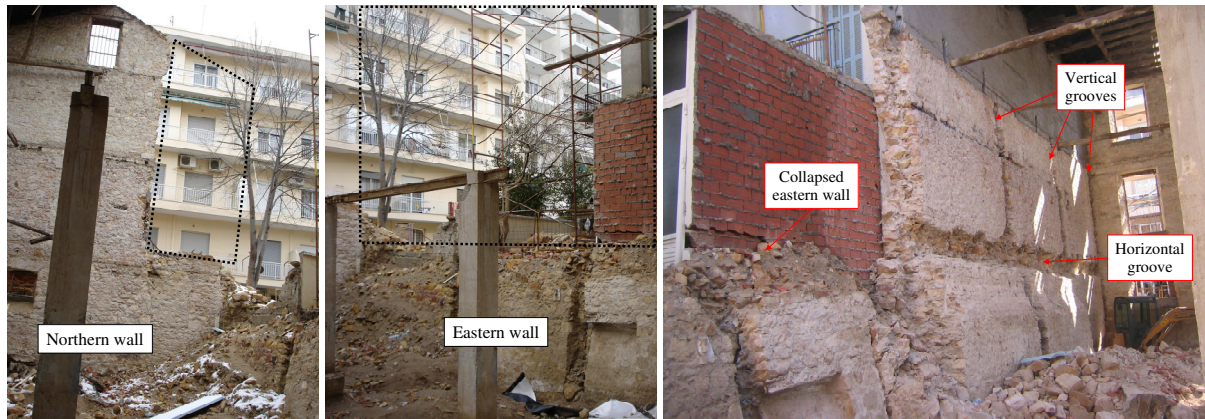
According to the plan of the recent interventions those grooves were meant to be the positions of the RC columns (vertical grooves) and beam (horizontal groove) of the new internal RC structure. In order to gain space, the new RC columns and beams at the eastern side of the inner structure were designed to be placed inside the existing masonry walls. For this reason the cutting and creation of vertical and horizontal grooves in the masonry of the existing eastern wall was planned. However, this intervention proved to be quite inappropriate, very dangerous and in effect catastrophic for the stability of the existing masonry walls and the old structure as a whole.

Figure 5: Inner views of the (a) northern and (b) eastern masonry walls of the building after the partial-collapse of 2005. (c) Eastern masonry has three vertical grooves and one horizontal groove on the internal part of the wall.

However, the depth of the grooves is approximately half of the total width of the wall and the capacity and stability of this stone masonry is considerably decreased. Further, the wall at the upper floor and the attic has been reconstructed during the recent interventions using low capacity cinder blocks. Furthermore the removal of the three horizontal wooden floors of the building has made the 11 m height wall extremely unsafe and totally unpredictable in any new intervention.

The problem can be approached with the use of cast-in-place concrete or shotcrete with dry-mix process that can fill the vertical and horizontal grooves, forming a RC beams-columns supporting system of the masonry [8-12]. These new RC members will also be part of the new internal RC structure. Geometrical outline figures of the RC internal frame of the eastern masonry wall are presented in Figure 8. The RC members can be designed according to the specifications of Eurocode 2 and 8 [13-16].

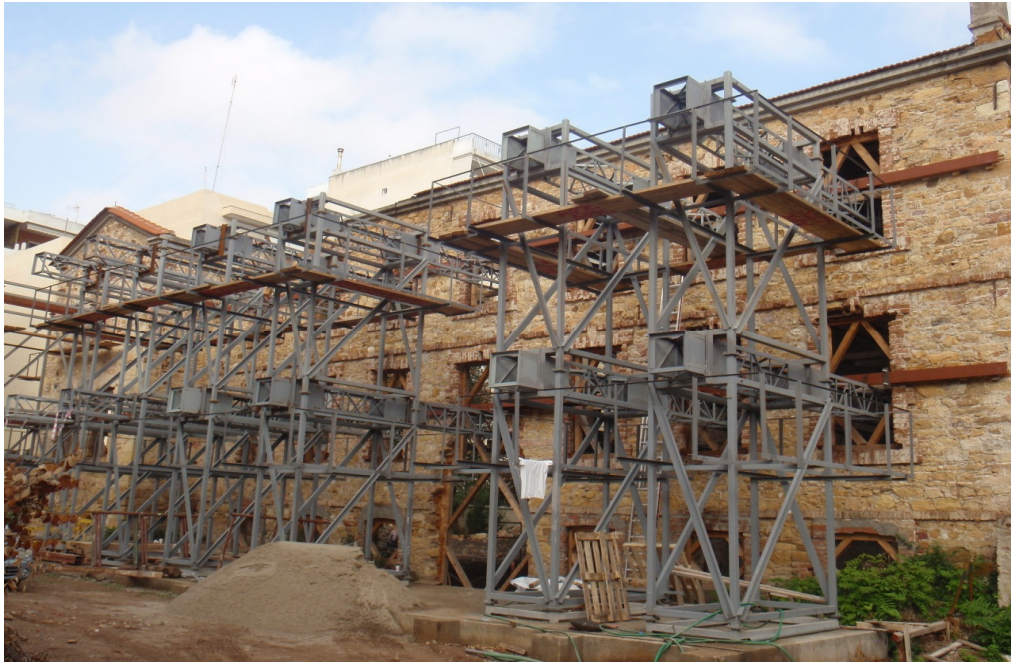
Figure 6: Outside view of the external non-permanent steel towers for the temporary support of the façades.

The geometry of the building, the condition of the damaged masonry walls, the urban character of the project, the free space inside the building plot, the neighboring buildings, the foundation soil and the seismicity of the region were the parameters that have defined the supporting system of the façades. Thus, vertical steel towers placed outside of the building comprise the temporary supporting system of the masonry walls, as shown in Figure 6. These towers will be removed when the rehabilitation procedure will be completed. It is mentioned that before the installation of these supports, it is necessary all the openings (windows and entrance) of the building to be properly stabilized. This can be achieved by mounting wooden frames and beams inside these openings (see also Figures 6 and 7).

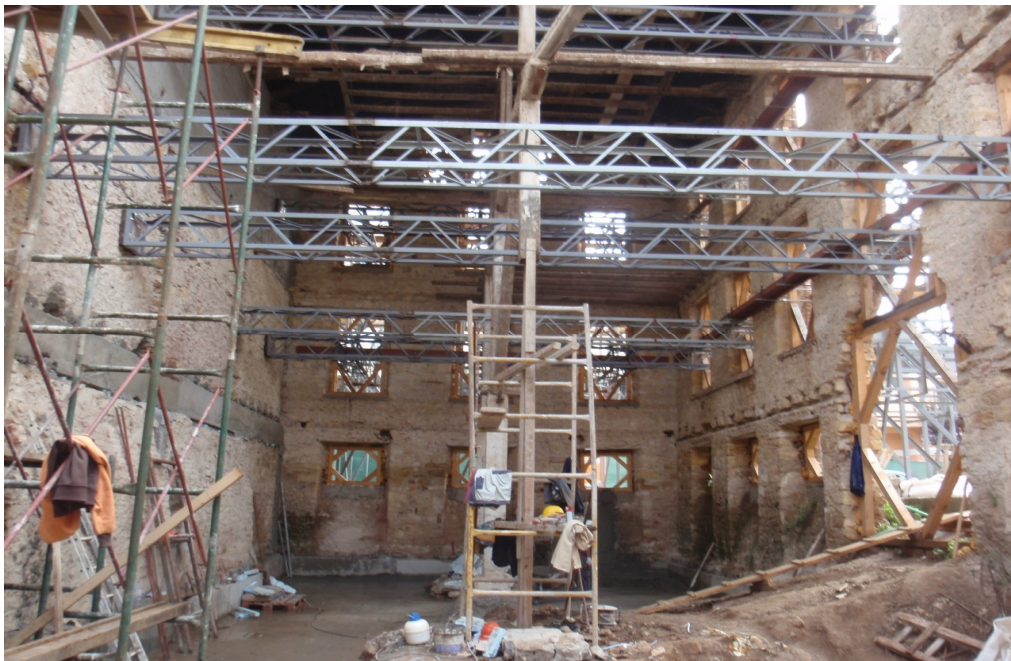
Figure 7: Inside view of the temporary supporting system of the substantially damaged eastern masonry wall.

One of the challenges of the rehabilitation design plan is how to face the problem of the supporting and strengthening of the heavily damaged and unsecure eastern masonry, since at this side of the building there is an adjacent multi-storey apartment building and there is no space for the installation of an exterior steel tower. Part of this masonry wall has collapsed and furthermore some very deep and dangerous vertical and horizontal grooves have been formed on this stone wall during the works of 2005. These grooves have been cut for the construction of the RC columns and beam of the new internal frame structure that was the next step of the rehabilitation plan.

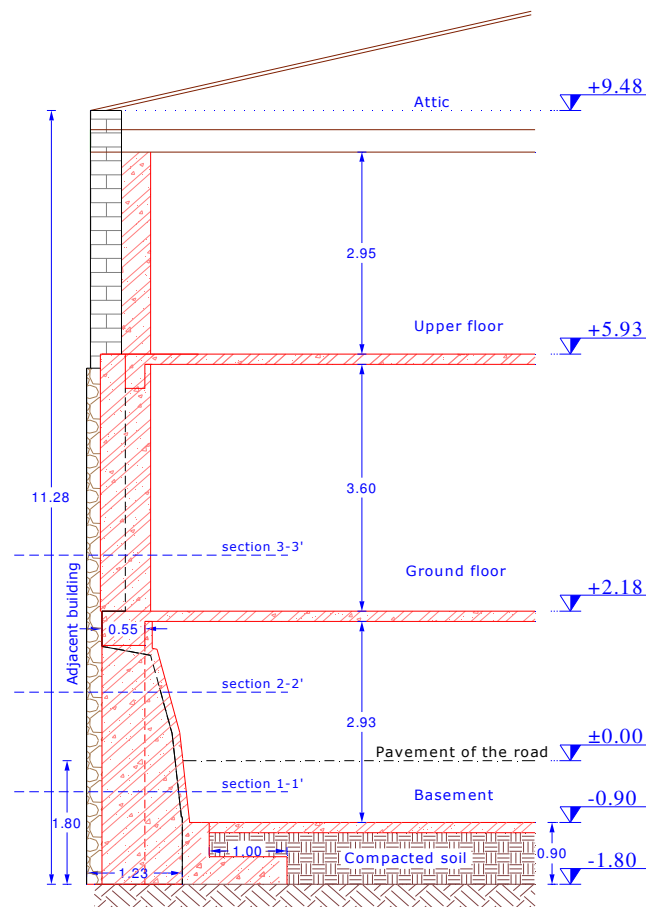
Figure 8: Geometrical outline figure of potential internal reinforced concrete frame inside the grooves of the eastern masonry wall.
