## RECORDING HISTORIC MASONRY BUILDINGS USING PHOTOGRAMMETRY- TWO CASE STUDIES

**Keywords:** Masonry Building, Partial Collapse, Surveying, Photogrammetry.

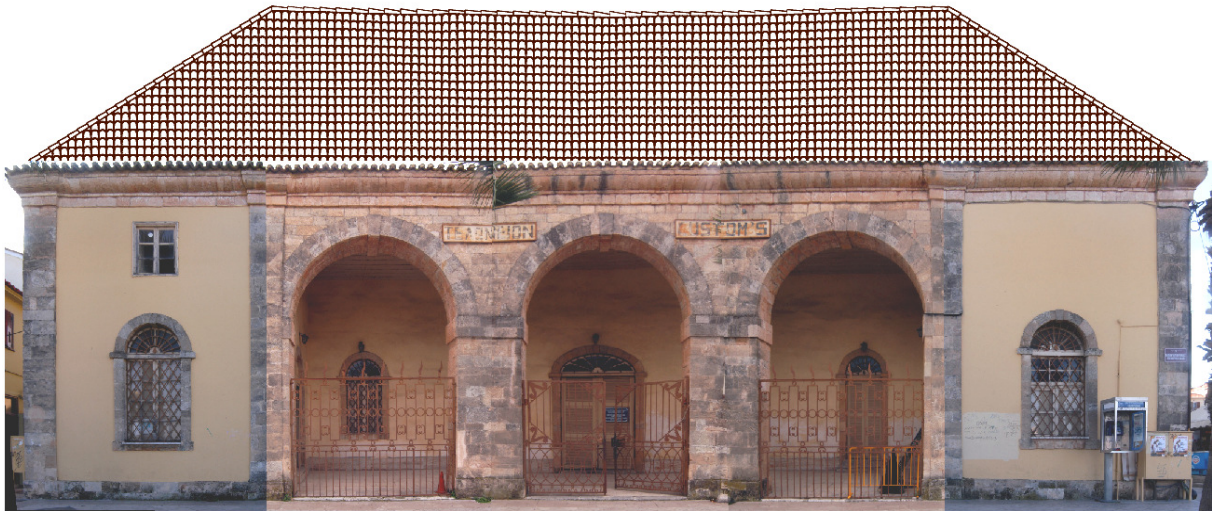
Figure 3: Northern façade of the old customs house.

The building suffers from damages and wears due to the aging of the materials, to the high humidity due to its seaside location as well as the neglect and lack of maintenance. The damages that are related to the structural system of the building (masonry) are local wears and cracks at the arches of the lintels as well as at certain masonries. Cracks are also observed at the connections of the inner masonries. The majority of the cracks are transversal with rather small to medium width (under 10 mm). Some slight longitudinal cracks (width < 3 mm) are also detected near the windows (lintels and sills). Finally, some carved limestones, without any coating, that cover the pillars of the arcade sustain wears due to aging. Further, as it was expected, all the construction materials of the masonry, natural stones, clay mortars, carved limestone and bricks contain soluble salts, mostly chloroide, because of their exposure to the marine environment according to the results of their examination at the laboratory. A vertical displacement of 14 cm is also observed at the roof (see also Figure 3). This deformation is

located mainly at the northern and the southern façade. The wooden elements of the roof (trusses, batters, sheeting) are more or less in a good condition given their age. However certain wooden elements should be replaced due to aging and the lack of maintenance.

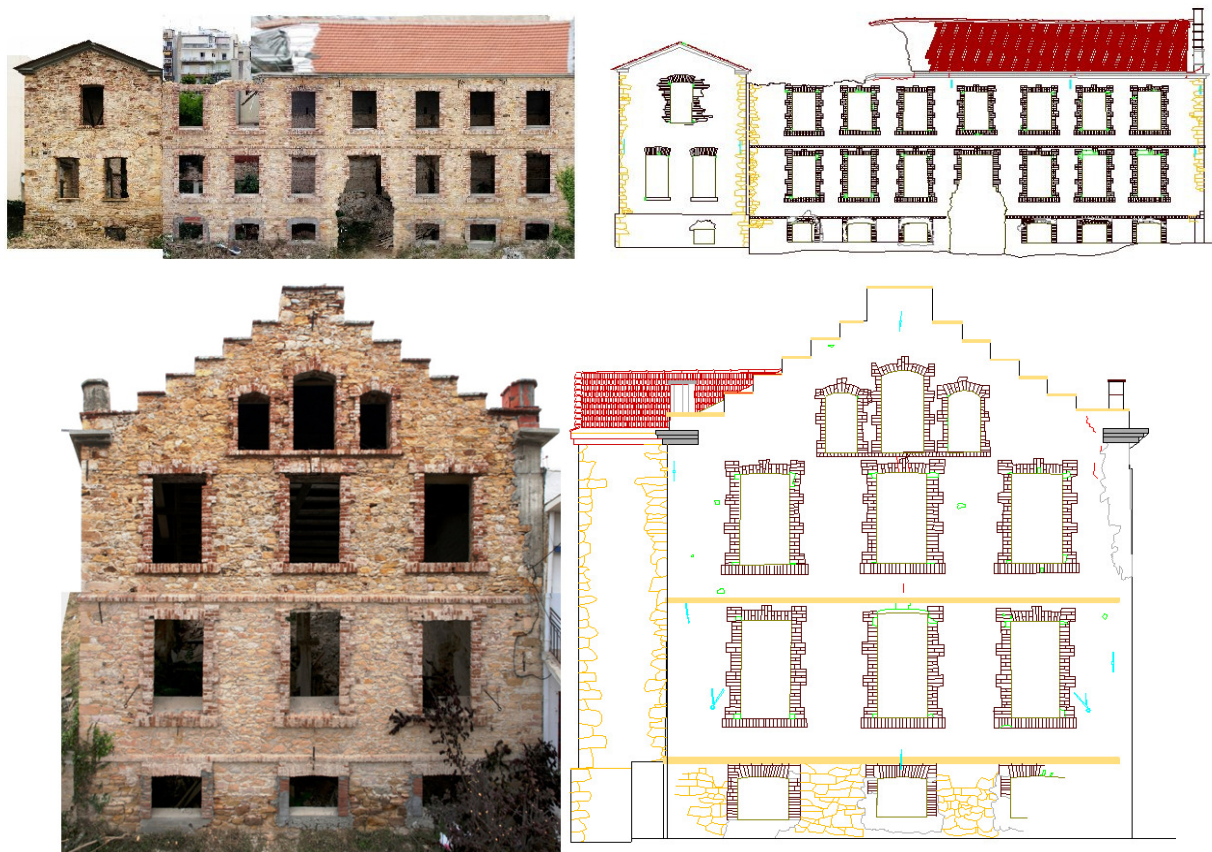
Figure 5: Rectified mosaic of images (left) and corresponding digitized façade (right) of the western and the southern façades of the partially-collapsed tobacco warehouse in Alexandroupolis

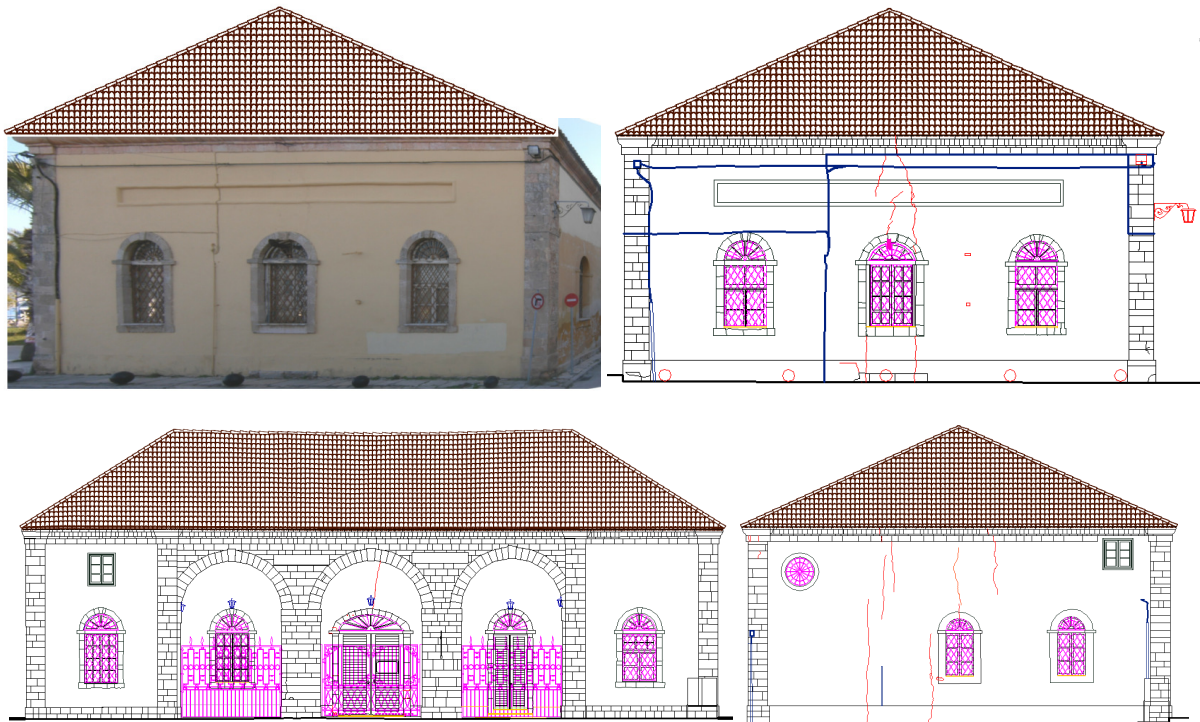
Figure 6: Rectified mosaic of image of the western façade and digitized façades (western, northern and eastern) of the old customs house in Nafplio along with the detected cracking of the masonries.
