STRUCTURAL UPGRADING OF A 3-STOREY HERITAGE STRUCTURE OF 1925 IN THESSALONIKI

Abstract. *The structural upgrading and rehabilitation procedure of a historic building representative of 1920s construction in Thessaloniki, Greece is presented. The case study building is a listed three-storey reinforced concrete flat-slab frame structure sited in Nikis Avenue in front of the old seaside of the city of Thessaloniki. Reinforced concrete columns and beams frames along with wide infilled masonry walls are the load-bearing elements of the structure. The building was designed in 1925 without Seismic Code requirements and constructed in 1926. The ground floor was used for many years as a cinema, whereas the upper floors are areas where people may congregate since they are used as assembly halls (dining halls, reading and conference rooms). Concrete core tests and in-situ non-destructive tests were first performed to evaluate the compressive strength of the concrete and to detect - determine the existing steel reinforcements of the reinforced concrete members. The concrete strength was low and the steel reinforcement of several columns of the ground floor and slabs of the upper floors was fou

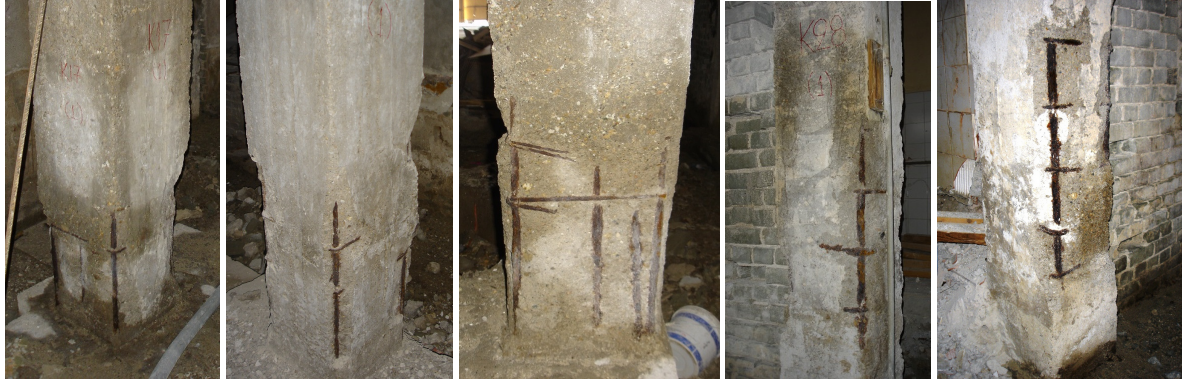
Figure 3: Corrosion of the steel reinforcement of the RC columns K17, K21, K24, K28 and K29 (ground floor).

The main damages of the building come from the aging of concrete and the extensive corrosion of the reinforcing steel, as shown in the photographs of Figures 3 and 4. Limited and rather expecting cracking has also been observed in the RC beams and slabs of the structure

Plain round mild steel bars and stirrups have been used for the reinforcement of the concrete elements of the building. The characteristic strength of the mild steel used is 220 MPa. Further, in situ observations and half-cell potential measurements highlighted the problem of corrosion in the steel reinforcement of many RC elements (see also Figures 3 and 4).

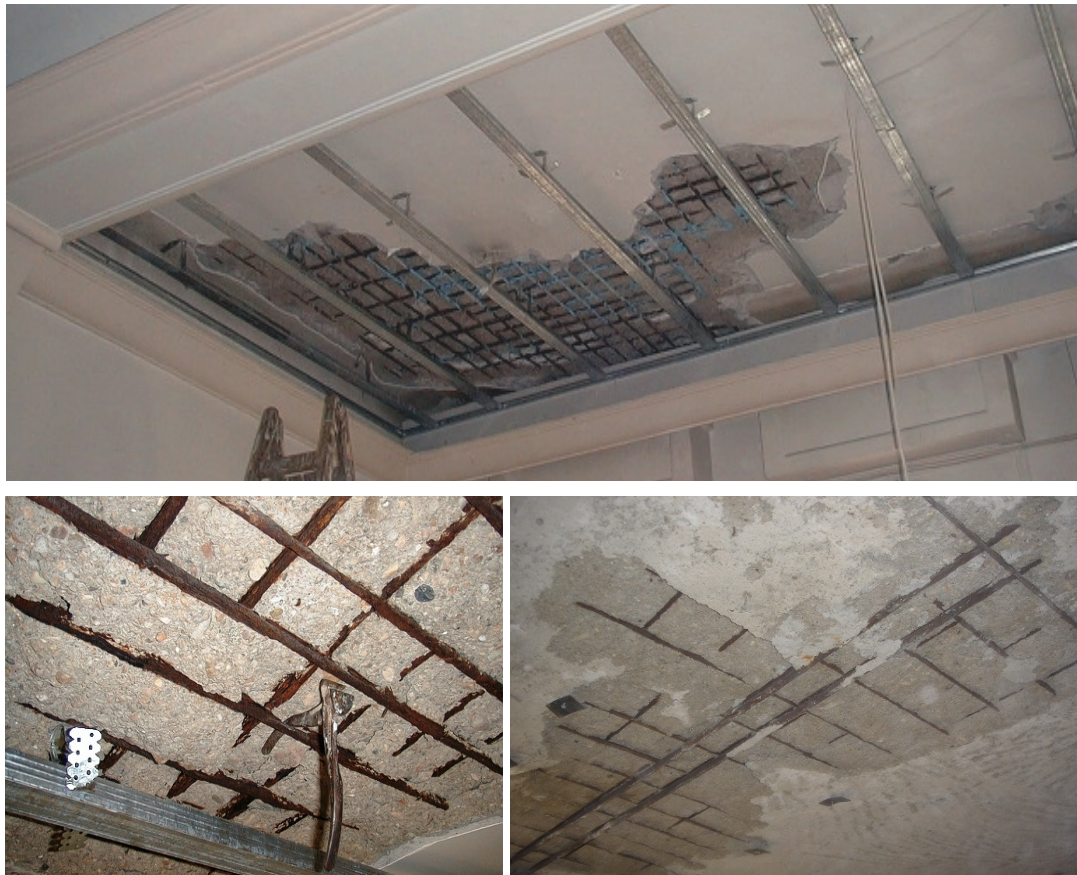
Figure 4: Extensive corrosion of the steel reinforcement of the RC slabs.

Further, selected infilled masonry walls along with the deficient beams and slabs due to corroded steel reinforcement have also been strengthened using new steel reinforcement and shotcrete, as shown in Figure 5. Moreover, since the front façade of the upgrading heritage building should be remained intact, a new two columns - beam RC frame has been constructed in the interior of the structure. This frame is in contact and connected with the structural RC elements of the front façade.

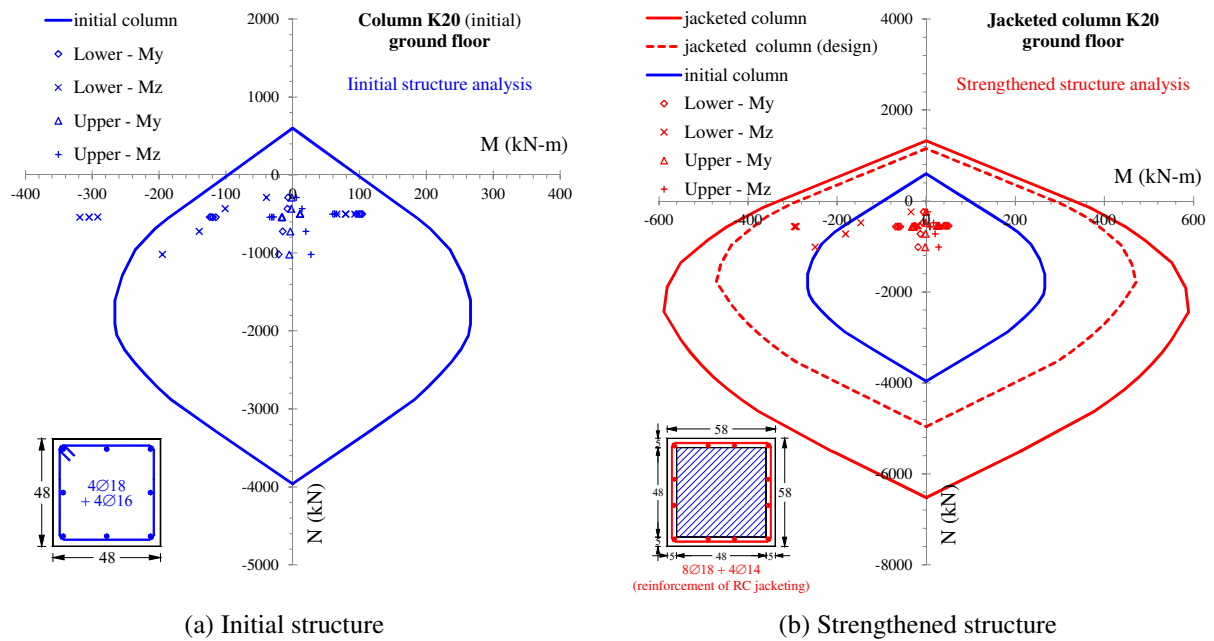
Figure 8: Bending moment (M) versus axial force (N) interaction curves for the column K20 of the ground floor. The data points (M, N) represent the design values of the applied M and N derived from the seismic analyses of the (a) initial and (b) strengthened structural system. The strength of the existing column does not satisfy the design requirements of both analyses (initial and strengthened). Thus, column K20 of the ground floor is strengthened by applied RC jacket.

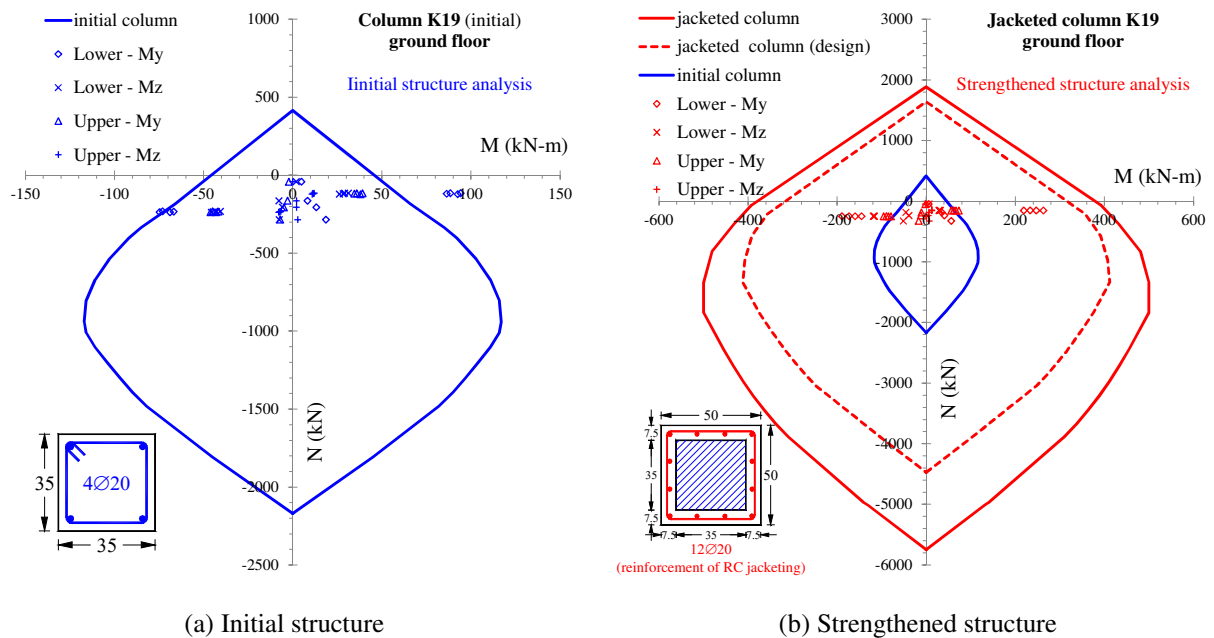
Figure 9: Bending moment (M) versus axial force (N) interaction curves for the column K19 of the ground floor. The data points (M, N) represent the design values of the applied M and N derived from the seismic analyses of the (a) initial and (b) strengthened structural system. The strength of the existing column does not satisfy the design requirements of both analyses (initial and strengthened). Thus, column K19 of the ground floor is strengthened by applied RC jacket.
