THE EMILIA EARTHQUAKES: REPORT AND ANALYSIS ON THE BEHAVIOR OF PRECAST INDUSTRIAL BUILDINGS FROM A FIELD MISSION

Dionysios A. Bournas¹, Paolo Negro², and Fabio Taucer²

² Joint Research Centre, European Commission
T.P. 480, I-21020 Ispra (VA), Italy
e-mail: paolo.negro@jrc.ec.europa.eu; fabio.taucer@jrc.ec.europa.eu

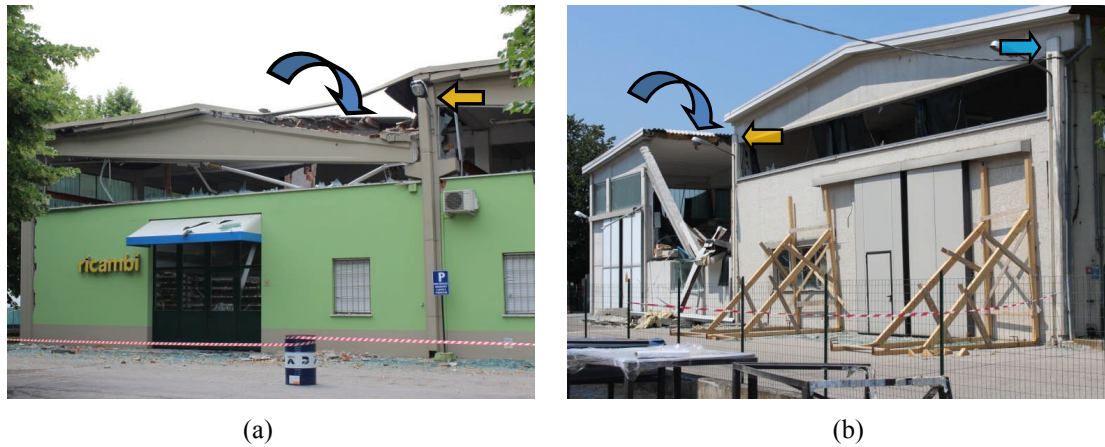
The weak link in the vast majority of the industrial buildings visited was the absence of mechanical connections between roof-girders and columns. The most common typology corresponded to double-slope beams, simply supported over special openings (forks) at the top of columns as shown in Fig. 4. This typology was used in Italy during the 60s and 70s for agricultural buildings, now being replaced by the more common flat-roof systems. In this connection typology, the capacity of transferring lateral loads depends entirely on the static coefficient of friction between the supporting surfaces of beam and column and on the length of the beam seating when the friction forces are exceeded by the earthquake force demands.

Figure 5: (a) Loss of beam seating from the central column and associated collapse of a double slope precast beam (the blue curved arrow shows direction of collapse and the orange arrow shows the intermediate beam); (b) Longer seating of the end beam at the external column (blue arrow).

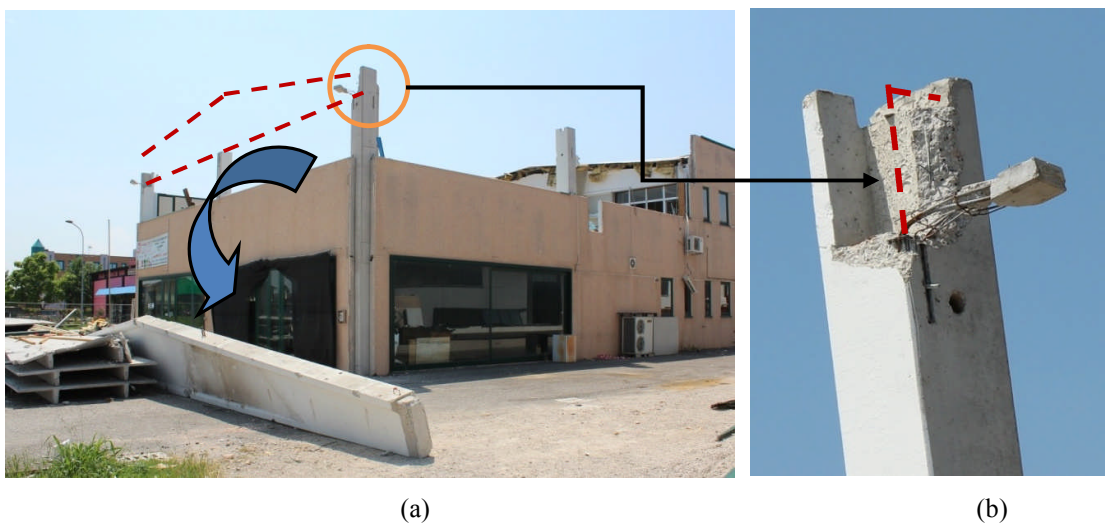
Figure 6: (a) Out-of-plane collapse of a double slope precast beam after unseating following failure of the lateral restraint of the fork at the seat pocket; (b) Detail of the shear failure of the fork.

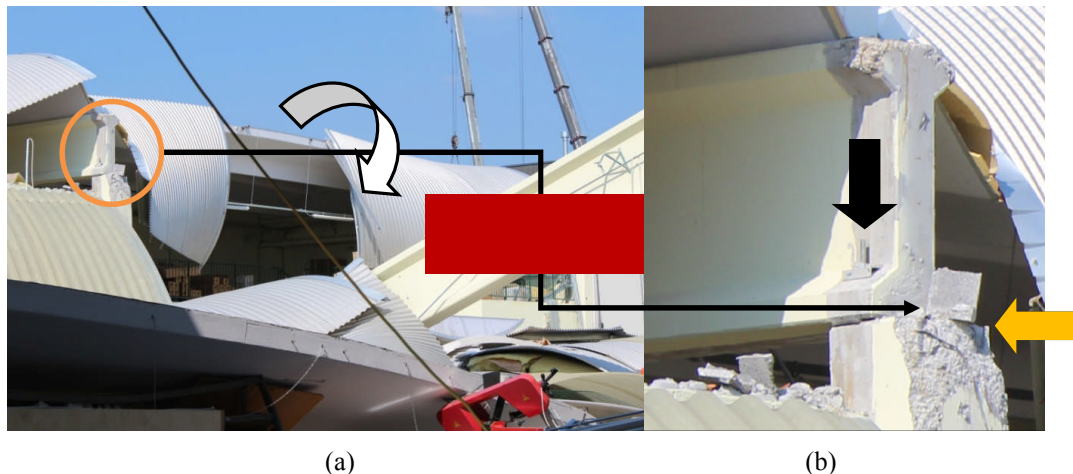
It is worth mentioning that a building completed in 2010 showed partial collapse, in spite of having been designed (according to information provided by the owner) with pinned beam-column connections following the new Italian construction standards. Visual inspection revealed failure at the top of one of the central column beam-column connections. This failure was followed by loss of the girder seating and its subsequent collapse (Fig. 7a). The rather limited distance of the dowels from the edge of the column and the limited amount of transverse reinforcement might have resulted into the formation of a shear crack across the concrete cover (Fig.7b), followed by the loss of the dowels anchorage and consequently the loss of the girder seating. This failure reveals the absence of specific provisions for detailing the beam-to-column connections in the current Italian construction standards and the as well as in the Eurocodes [10].

Figure 7: Loss of girder seating in a recently constructed industrial building after failure of the pinned beam-column connection: (a) General overview of the collapsed beam (red dashed lines); (b) Detail showing failure of the column support at the beam-column pinned connection. Orange arrow shows damaged area at the top of the column, while red arrow shows an undamaged pinned connection.

The partial collapse of the industrial building with pinned beam-column connections completed in 2010 and described in Section 4.2 brought in light the lack of specific provisions for the detailing of beam-to-column connections by the Italian construction standards and the Eurocodes. To address such issues related to the seismic design of precast concrete structures a large amount of pre-normative research [17, 18] for the development and maintenance of the Eurocodes was carried out at the European Laboratory for Structural Assessment (ELSA) of the Joint Research Centre (JRC) of the European Commission at Ispra (Italy). To this end the research project [SAFECAST](#) (Performance of innovative mechanical connections in precast buildings structures under seismic conditions, Grant agreement n° 218417-2), financed by the Seventh Framework Programme of the European Commission, was recently undertaken to fill the gap in the knowledge of the seismic behavior of the mechanical connections used in precast concrete structures. A set of guidelines for the design of connections of precast structures in seismic areas was finally delivered in the framework of SAFECAST [19].

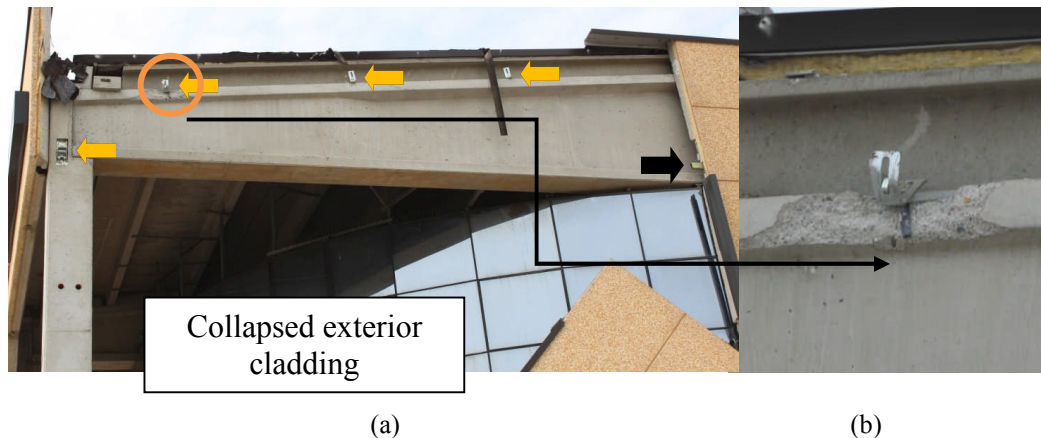
Figure 8a illustrates the in-plane detachment of an exterior cladding element after failure of the connections (Fig. 8b) with the main structure. The design of the claddings connections proved to be insufficient also in the orthogonal direction. The out-of-plane inertial effects of the panel led to the development of high out-of-plane lateral forces that induced failure in the panel-to-frame and panel-to-panel connections.

Figure 8: (a) Cladding panel collapse after failure of the connections with the main structure (orange arrows showing the location of connections of the collapsed exterior cladding); (b) Detail showing failure of the mechanical connection.

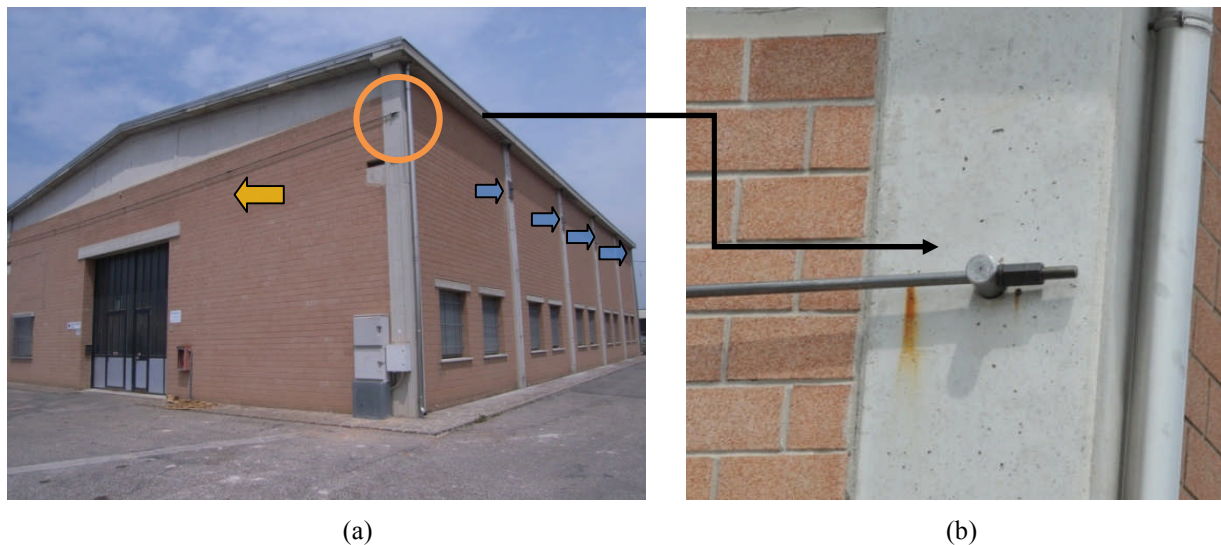
During the field visit the team inspected a precast industrial building that had been retrofitted following the first event (after information gathered from the building owner). The building corresponded to the typology with simply supported beams on columns designed for gravity loads only. The retrofit consisted in a series of steel ties in line and below the main girders, as shown in Fig. 9. The steel ties were anchored at the top of the columns in the transverse direction and might have prevented opening of the columns and loss of seating of the girder during the 29 May event.

Figure 9: (a) Steel ties anchorage system installed after the main event to stabilize the structure: orange arrow showing the external tie, blue arrows showing the internal ties. (b) Detail of the anchorage at the external tie.
