## FINITE ELEMENT SIMULATION OF A STEEL BRACED FRAME STRUCTURE DAMAGED BY THE 2011 TOHOKU EARTHQUAKE

**Abstract.** *During post-earthquake reconnaissance after the March 11, 2011 Tohoku Earthquake, the writers examined a damaged parking ramp structure. The structure was a two-story steel structure with a 52.5 by 48.5-m floor plan which relied on chevron braces for lateral load resistance. The earthquake damaged nearly all first-story braces in their connection to the beam. The majority of bracing connections had fractured in the east-west frame while many bracing connections were distorted, but none of them fractured, in the north-south frame. The cause of the observed damage was examined by detailed finite element simulations. Planar models of the structure, one extracted from the east-west frame and another extracted from the north-south frame, were subjected to static cyclic loading and to a ground motion record obtained within 800 meters from the structure. The simulation captured the main features of the observed damage. The results suggest that the bracing connections in the east-west frame failed under a compressive force much smaller than the buckling load of the brace. Al

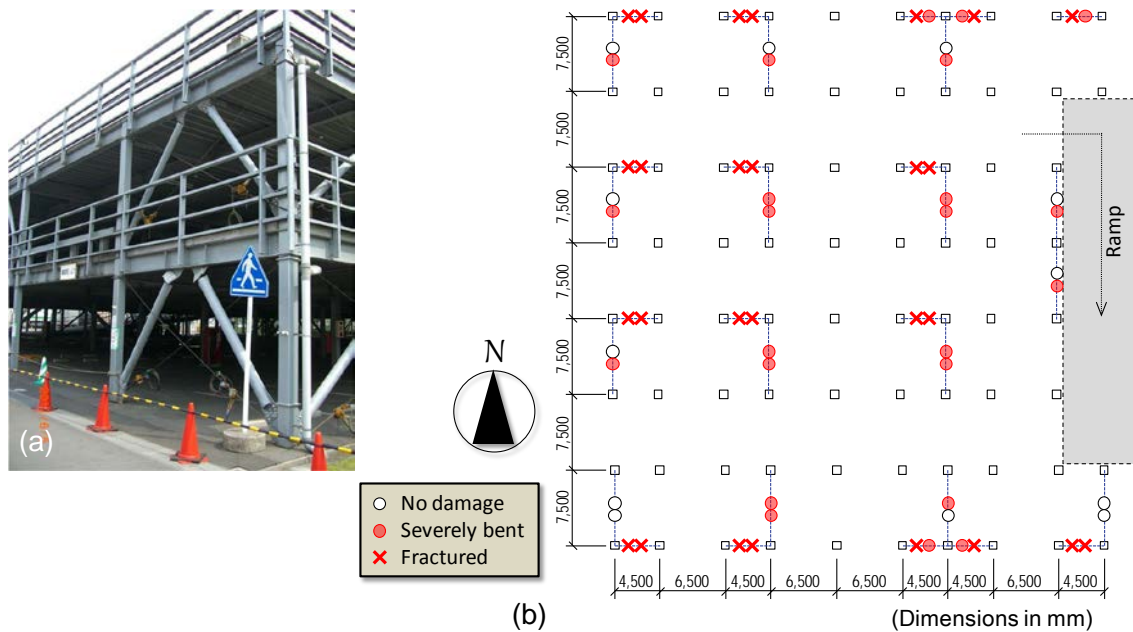
During post-earthquake reconnaissance after the 2011 Tohoku Earthquake, the writers examined a damaged parking ramp structure. The structure was a two-story steel structure with a 52.5 by 48.5-m, 9 by 7-span floor plan, comprising square-hollow structural section (HSS) columns, I-section beams, and round-HSS braces, all of galvanized steel. The beams were simply connected to the columns, and single-lap bolted connections were used for the bracing connections. Although not confirmed, it is believed that the base of the column base (which was covered in asphalt and hence not visible) was connected to a foundation through a base plate and anchor rods. Fig. 1 shows the primary dimensions and sections in the east-west and north-south braced bays. The slenderness ratio of the braces based on the diagonal, face-to-face distance between the beam and column, was 54 in the east-west bay and 69 in the north-south bay. The residual story drift ratio was 0.01 rad. in the east-west direction but minimal in the north-south direction. As indicated in Fig. 2, nearly all first-story braces were damaged in their connection to the beam. The majority of bracing connections had fractured in the east-west frames while many bracing connections were distorted, but none of them fractured, in the north-south frames. The damage is extremely concerning because this structure relied solely on the braces for lateral-load resistance. The structure was sealed from entry when the writers visited, and demolished shortly afterwards.

Figure 2. Damaged parking ramp: (a) photo; and (b) floor plan indicating damage location in the first story.

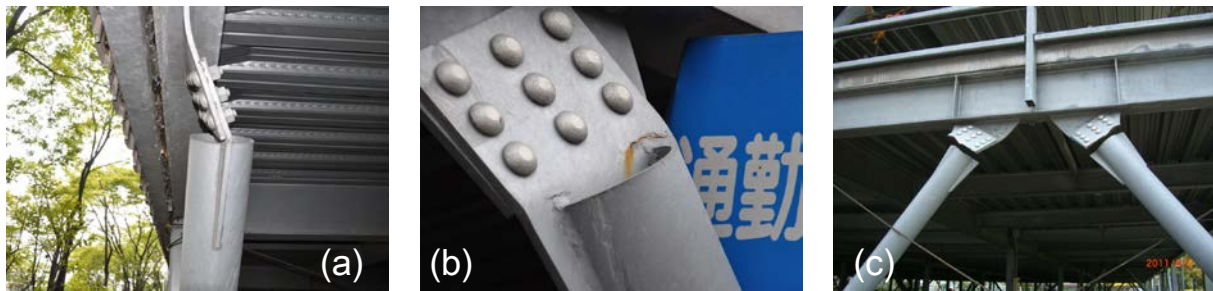
The use of single-lap bolted connections in the bracing connections seemed to be a primary cause of the extensive damage. The difference in out-of-plane flexibility was believed to have caused the fracture to occur only in the upper-end gusset plate and not in the lower-end gusset plate. Fig. 3 shows bracing connections at different stages of failure, from (a) out-of-plane

Figure 3. Connection damage: (a) bent out of plane; (b) fracture initiation; and (c) complete fracture.

distortion, (b) fracture initiation near the termination of the welds connecting the brace to the gusset plate, to (c) complete fracture. Although the cause of damage seemed to be straightforward, a number of questions remained after the field study. Most notably, why was the damage clearly more severe in the east-west frames than in the north-south frames, and what was the actual lateral strength of the structure?

than in the gusset plates. Consequently, in compression, the gusset plate was substantially weaker than the brace in the east-west model, but the gusset plate and brace were similar in strength in the north-south model. While fracture was not explicitly modeled in the simulation, the computed plastic strain indicated that the observed fracture in the bracing connection (see Fig. 3) was due to severe cyclic deformation produced while the brace was in compression.

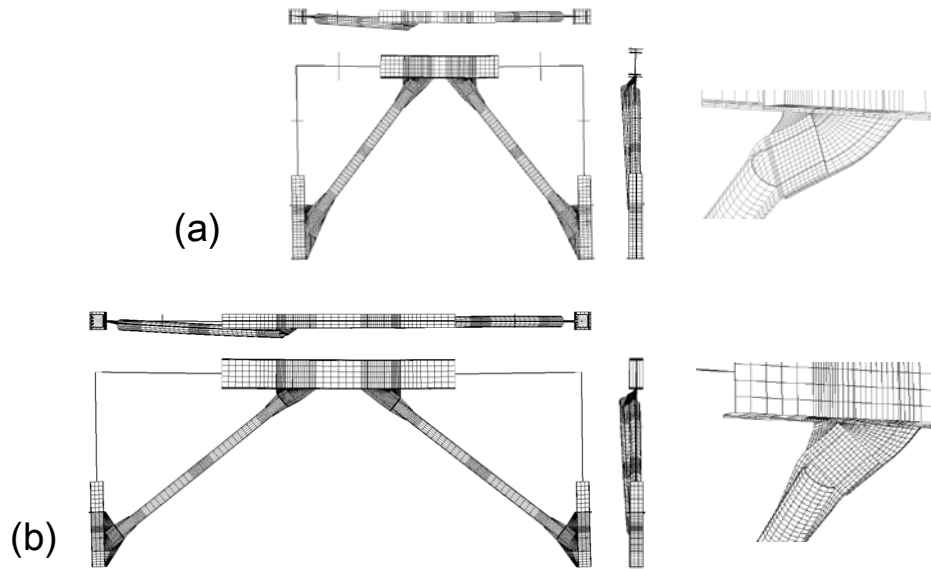
Fig. 7 shows the deformation of the model at the end of the analysis where the model was deformed to a story drift of -0.018 rad. In both models, deformation concentrated in the upper-end bracing connection. The beam is deflected downwards, as described above, due to the force unbalance between the two braces. In fact, throughout the analysis, all other members remained elastic while the upper-end bracing connection folded and straightened, and the beam deflected downwards twice within each loading cycle. The deformed shape suggests that, due to the intrinsic eccentricity in the single-lap connection and lack of edge support, the gusset plate deformed out of plane when compressed. The computed deformation coincides with the damage of the original structure described previously.

Figure 7. Deformed model at end of analysis: (a) east-west model; and (b) north-south model.
