SEISMIC RETROFITTING EFFECT OF 10-STORY RESIDENTIAL BUILDING RETROFITTED USING PASSIVE SEISMIC CONTROL SYSTEM WITH AMPLIFIER MECHANISM

Y. TAKASE¹, T. IKEDA², AND T. SUZUMURA³

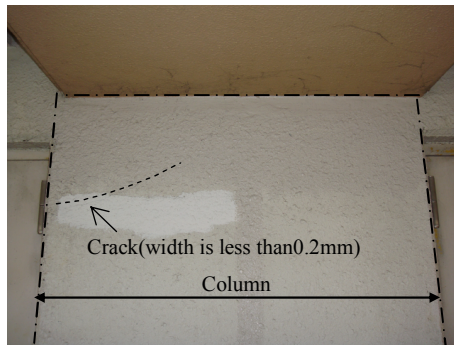
Photographs 1 and 2 show an existing column with cracking and a wall with slits on three sides, respectively. Small cracks were confirmed in some of the existing columns and beams, most of which had a width of 0.2 mm or smaller. The damage was classified by the Japanese guidelines for evaluating seismic performance of reinforced concrete structures as the “one that enables continued use of the structure without repair”. Photograph 2 shows that shear cracks occurred in the wall with three slits but that none progressed to existing columns. It was thus determined that the slits worked effectively

Photo. 1: Example of Columns with cracking

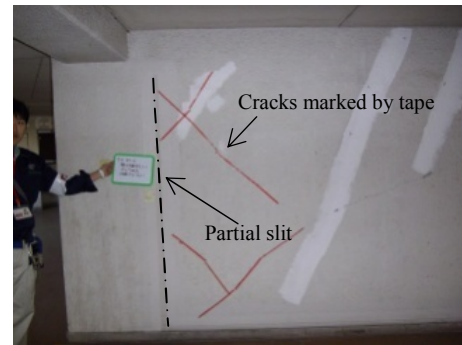
Photo. 2: Shear wall with slit

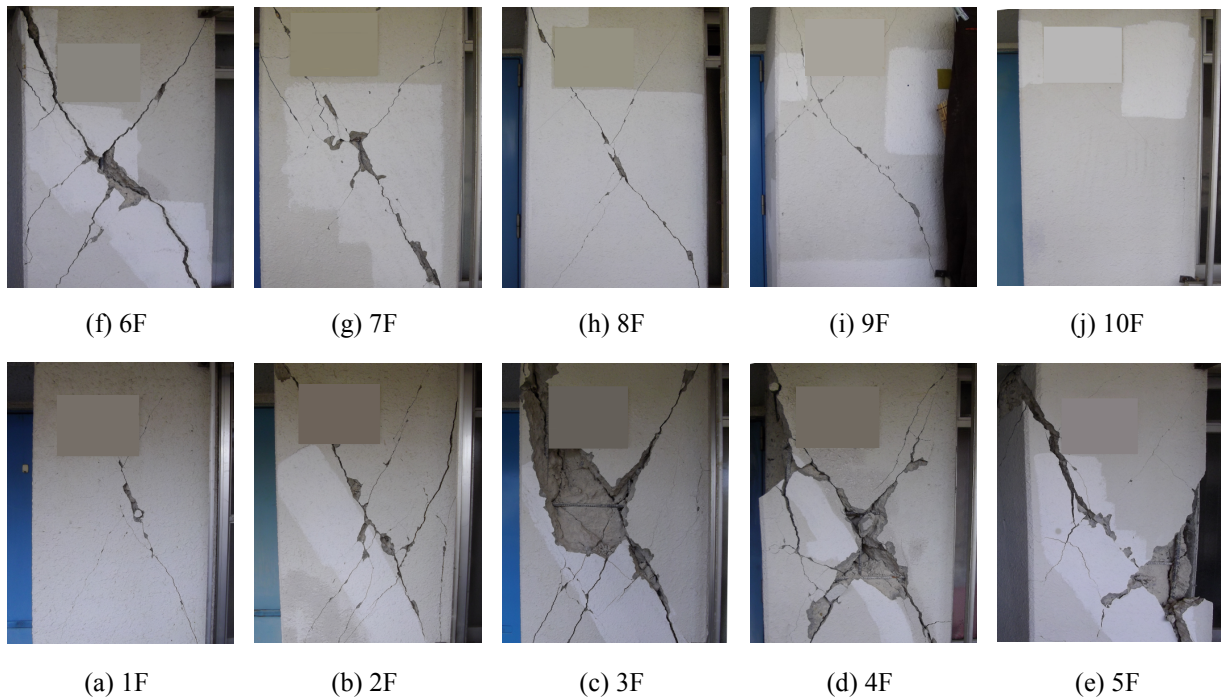
No measures were considered in the retrofit design to avoid or reduce damage to nonstructural members. Shear cracks were confirmed in the partial walls on the side of the side corridor. In the 120-mm-thick partial wall, $\phi=10\text{mm}$ reinforcing bars were arranged at a pitch of 250 mm. Photograph 3 shows the damage to the partial walls between lines (viii) and (ix) on the first through tenth floors. Only moderate shear cracks with a width of approximately 0.2 mm (concrete crack width except spalling) were found in the partial walls on the first and tenth floors. Damage was larger on the middle floors. The spalling of concrete cover was confirmed on the third through fifth floors. In the surveys, the residual crack width was measured with a crack scale in partial walls on each floor. The results are shown in Section 3.5.

Photo. 3: Failing of partial walls

One of the characteristics of damage to the Building was the confirmation of shear cracking in partial walls despite the soundness of structural members owing to seismic retrofit. Partial walls were nonstructural members. The damage to partial walls was allowable according to the seismic design policy of the Building. Knowing the degree of influence of partial walls on the seismic behavior of the Building provides valuable data for future seismic retrofit design. In this chapter, the maximum shear on the partial wall, shear deformation angle in shear failure is reached and the time of partial wall failure are estimated.

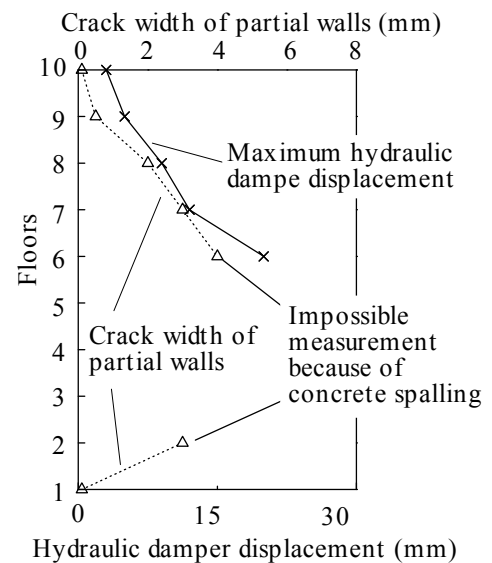
Figure 2: Results of the survey

In the surveys, total traces of lubricant left each time the hydraulic damper worked during an earthquake were verified. Hydraulic displacement was measured based on the trace. If it was assumed that the hydraulic damper returned to the center after the earthquake, the measurement would have indicated the unidirectional hydraulic displacement (in the direction in which the damper shrank). The maximum hydraulic damper displacements on respective floors are shown in Figure 2 together with the residual crack widths in the partial walls. The figure shows that the hydraulic displacement of damper was largest on the sixth floor and smaller on the upper floors. The tendency was similar to the state of residual crack widths in the partial walls. In the partial walls on the third through fifth floors, no residual crack widths could be measured because of the spalling of concrete.

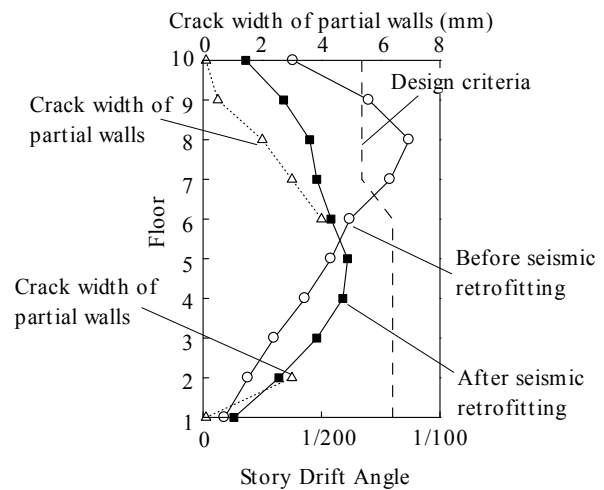
Figure 6: Story Drift Angle

Figure 6 shows the results of analysis of the maximum story drift angle in the longitudinal direction in the case with or without seismic retrofit for comparison. Story drift angle before seismic retrofit exceeded the design criteria (reinforced concrete structure: 1/150, SRC structure: 1/125) on the seventh through ninth floors and increased to 1/115 on the eighth floor. In the case without seismic retrofit, therefore, some damage may have occurred such as the shear failure of structural members on upper floors of the Building. The distribution of story drift angles in the direction of height in the case without seismic retrofit shows that the story drift angle was largest on the eighth floor. The tendency was different from the state of damage to partial walls confirmed by field surveys and described in the previous chapter in which damage was moderate on the lowest and highest floors and damage increased on middle floors.

The maximum story drift angle after seismic retrofit was 1/164, approximately 70% of a maximum value of 1/115 in the case without seismic retrofit. Story drift angle after seismic retrofit was smaller than the design criteria on all floors, which was in agreement with the results of field surveys in which no damage was found in structural members.

The distribution of story drift angles in the direction of height after seismic retrofit shows that story drift angle was largest on the fifth floor. The deformation was in agreement with the damage to the partial walls found in the building surveys. Figure 6 also shows the width of the residual crack in the partial wall between lines (viii) and (ix) for comparison with story drift

angle. No measurement could be made on the third through fifth floors. Small cracks on the upper and lower floors and large cracks on the middle floors were in agreement with the distribution of story drift angles. The tendencies of hydraulic displacement and residual crack width (Figure 2) were also similar. Thus, the results of seismic response analysis for evaluating post-seismic-retrofit conditions were also in agreement with hydraulic displacement.

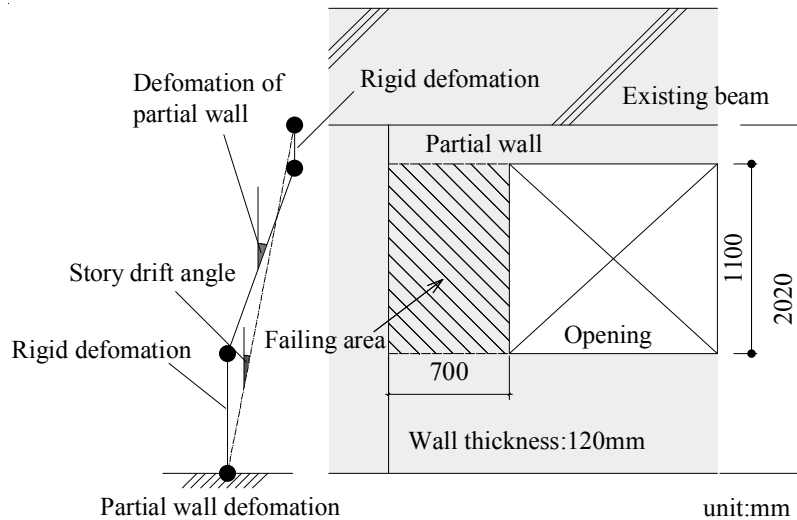
Figure 8 shows the detail of the partial walls of the Building. In structures of that partial wall is integrated with a hanging wall and a spandrel wall, like the Building, deformation concentrates locally as shown in figure 8. Then, story drift angle is not identical to the deformation angle of the partial wall. No shear cracking was confirmed in hanging walls and spandrel walls of the Building. It is therefore reasonably assumed that no deformation occurred in these sections but that deformation concentrated at the center of the partial wall. In other words, it was assumed that the partial wall suffered shear failure before story drift angle reached the deformation angle at the shear strength of the partial wall. It was assumed that the hanging wall and spandrel wall were subjected to rigid deformation. The story drift angle when the partial wall collapsed was referred to as the Cd-angle (concentrated drift angle), and listed in Table 1. The Cd-angle is the story drift angle at which the partial wall suffered shear failure at the earliest time. The story drift angle that was the same as the deformation angle at the shear strength of the partial wall was referred to as the Dd-angle (distributed drift angle). At which story drift angle the partial wall suffered shear failure was estimated based on the results of time history response analysis and of the surveys of the Building.

Figure 8: Partial wall derogation when the earthquake.

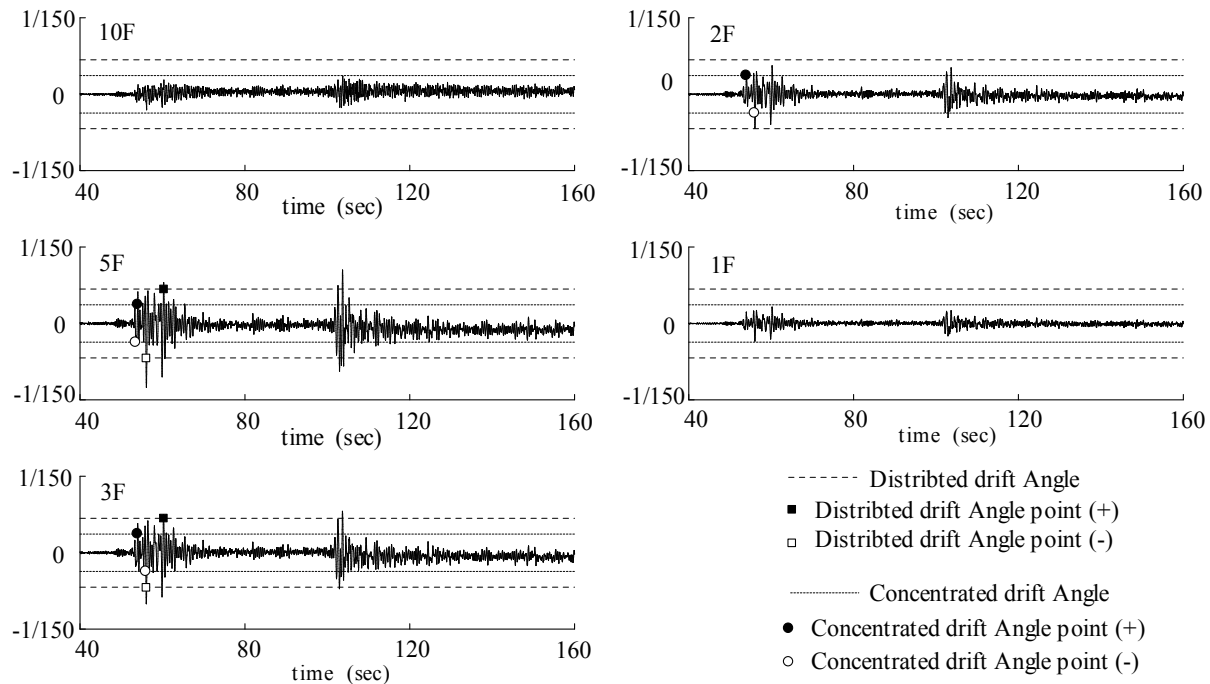
Figure 9: The time history output waveforms of story drift angle after seismic retrofit

Figure 9 shows the time history waveforms of story drift angle on the first, second, third, fifth and tenth floors after seismic retrofit based on the results of seismic response analysis. The time when story drift angle reached the Cd-angle (Cd-angle point) and the time when story drift angle reached the Dd-angle (Dd-angle point) were plotted on the output waveform on the positive and negative sides, respectively. The time history output waveforms of story drift angle were obtained as a result of calculation for the column member (line (viii)) on the west side of the partial wall shown in Photograph 3.

Figure 9 shows that story drift angle did not reach the Cd-angle during the Earthquake on the first and tenth floors, which confirms that only moderate damage occurred in the partial walls on the first and tenth floors.

Focus is now placed on the second, third and fifth floors in Figure 9. One of the characteristics of the input ground motion is two peaks in the acceleration waveform. On the third and fifth floors, the Cd-angle and Dd-angle points existed before the first peak was reached. On the second floor, the Cd-angle point existed but no Dd-angle point existed before the first peak was reached, which indicates that the Dd-angle was not reached. It was, however, determined that partial walls suffered shear failure on the second floor (Photograph 4 (b)) and 3-mm residual crack width. It is therefore highly likely that partial walls suffer shear failure when the story drift angle reaches the Cd-angle.

The Cd-angle point in the partial wall suggests that the partial wall suffered shear failure in the early stages of the Earthquake because the story drift angle reached the Cd-angle point before the first peak was reached on the second, third and fifth floors. The tendency was similar on the fourth, sixth, seventh and eighth floors. In seismic retrofit design, no seismic energy absorption by partial walls was considered. The partial walls suffered shear failure in the early stages of the Earthquake and it was concluded that seismic energy absorption of partial walls made little contributions to the structural performance of the Building.
