THE COMBINATION OF NDTs FOR THE DIAGNOSTIC STUDY OF HISTORICAL BUILDINGS: THE CASE OF KAISARIANI MONASTERY

Antonia Moropoulou¹, Maria Apostolopoulou¹, Petros Moundoulas¹, Maria Karoglou¹, Eka-
terini Delegou¹, Kyriakos Lampropoulos¹, Margarita Gritsopoulou¹, Asterios Bakolas¹

Kaisariani Monastery

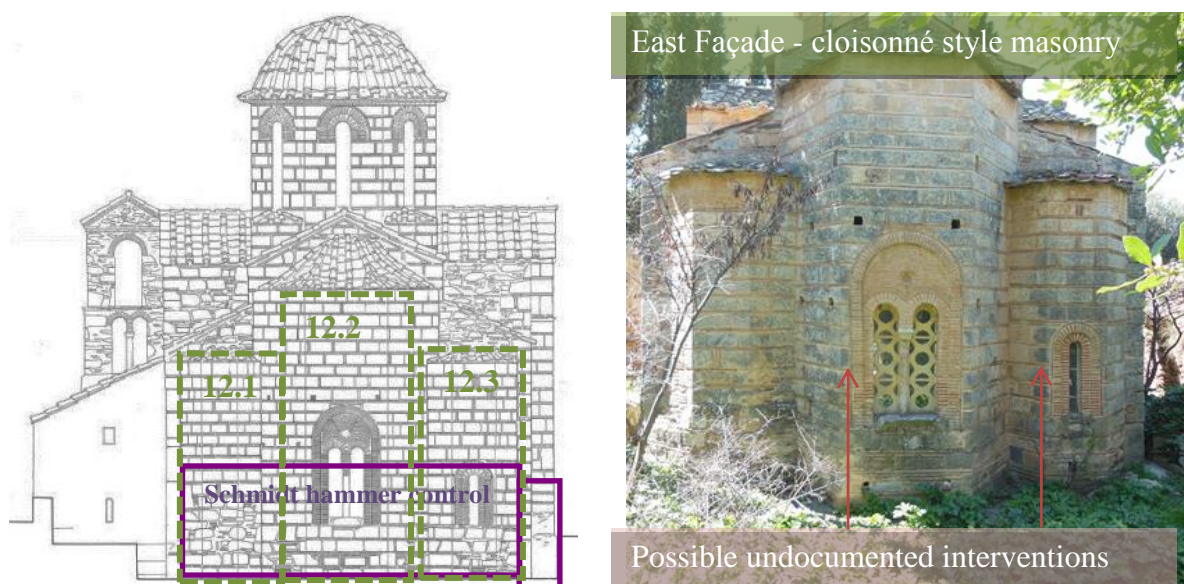
Image 2: East Façade [16] and control areas – Picture of cloisonné style construction and Areas 12.2&12.3

Areas 12.2 and 12.3 (Image 2) were selected as areas of interest to demonstrate the use of NDTs for the detection of non-documented past interventions, as well as for the examination and characterization of building materials in historic structures. Schmidt hammer rebound testing was implemented to estimate compressive strength the building materials.

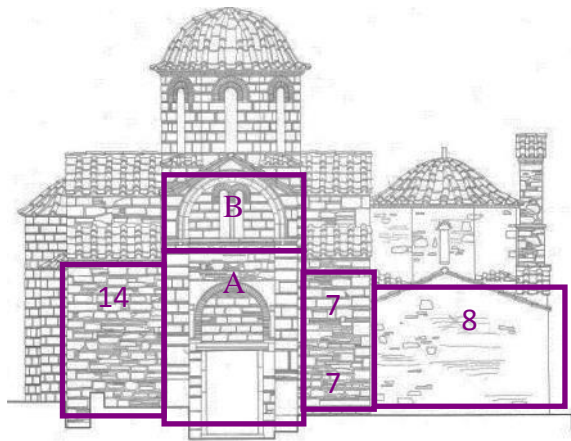
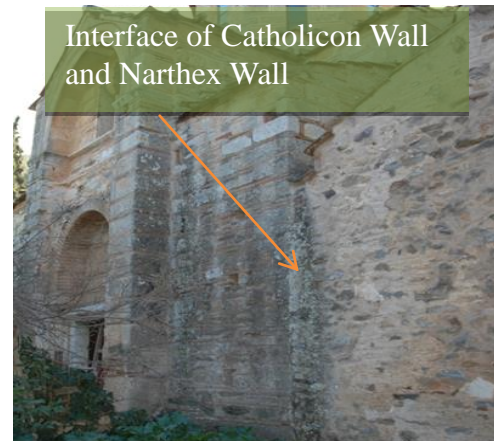
Image 3: North façade [16] and control areas – Picture of Areas 7&8 with distinct construction phases

Areas 7 and 8 were selected in order to examine the masonry structure and investigate possible construction phases. Areas 7 and 8 of the north wall belong to different construction periods, as area 7 is part of the original Catholicon and area 8 belongs to the Narthex (Image 3). The materials of area 7 appear in a much worse preservation state than the materials of area 8; this is highly evident in the comparison of slate stones in the two areas (Images 13-15) as well as in the comparison of bricks from the two areas (Images 16-18). However, it seems that a similar slate stone was used for the construction of both walls; furthermore, microscopically the bricks of area 7 seem to appear similar to those of area 8.

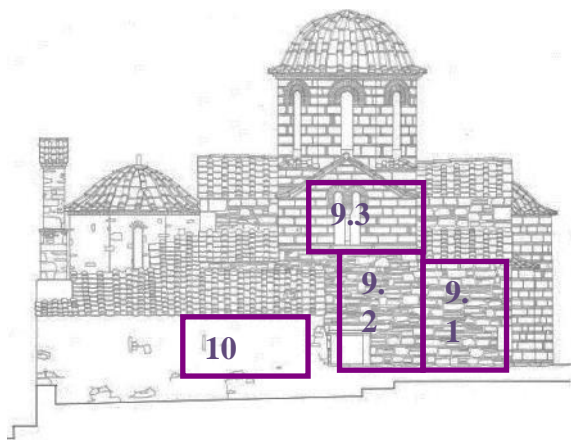
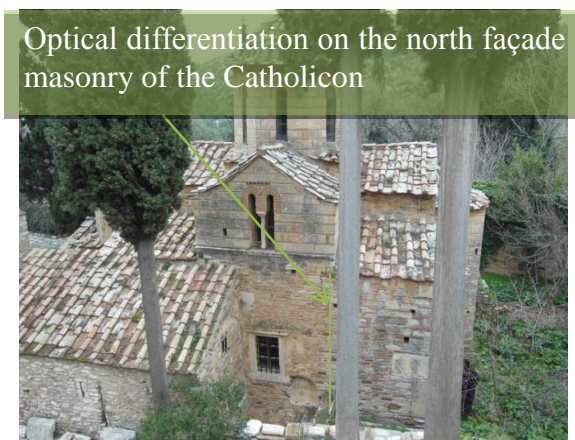
Image 4: South façade [16] and control areas – Picture of Areas 9.1&9.2 with evident differentiation

On the south façade, Areas 9.1 and 9.2 were selected as areas of interest, in order to investigate the masonry structural continuity and possibly document a lost construction phase. The south façade of the Catholicon is optically divided into two areas, 9.1 and 9.2. Area 9.2 is characterized by its orange hue and spattered appearance. Areas 9.1. and 9.2 of the north wall, seem to be distinctly different (Image 4). The microscopic examination of the bricks, mortars and stones however does not offer a clear image, as all building materials of area 9.2 seem to be covered by an orange plaster residue (Images 31, 34, 36-37).

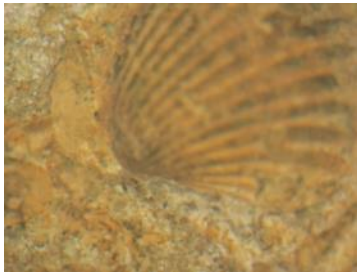
The porous stone of the east façade is a fossiliferous stone (Image 5). The original mortar of the east façade, although attributed to the first construction phase, and therefore subjected to environmental factors for a much longer period compared to the subsequent phase materials, is in a good preservation state (Image 6). A different type of mortar was encountered in areas around the windows of areas 12.2 and 12.3 (Image 7), which is most likely a restoration mortar applied during a past, undocumented restoration intervention. Microscopically these mortars seem to exhibit a certain extent of compatibility, although the restoration mortar seems to exhibit better coherence.

Image 5: Area 12.1 (x30)
Typical stone of the east façade

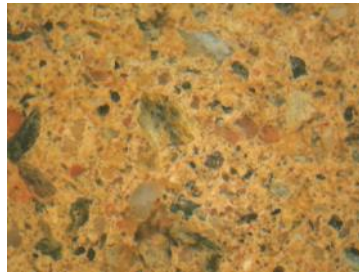
Image 6: Area 12.1 (x50)
Mortars

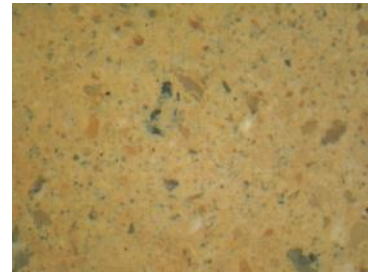
Image 7: Area 12.2 (x50)
Restoration mortar

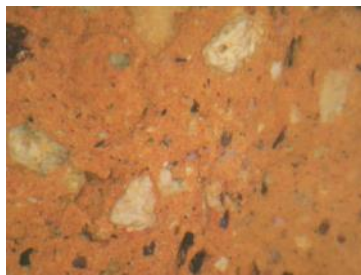
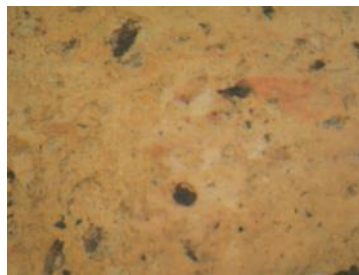
The authentic bricks of the east façade showed relative homogeneity and appear in two different colors, due to a different production technology (Image 8 and 9). Another type of brick was detected, exhibiting a different microstructure (Image 10), which seems to correspond to a newer restoration brick; however, a corresponding intervention using this newer restoration brick was not documented. This type was encountered throughout the east façade around the window of area 12.2 and the window of area 12.3 in accordance to the presence of the restoration mortar described above. The restoration brick seems less porous than the original authentic byzantine brick.

Image 8: Area 12.2 (x50) – Red
brick

Image 9: Area 12.2 (x50) - Yellow Brick

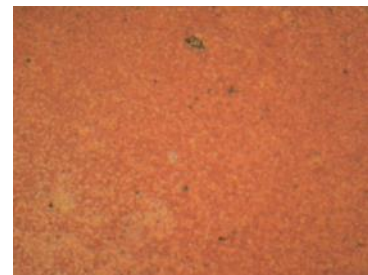
Image 10: Area 12.2 (x50) - New
Restoration Brick

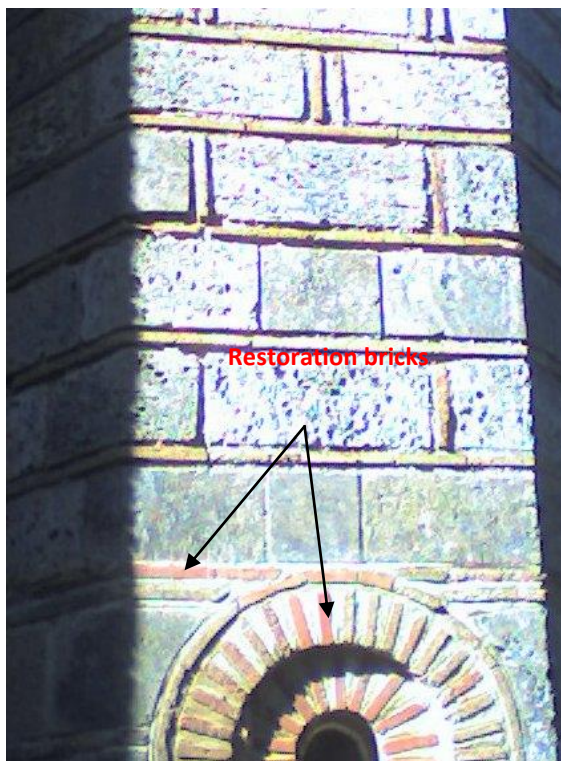
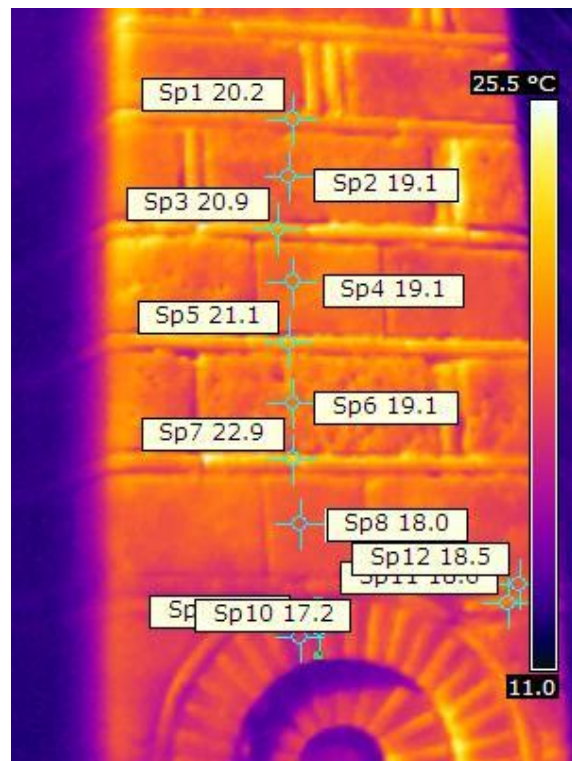
The results from FOM indicated an undocumented intervention evident on the east façade; on the arch of the window of area 12.2 (Image 11), as well as around the window of area 12.3. When examined by Infrared Thermography (Image 12), the majority of the bricks of the east façade, corresponding to authentic bricks, exhibited temperatures well above 20 °C and up to 23 °C, compared to the bricks of different color above the window in area 12.2, which exhibit much lower temperatures, in the range 18-19 °C. The authentic joint mortar between the bricks surrounding the double arched window in area 12.2 exhibits temperatures between 17,3 °C and 18,1 °C. Again, the joint mortar with a different color exhibits lower temperatures, between 16,5 °C and 16,8 °C. This was also observed in area 12.3; the temperature differences are due to the different materials used in this undocumented intervention.

Image 11: Detail of area 12.2 - Thermogram area

Image 12: IR image [6440], Date: 17/2/2014

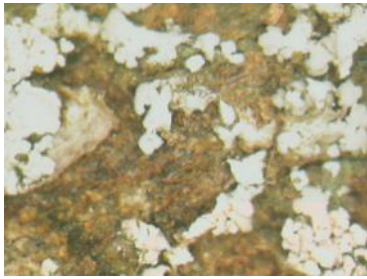
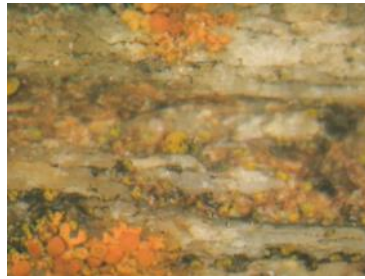
Image 13: Area 7 (x50) - Slate stone with evident decay

Image 14: Area 7 (x50) - Slate stone with evident decay

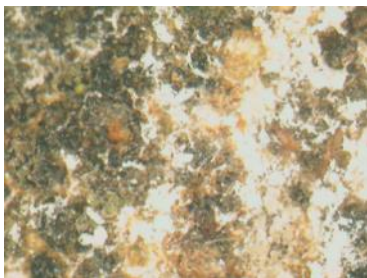
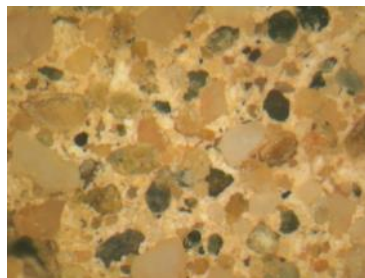
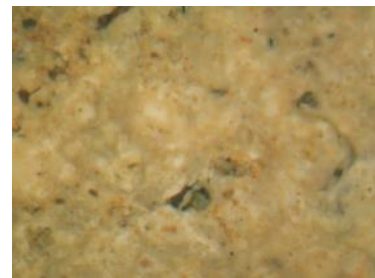
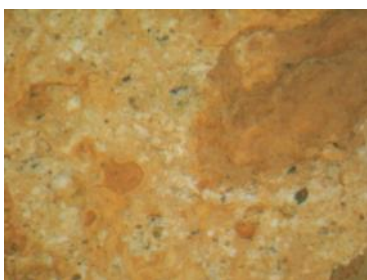
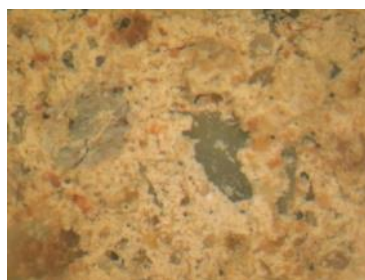
The worse preservation state of area 7 is also evident during the examination of mortars (Images 19-23); however it must be emphasized that area 8 has undergone many interventions, as the use of many different non-documented restoration mortars evidence. The different mor-

tars used in area 8 seem to exhibit different coherence and microstructure and may not be compatible to the original masonry materials.

Image 19: Area 7 (x50) - Mortar

Image 20: Area 8 (x50) - Grey mortar

Image 21: Area 8 (x50) - Grey cementitious mortar

Image 22: Area 8 (x50) - Orange cementitious mortar

Image 23: Area 8 (x50) - Pink mortar

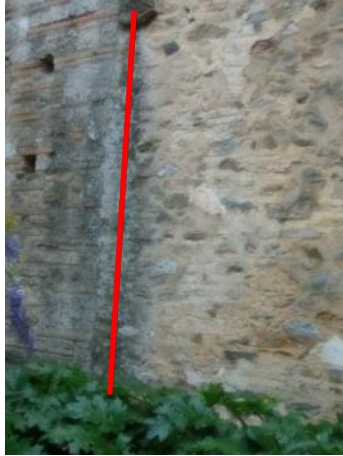
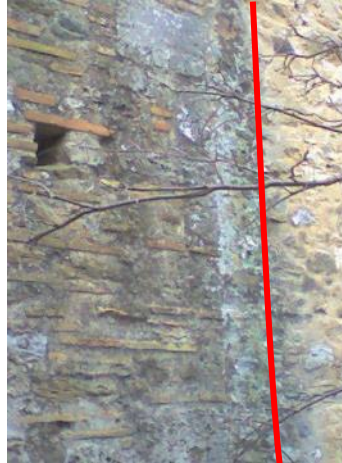
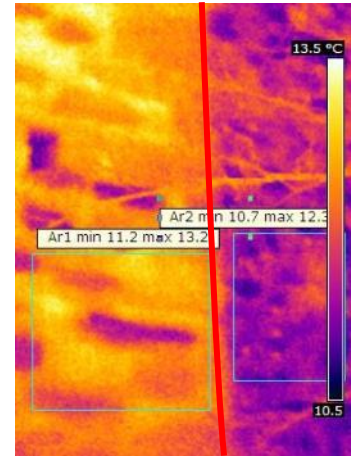
In order to better examine this area, a IR image was taken (Image 24) depicting the north wall of the Catholicon (area 7) and of the Narthex (area 8) simultaneously. The different construction phases are evident, even by macroscopic observation (Images 25-26), due to the different construction technique of the masonry during the mid-byzantine and post byzantine era. The difference between the two different phases is evident also in the thermogram, through

the intense surface temperature difference that the two areas exhibit. The wall of the Catholicon exhibits temperatures ranging from 11,2 °C to 13,2 °C, whilst the Narthex wall exhibits lower temperatures, ranging from 10,7 °C to 12,3 °C. This is due to the different type of construction and the use of different construction materials; however it is unclear through thermography alone whether this is the result of the higher humidity content of the Narthex.

Image 24: The north wall - different construction phases

Image 25: Detail of the thermo gram area

Image 26: Thermo gram [6357],
Date: 5/2/2014

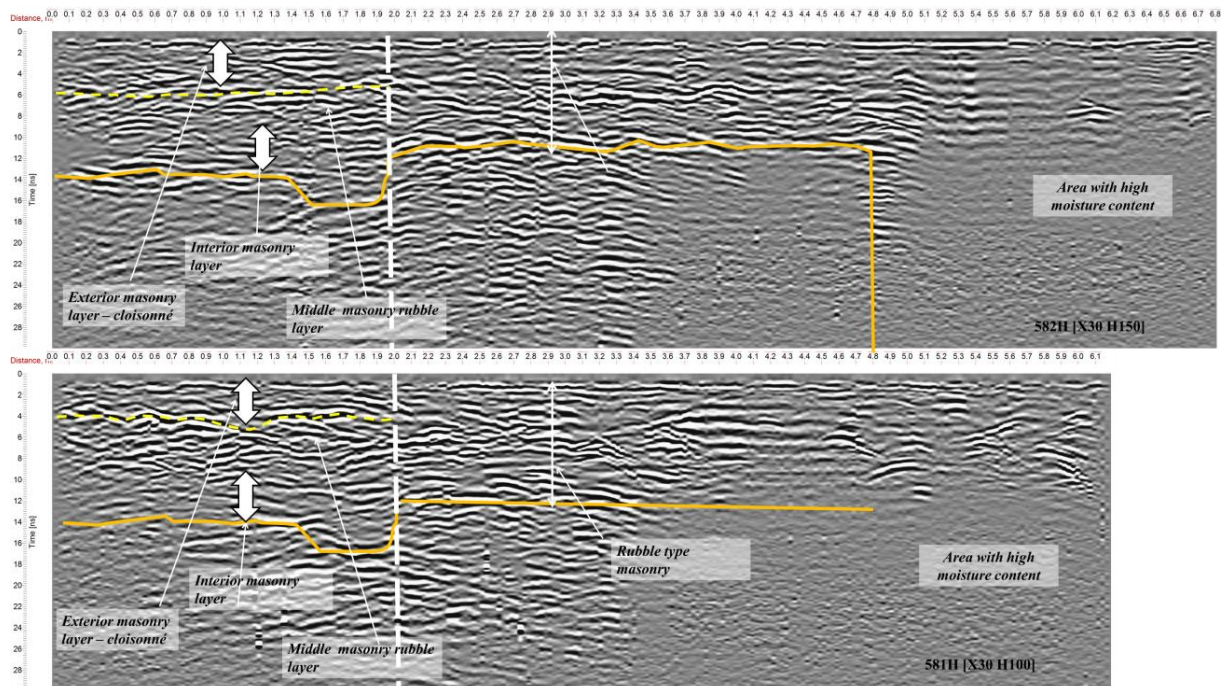
Image 28: Horizontal GPR scans H581 and H582 respectively

The GPR scans reveal interesting information. A discontinuity at the interface of the Catholicon wall and the Narthex wall is evident, at exactly 2 m from the beginning of the scan, confirming the IR results; furthermore, it is evident that the wall corresponding to the original mid-byzantine structure corresponds to a three leaf cloisonné masonry, whereas the wall corresponding to the Narthex clearly corresponds to rubble masonry extending to the core of the structure. Another interesting aspect that the GPR revealed is the presence of a high content of moisture in the Narthex wall; this explains the presence of several restoration mortars on the Narthex wall. It is also possible, that due to the incompatibility of the restoration mortars with the original masonry materials, transpiration of the masonry is difficult and humidity is trapped in the core of the Narthex wall, intensifying the problem.

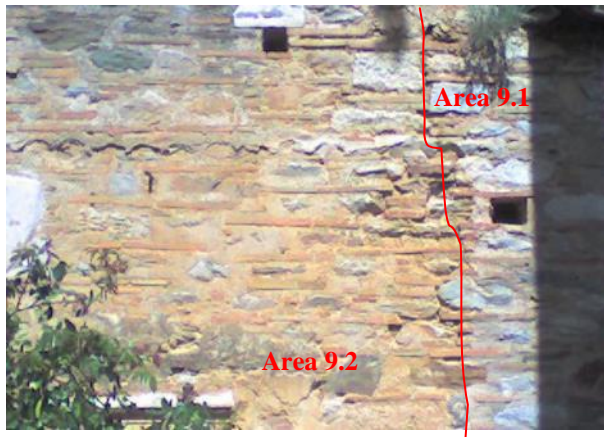
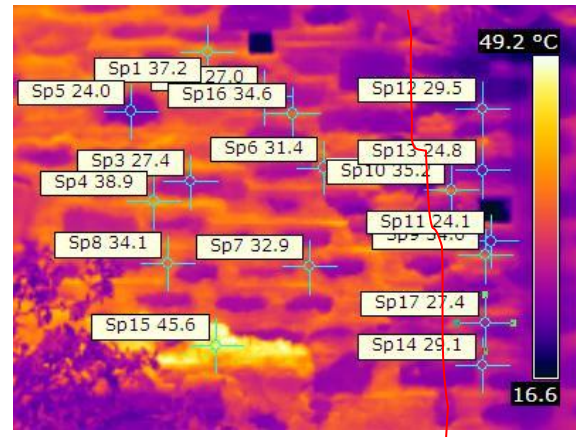
An IR image (Image 39) was taken in order to include both areas 9.1 and 9.2, simultaneously (Image 38). The surface temperature of the stones of both areas exhibit similar values, indicating that the same type of stone was used. The same applies in the case of the brick elements. However, in the case of the joint mortars, this is not the case; the temperature of the mortar in area 9.1 ranges from 29,1 °C to 29,5 °C, whereas in area 9.2 the temperature of the joint mortar ranges from 31,4 °C to 34,1 °C. This is an indication that a different mortar was used in the two areas. An explanation of this would be that the chapel used to extend further to the east, and therefore area 9.2 was at some point the interior of the chapel. In addition, the remains of a tile roof, which is observed by optical observation on the upper limit of area 9.2, exhibits the same temperature as the bricks, indicating that this is part of the older structure; perhaps it was the roof of the chapel when it extended further to the east. However, with IR thermography, the surface of the structure is examined; the masonry structure must be examined as to assess whether the different mortar is only on the surface or whether the use of the different material extends to the masonry core.

Image 38: South wall - Areas 9.1 and 9.2

Image 39: Thermogram [7182], Date: 27/3/2014

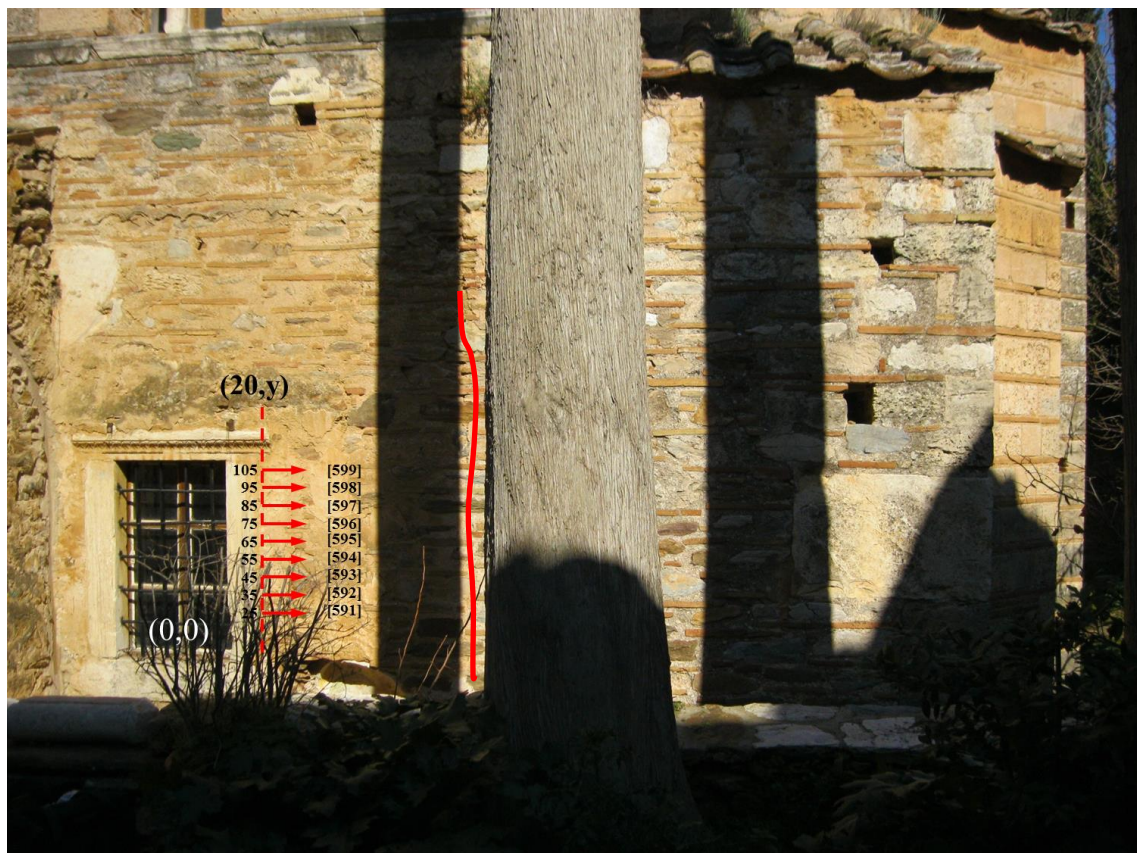
Ground penetrating radar was employed in order to assess whether the differentiation of the masonry between these two areas is structural or only at the surface. Specifically, horizontal scans were carried out on the exterior of the south wall of the Catholicon, across area 9.2 and area 9.1., in order to assess whether the optical differentiation corresponds to a structural differentiation. Furthermore at the interface of area 9.1 and 9.2 it seems as though a crack is present; however this is not confirmed during a close optical investigation. This area of the south wall is where the pillars receiving the compressive forces from the dome are; through GPR scanning, it will be possible to examine whether these elements are constructed in a different manner than the rest of the masonry. Scans were conducted from the east side of the window to the corner of the east façade (Image 40).

Image 40: Exact positions of GPR scans on the south wall – depiction of the differentiation

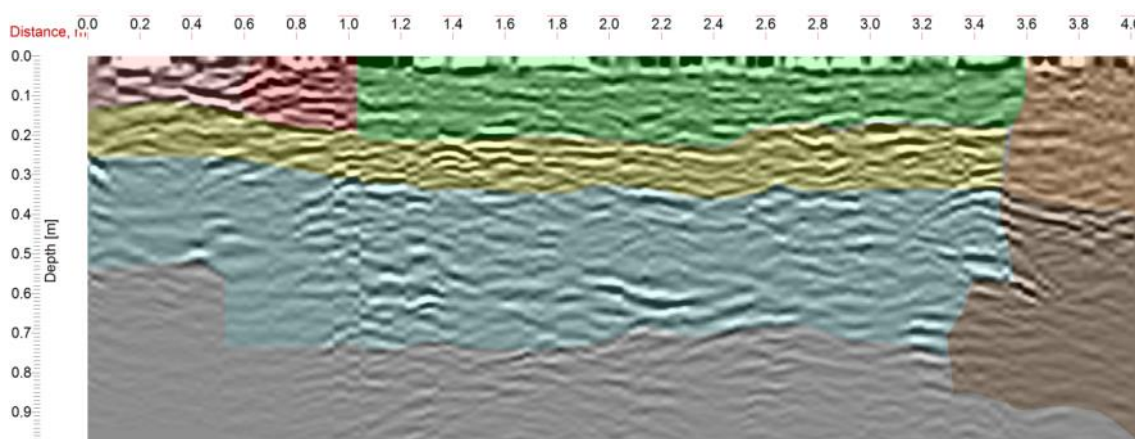
The result (Image 41) shows that the differentiation of area 9.1 and 9.2 is due to the use of different materials in area 9.2 and area 9.1. This is obvious in the scan, as a diversification of the signal is evident at 1 m from the beginning of the scan; this is also where the optical differentiation occurs. However, this differentiation is at the surface; from 10 cm from the surface and below, the materials and the structure are continuous throughout the scan and therefore throughout the two areas. The end of the scan corresponds to a large carved stone at the southeast corner. Again the structure of the wall corresponds to the byzantine type of building, where three layers are evident; the outer layer, the middle rubble layer and the inner layer of the wall, thus indicating a three leaf masonry. Therefore, in the case of the south wall the middle layer and the interior layer are homogenous and continuous, whereas the joint mortar of area 9.2 is different, but only on the exterior layer, which is 10 cm deep.

Image 41: GPR scan of south wall
