NON-LINEAR DYNAMIC ANALYSES OF AN RC FRAME BUILDING COLLAPSED DURING L'AQUILA 2009 EARTHQUAKE

Abstract. *This study focuses on the partial seismic collapse of a building during the earthquake of L'Aquila (Italy) on April 6th 2009. Designed in the early '60s, the 7-story building has a reinforced concrete frame structure. In elevation, above a first basement and a ground floor, three wings rise. The collapse affected the North wing, where three separate collapse mechanisms were identified. All the columns at ground story failed with a weak-story mechanism in North-South direction. Three columns, located near the interface with the other wings, failed on the full height. In the same area, subjected to strong distortions due to the difference in vertical displacements following the weak-story mechanism, at stories 1-4 a third collapse mechanism involved a beam supporting a non-structural wall inserted in recent renovation works. Previous investigations carried out with both pushover and nonlinear dynamic analyses explained why the collapse was confined to the North wing, the collapse sequence and the role of the non-structural wall. Based on nonlinear dynamic analyses on a refined 3D

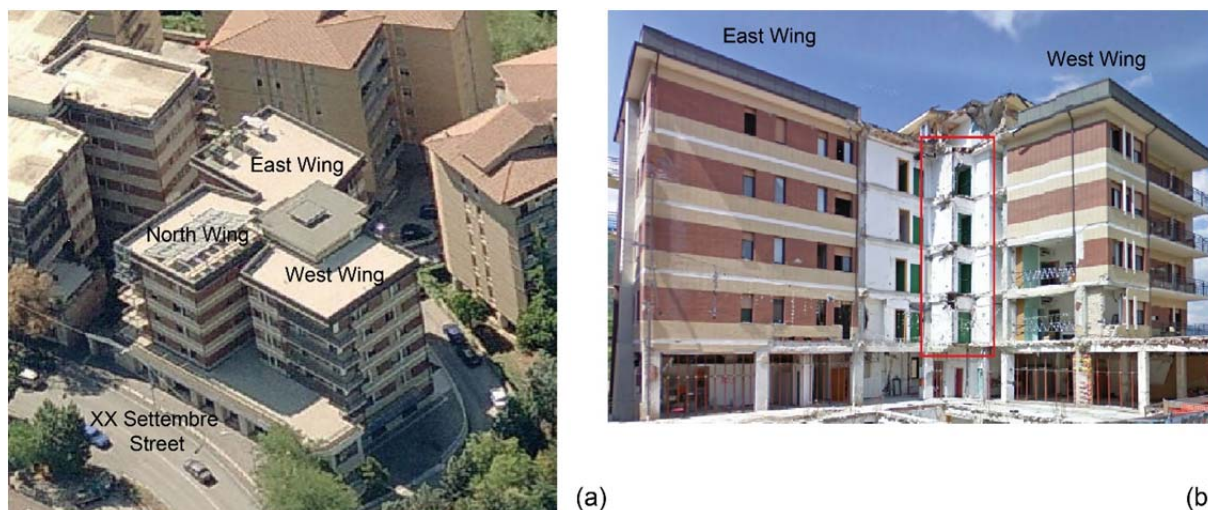
The partial collapse was limited to the North wing facing XX Settembre Street (Fig. 1). Previous studies conducted for legal reasons [4, 5], pinpointed the existence of two distinct collapse mechanisms in the collapsed wing: a) failure of all columns at the ground floor, which triggered a soft/weak story mechanism in the North-South (N-S) direction, and b) failure of three columns along the total height of the building. In the same region, the mid-span failure at floors 1-4 of the beam connecting columns 18 and 29 took place (see Fig. 1b). The beam was affected by the insertion of a non-structural wall during the renovation works of 1999-2001. Legal tests and studies showed that the lack of flexural strength of ground story columns was detected as the main mechanical cause of the collapse.

Figure 1: The CdS building: (a) aerial view, original configuration; (b) front view from XX Settembre Street after the removal of debris. In the red box the remaining of beam 18-29. The severely damaged external partitions of the West wing were removed for safety reasons. The jacketed column had several shear cracks. (after [7])

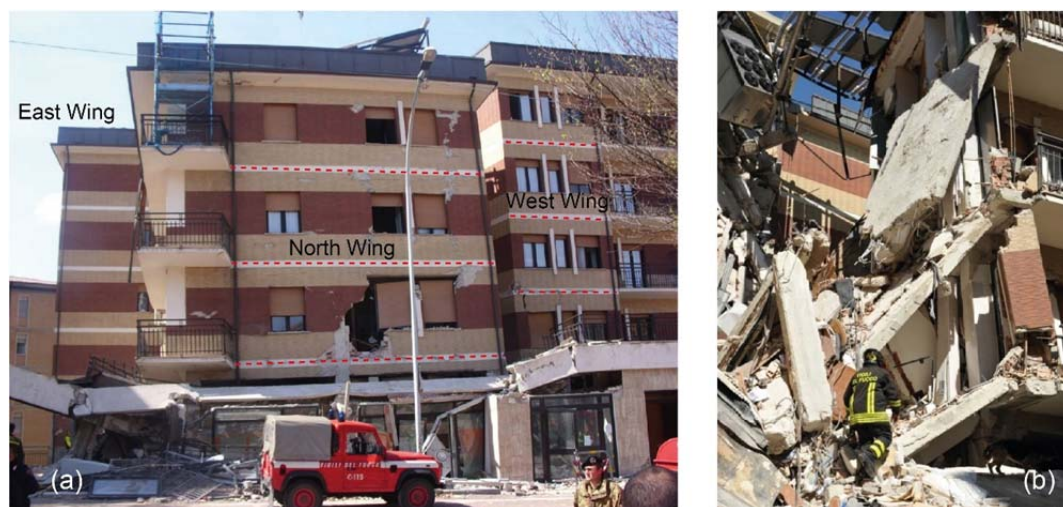
The partial collapse of the structure was limited to the North wing (Fig. 1), where two separate collapse zones were detected. The columns at the ground story failed with a soft/weak story mechanism along the N-S direction (Fig. 3a). In addition, three columns (C21, C25 and C29 in Fig. 2) collapsed totally from the ground story to the top of the building, at the interface between the North wing and the remaining ones (Fig. 3b). Part of the beam 18-29 (where the non-structural wall was not inserted in) collapsed as well.

Figure 3: View of the building before demolition of the collapsed wing: (a) weak ground story mechanism on the North wing. Windows along XX Settembre Street, aligned on the E-W direction, are intact. (b) Collapse of the columns at the interface between the North wing (right) and the remaining ones (left and back). (after [7])

The most likely collapse sequence was determined in [5] based on (i) the study of the design criteria adopted in 1965; (ii) the results of modal analyses of the building in its original configuration and after refurbishment; and (iii) the analysis of damage in the parts of the building that survived the earthquake. The severe lack of flexural strength of ground story columns of the North wing and the corresponding shear failure, as a result of design and con-

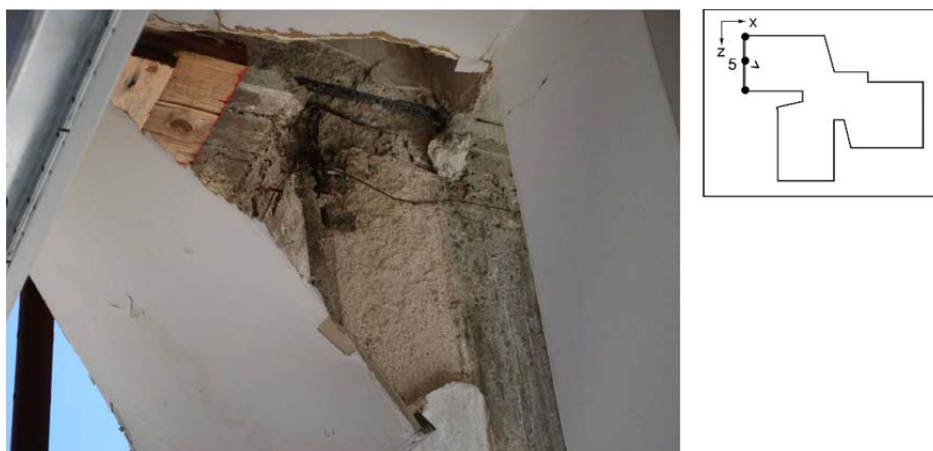
Structural damage was observed in the East and West wings especially in the columns that are part of the transverse frame placed both on the short and on the inclined side of each wing. Figure 4 shows the damage at the beam-column joint of the ground story column C5, belonging to the external transverse frame of East wing.

Figure 4: Damage at the beam-column joint of column C5 at ground floor.

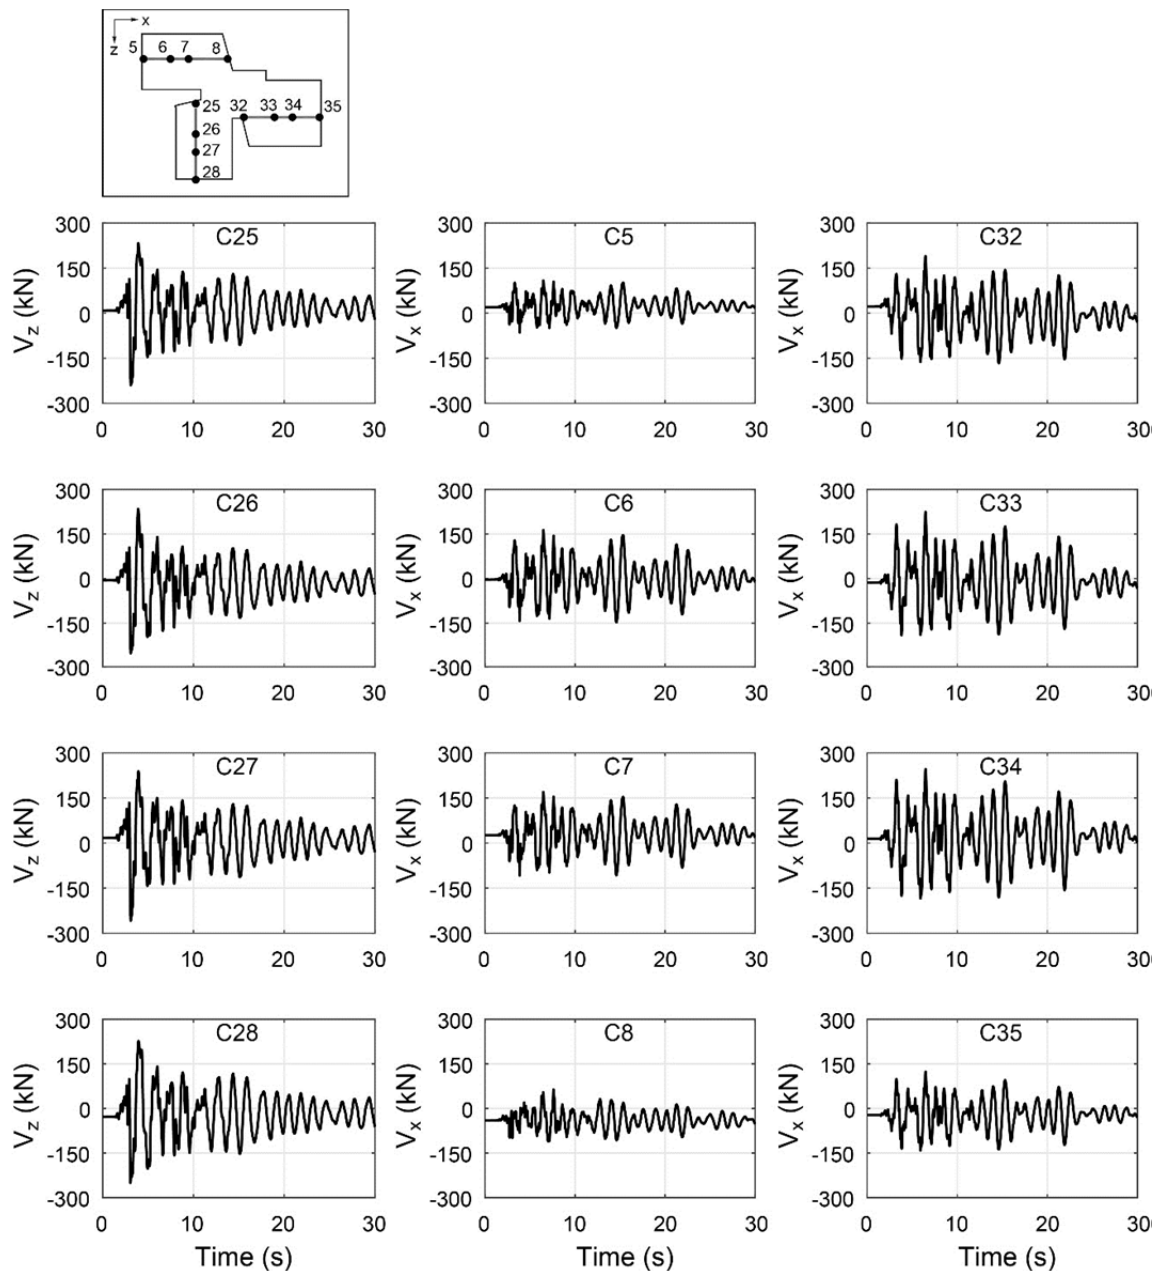
Figure 6: Shear force V_z and V_x along the strong axis at the base of ground story for the central frame columns of the North (on the left), East (at center) and West (on the right) wings.

Figure 6 shows, for the central frames of the three wings, the shear forces at the base of ground story columns in the plane of the frame, i.e. along the strong direction of each frame. The largest value of shear force, in terms of V_z , are attained in the North wing. The demand on East and West wings is lower, but not uniform on the two. The smallest values of V_x are found in the East wing, with a minimum on C5 and C8 at the two ends of the frame. A larger demand is detected in the West wing, with the exception of C35, located at the maximum distance from the North wing.

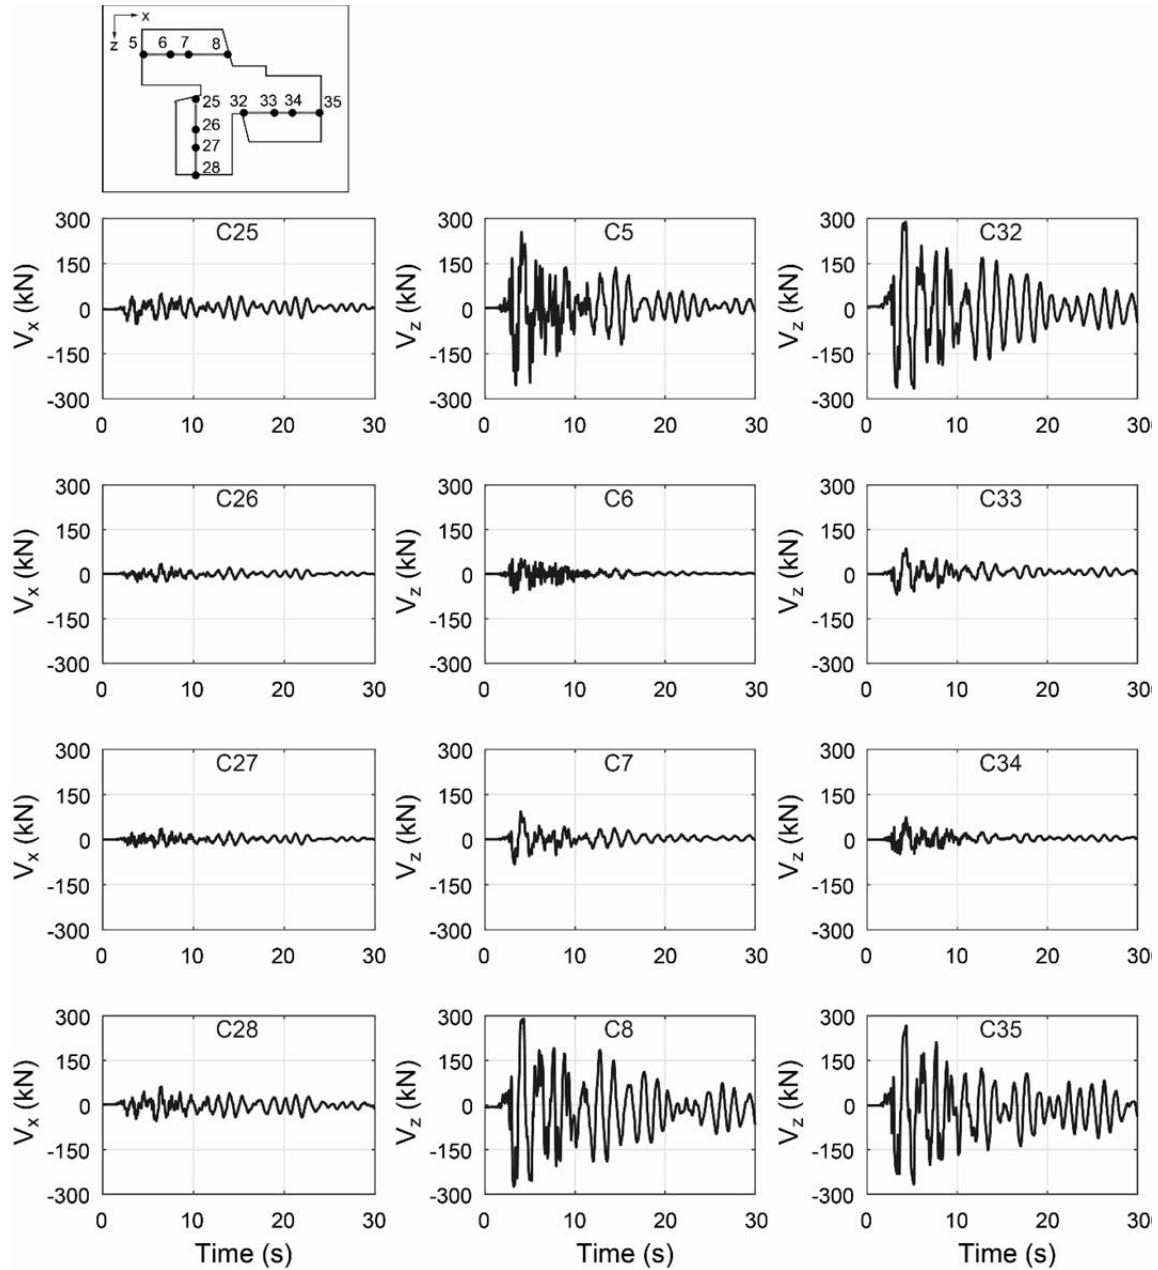
Figure 8: Shear force V_x and V_z along the weak axis at the base of ground story for the central frame columns of the North (on the left), East (at center) and West (on the right) wings.

Figures 8 illustrates, for the central frame of the three wings, the time history of shear forces at the base of ground story columns, along their weak axis. The out-of-plane demand along the x -axis on the North wing is very low. This finding is in agreement with the N-S direction of the prevailing displacement component: the numerical result is confirmed by both the absence of damage in the windows along XX Settembre Street (Fig. 3a) and rescuers' observations. Also, low amplitude values are detected for the central columns of the East (C6 and C7) and West (C33 and C34) wings. On the contrary, external columns of the East (C5 and C8) and West (C32 and C35) wings are subjected to high shear forces.

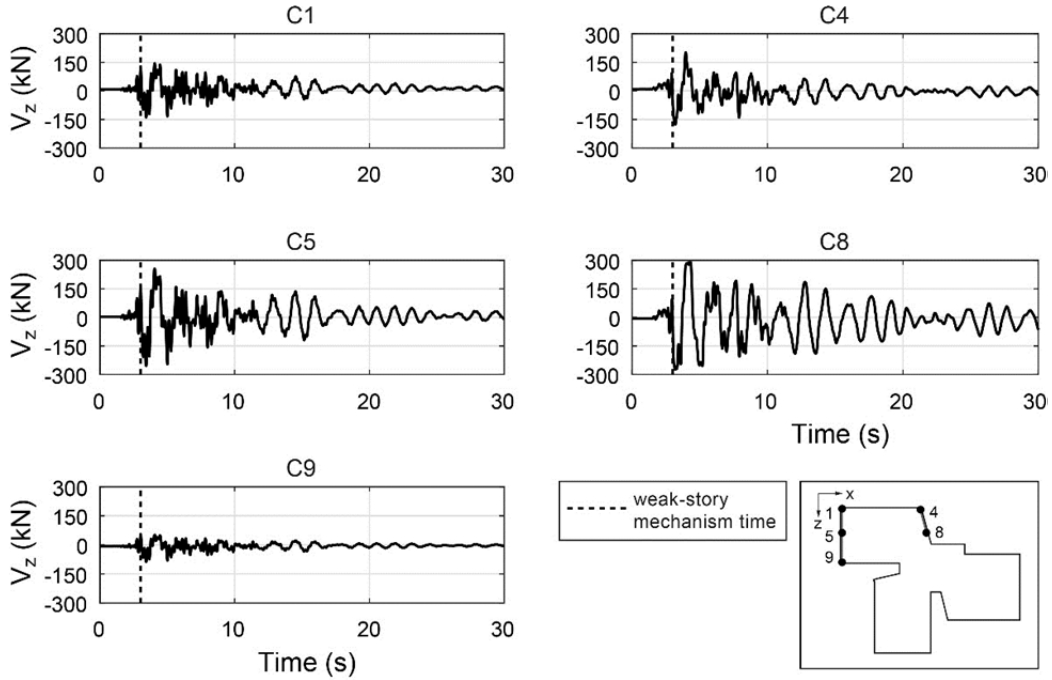
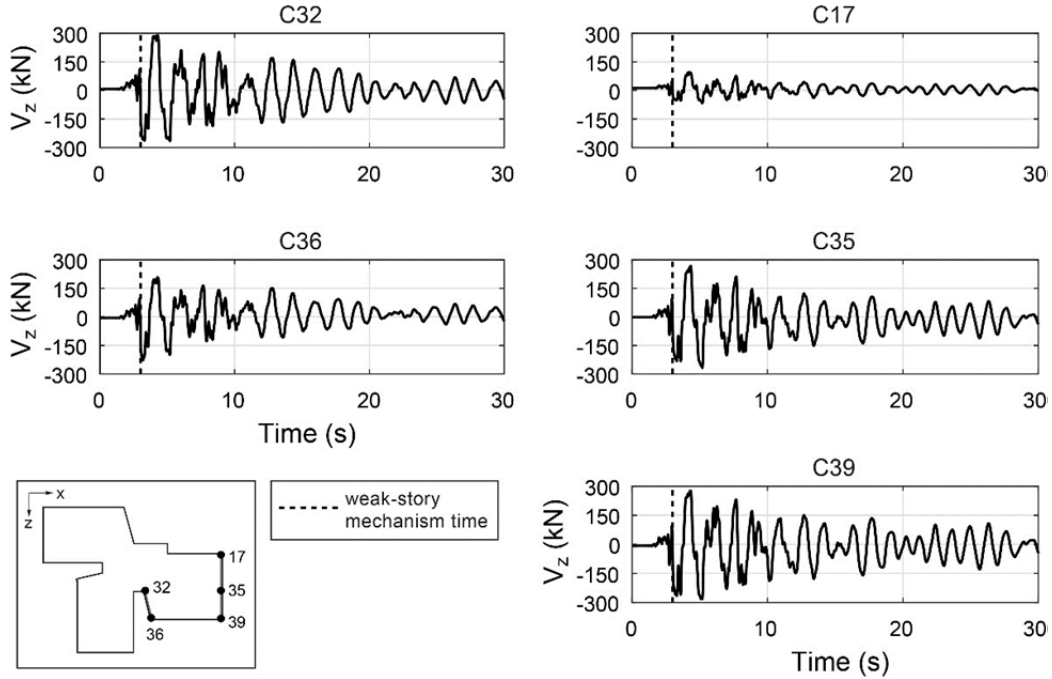
To investigate further this aspect, the transverse frames placed both on the short and on the inclined side of the East (columns C1, C5, C9 and C4, C8) and West (columns C17, C35, C39 and C32, C36) wings are considered. Figures 10 and 11 show the shear forces V_z along the N-S direction for the ground story of edge columns of East and West wings, respectively. The time instant at which the weak-story mechanism was triggered in the North wing is denoted with a dotted line in each time history. Both figures show that the edge columns belonging to the transverse frames were significantly loaded along the N-S direction, with the exception of columns C9 and C17. These columns are approximately aligned with the structure supporting the stairs, which can have played a role in resisting seismic forces in the N-S direction too. It can be concluded that the edge column on the short side of East and West have contributed to the global shear capacity along the N-S direction. However, it is apparent that this contribution was not sufficient to avoid the collapse of the North wing.

Figure 10: Shear force V_z at the base of ground story for the edge columns of the East wing.

Figure 11: Shear force V_z at the base of ground story for the edge columns of the West wing.
