## **HEALTH MONITORING OF A MONUMENT AT ACROPOLIS USING AN EXPERT ACQUISITION SYSTEM AND WIRED OPTICAL SENSORS**

*This paper presents the development and the implementation of a state – of – the – art methodology using an expert acquisition system (EAS) and wired optical sensors to monitor evolving deformations during a period of twenty – one months on a monumental structure “Propylaea” of the Acropolis in Athens. The aim of the on-going SHM program is to monitor deformations and increase the structural knowledge of the behavior of the ancient monument in order to take any precautionary measures and avoid excessive deformations.*

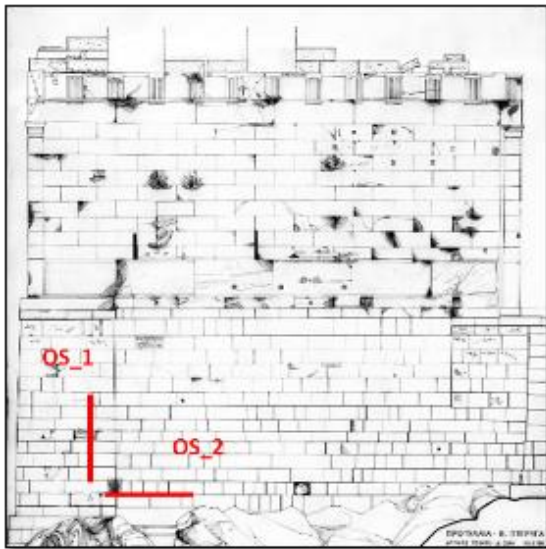
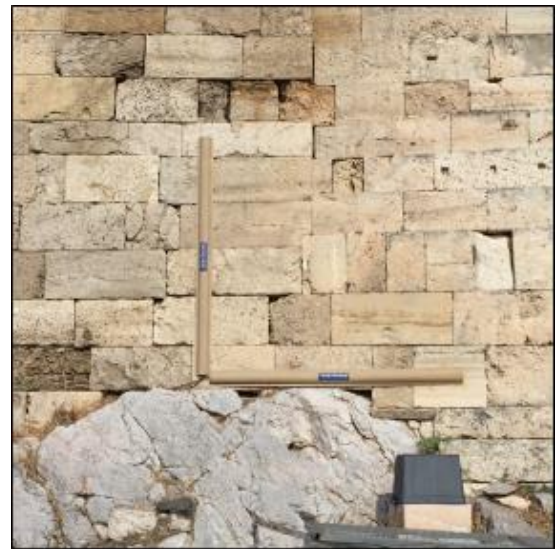
Figure 4: OS\_1 & OS\_2 Sensors locations / West side.

Under this framework, four innovative sensors (2.0 m length), based on optical fiber technology, were installed at the northern and western side of the Propylaea Gallery substructure both at the inner and outer surface [3]. The nomenclature, the geometry of the instrumentation and the final locations of the sensors, are all presented in Table 1. Figures 4 and 5 indicate the schematic location of sensors OS1 – OS4 as well as a corresponding photograph. The selection of the locations where the sensors were installed was based on two criteria: (i) the ob-

served deformation on the walls and (ii) the anchorage requirements. The OS1 and OS2 are anchored on masonry, while the other two sensors are attached to concrete.

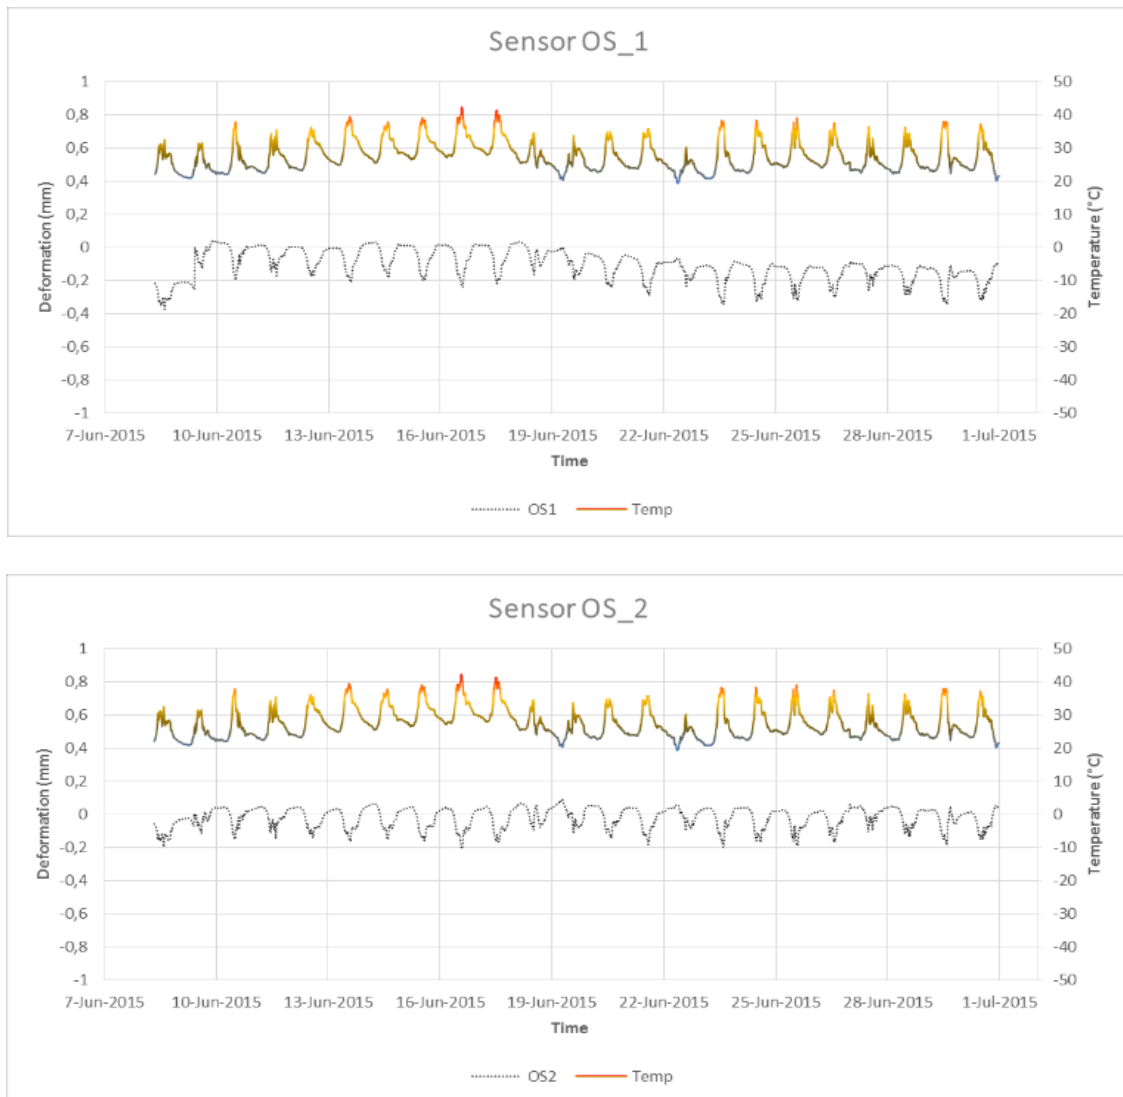
Figures 6-7: 1<sup>st</sup> Observation Phase (1<sup>st</sup> month – June 2015) / Axial deformation in function of Temperature.

As far as the initial observation data is concerned, it is clear that all sensors fully follow the temperature changes with an inverse behavior both on a daily and a seasonal basis. The daily deformational variations of the structure because of temperature effects are strictly related to the thermal coefficient of each material (OS\_1 & OS\_2: Masonry / OS\_3 & OS\_4: Concrete). The interpretation of measurements during the first observation stage indicate that the influence of the temperature is elastic on all sensors, as the deformation returns to its initial state after one complete temperature daily cycle.

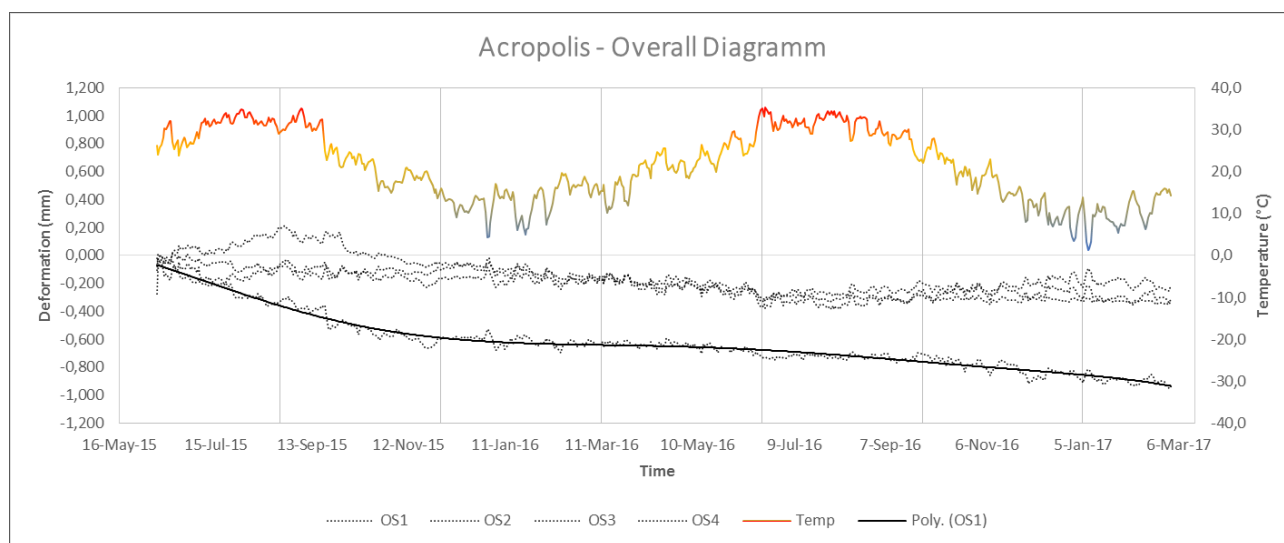
Figure 8: Overall Diagram of all sensors / Deformation in function of Temperature.

The overall diagram presents the time-history of the structure's western-side deformational behavior in both directions, vertical and horizontal, as detected by the external sensors in the western side OS\_1 and OS\_2 respectively. The dynamic evolution of compressive deformation in the vertical direction, in comparison to the lower participation of the horizontal one is depicted in the estimated overall deformational mechanism of the structural system and fully demonstrated in the records of the optical sensors.

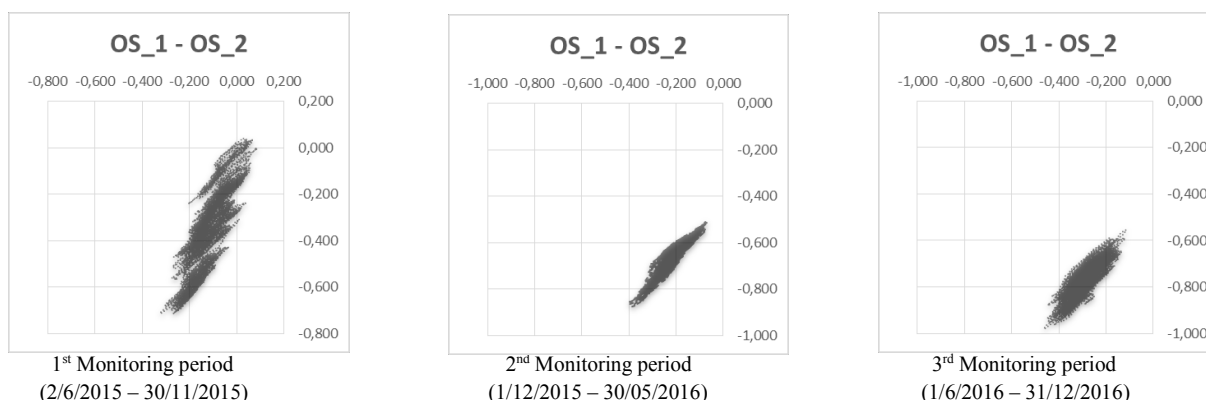
Figures 9-11: Biaxial deformational behavior over 3 monitoring periods.

Proceeding to the evaluation of the collected data, by completing a twenty-one (21) month period of structural health monitoring, there is a clear and comprehensive view of the overall response of the Propylaea Gallery north-western side wall under static loads in both directions (horizontal and vertical). As far as the vertical direction of the western side is concerned, an evolution of an irreversible deformational state with a clear compressive behavior is displayed (900 $\mu$ m, Fig.8). The sharp evolution of compressive deformations during the 2015 winter season is correlated with the sudden and extreme changes in weather conditions (strong storms, autumn 2015) which seem to have affected the Gallery support conditions. The phenomenon continues with less intensity for the rest of the monitoring period, whilst maintain the inelastic deformation of the system that never returns to its initial deformational state. Table 2 and Figures 9 -12 present the data collected during the three monitoring periods of the vertical and the biaxial deformations.

The compressive behavior in the vertical direction of the northwest corner of the Gallery leads to certain redistribution of permanent loads towards its side, which is associated with the overall movement mechanisms of the Propylaea structural system and should be evaluated in a context of a broader systematic monitoring process in order to give useful and significant conclusions. Possible unstable behavior of structure and rock-mass fixation conditions, related to the seasonal temperature cycles and environmental conditions, can prove the activation of the existing visible cracks both in the eastern and western side of the Gallery, although the original cause of these cracks might be completely different.

In the horizontal direction of the north-western side of the structure, a total residual compressive deformation in the range of 100 - 200mm has been recorded. The participation of the horizontal direction in the estimated structural deformational mechanism is significantly diminished, in comparison to the vertical one. Besides, all sensors tend to return to their initial state by completing deformational cycles entirely related to seasonal temperature variations.

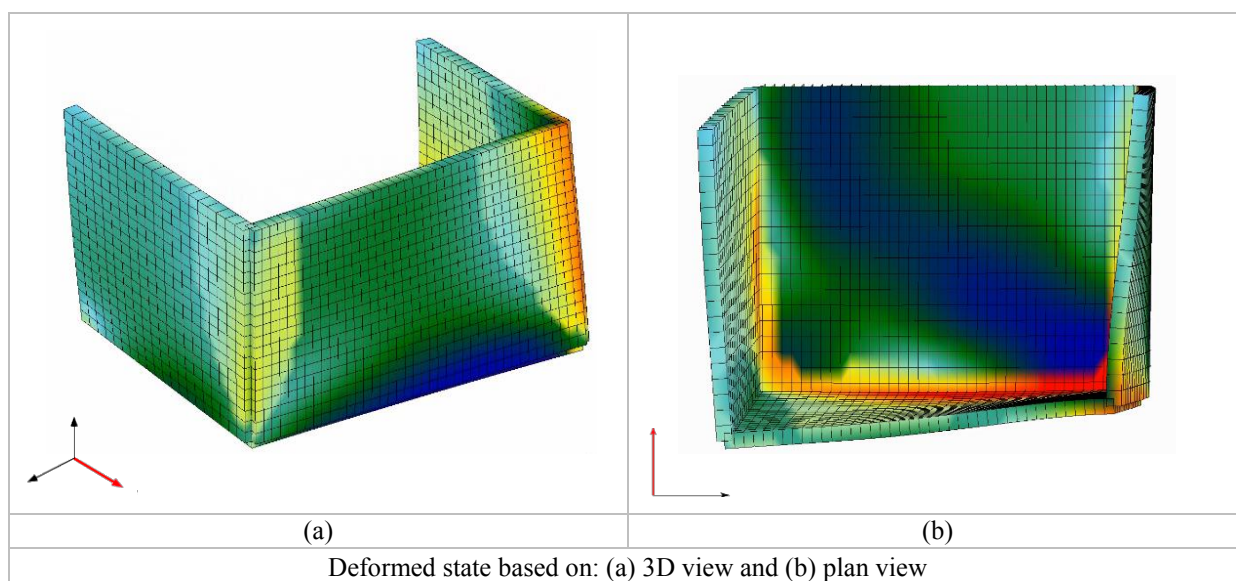
Figure 12: Finite element analysis model.

A finite element analysis model (Fig.12) was conducted as a rough approximation to simulate the Gallery's structure in relation to a slightly unstable subsoil-foundation system, which is subject to differential settlements because of possible soil deterioration [4,5]. The model indicates an ongoing distribution of internal stresses, as measured by the optical sensors, enhancing the belief that the long-term exposure to extreme weather conditions leads to a critically short (but still measurable) attenuation of support conditions on the north-western side of the Propylaea Gallery.
