## **DETAILED NUMERICAL ANALYSIS OF A HISTORIC BUILDING BASED ON ITS CURRENT CONDITION CAPTURED BY LASER SCANS AND MATERIAL TESTS**

**Keywords:** Cultural Heritage Masonry Structures, Structural Assessment, Laser Scanning, Material Tests, Finite Element Analysis.

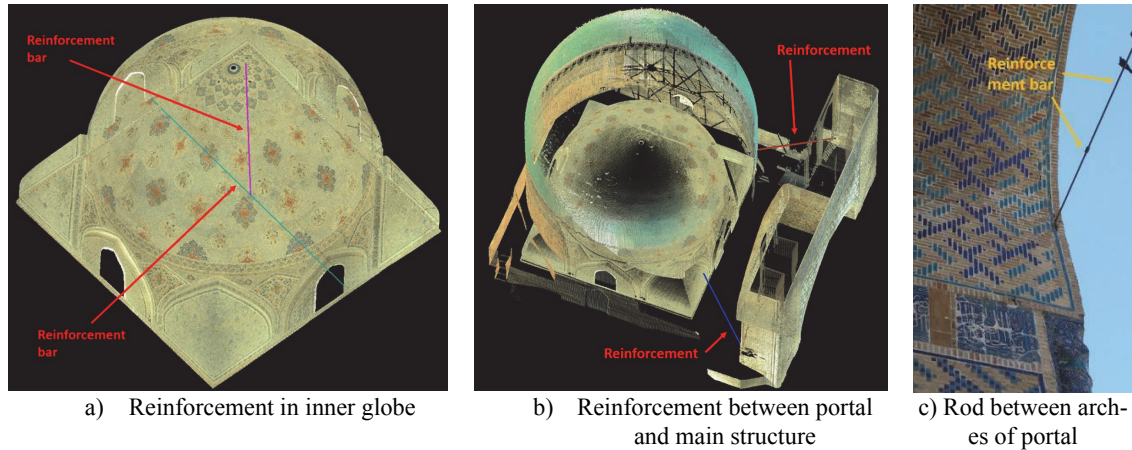
Figure 4: Major pre-existing reinforcements of mosque.

From analysis of the point cloud it was concluded that reinforcement rods did not reveal any sagging. This serves as evidence that the tension force was still present in the rods. One of the pretension rods applied force in weak direction of the reinforcement member (web of a double channel) that resulted in plastic deformations of the double channel. Because this reinforcement could not serve its purpose, it was not included in the model.

It worthy to note that the engineering detailing of the existing reinforcement was not done in a proper way. The current reinforcement attracts the forces and creates stress concentration points. Localized failures of masonry around the attachment points were observed at several locations throughout the monument. Therefore, these connection details need to be redesigned to distribute forces where the brace comes in contact with the masonry.

More analysis aiming at better reinforcement strategies are planned for future studies. These studies will include tests of the masonry wall, ambient vibration studies to estimate resonant frequencies at low excitations, and more detailed numerical models analyzed in a nonlinear time history simulation. The old reinforcement and any new reinforcement attracts the forces and creates stress concentration points. Therefore, these forces need to be properly distributed at the point where they come into contact with the masonry.

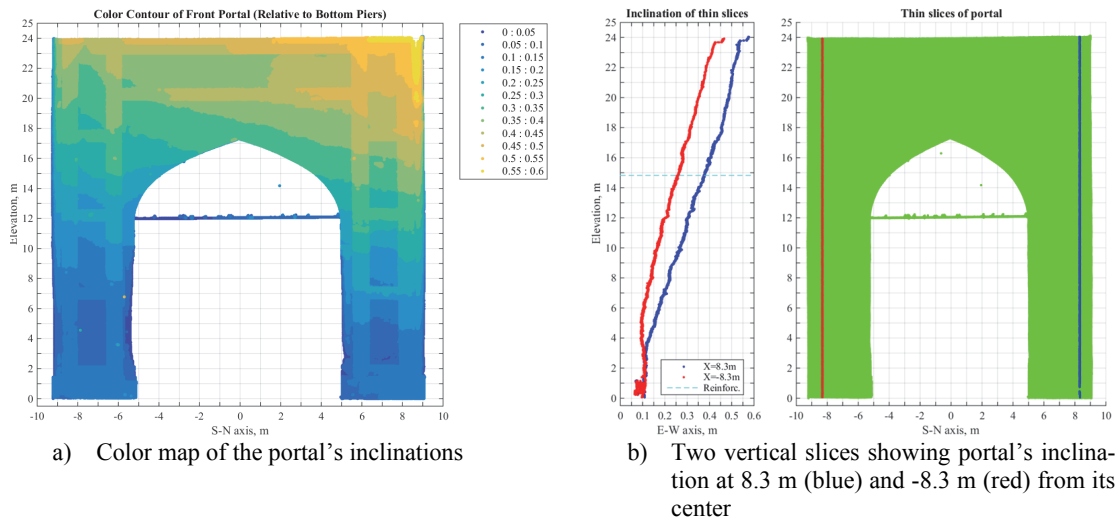
Figure 5: Residual inclinations of portal

The monument's point cloud was investigated for anomalies. The main portal was investigated for its inclination from a vertical plane passing through the bottom of both piers. A color map of the inclinations is presented in Figure 5a. The color map shows that the portal's inclination increases from south to north with the maximum differential displacement of 0.6m at the top north corner. To ensure that this degree of inclination of the portal is not progressing, a periodic monitoring by laser scanning was recommended. It was also advised to proceed with the installation of laser targets to increase accuracy of monitoring.

The same inclination for two vertical slices of the portal is presented in Figure 5b. The cyan line corresponds to  $Z = 14.62$  m where one type of reinforcement was installed.

Since the slope of the slice (plots on the left side) does not change after this elevation, most likely the reinforcement is not effective and does not provide enough support to prevent continuous leaning of the portal. Another major conclusion was drawn from the Figure 5b, that the residual drift of the structure remains the same from about 4 m to the top of the portal and

this elevation coincides with the starting elevation of the crack that essentially separated the portal from the main structure.

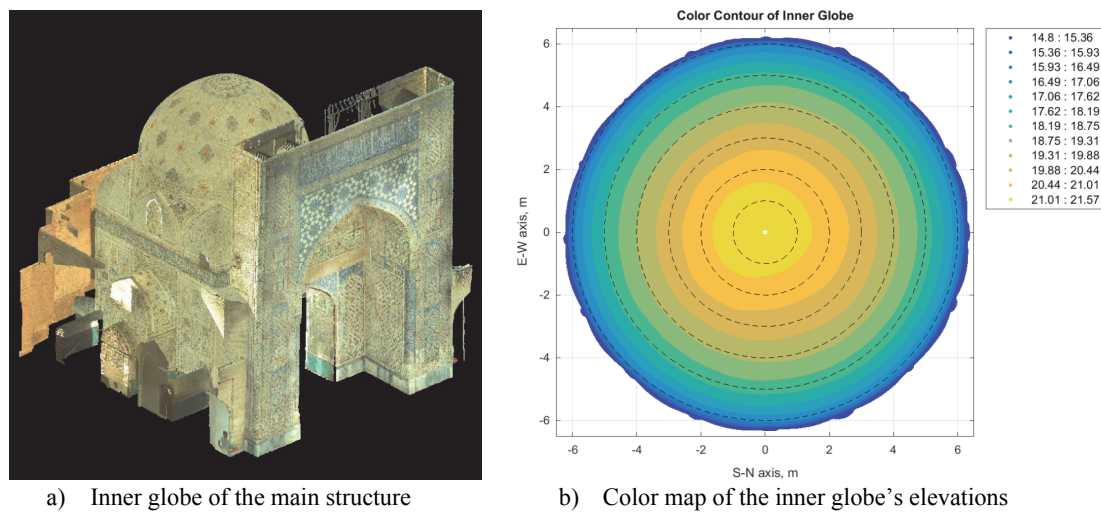
Figure 6: Current imperfections of inner globe.

Structural anomalies of the inner globe in the main structure shown in Figure 6a were also studied. The color map of the inner globe's elevations is presented in Figure 6b. The dashed lines show elevations with 1-meter increments and in many cases the color map for each elevation range have some deviations from the dashed lines. This shows imperfections of the globe. To ensure that the imperfections are not changing over time, a periodic monitoring by laser scanning was recommended. Two slices in S-N and E-W axes were cut from the inner globe as presented in Figure 7a. These slices are plotted in Figure 7b which shows that a slice at  $Y=0$  m is lower on the left (south side) at elevation close to 14.8 m.

The inner globe has some imperfections with the north half at a higher elevation than that on the south side. The latter can be a result of soil settlement on the south side of the building. Periodic monitoring by laser scanning is planned for future investigations.

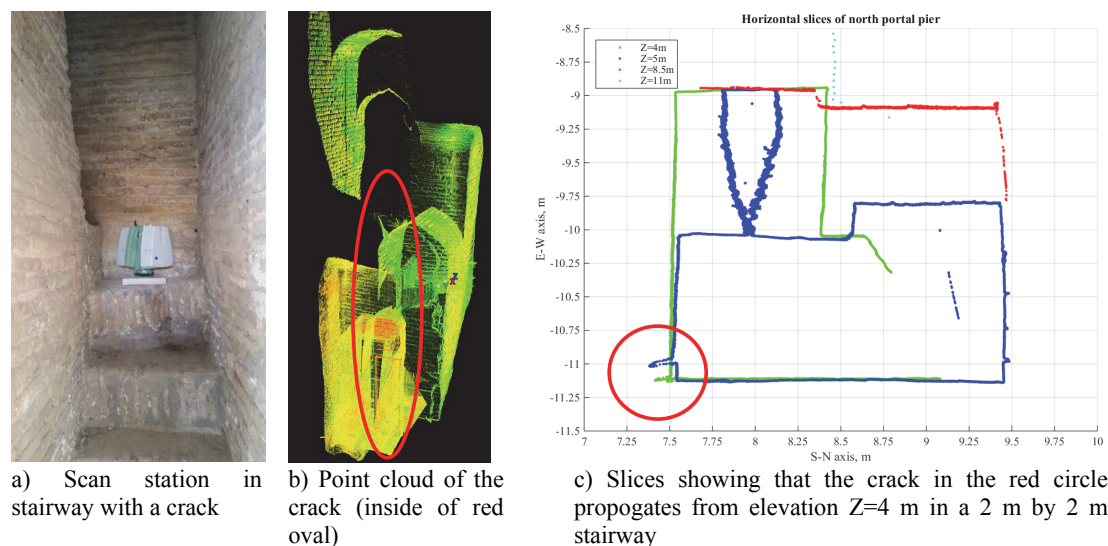
Figure 8: Continuous crack in a narrow stairway (north pier of portal).

The horizontal slices of the north pier and the stairway with a long crack between the portal and the main structures are shown in Figure 8. The scanner was installed at several eleva-

tions of the stairway with one of them shown in Figure 8a. These scans were also stitched with the main registration. The view of the stairway's point cloud is shown in Figure 8b. The horizontal slices at several elevations of the stairway are presented in Figure 8c. A similar, but smaller crack, was observed inside of the south pier of the portal.

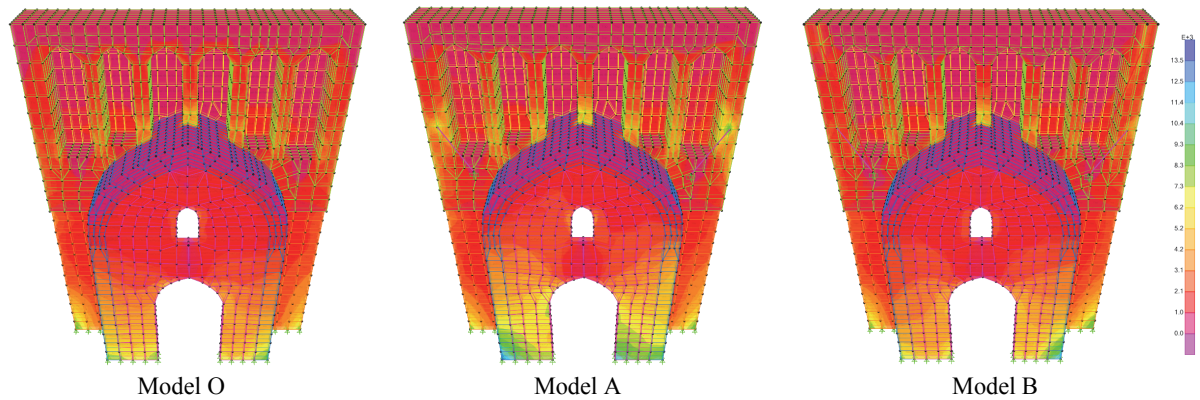
Figure 11 – Envelope of tension stresses (S33) for time history runs

An analysis of the numerical results leads to the following conclusions. The current reinforcement is not as effective as it was intended to be. As presented in left and middle images of Figure 11, the stress concentration at the bottom of the reinforced model is even greater than that in a model without any reinforcement. The same conclusion can be drawn from the displacements on top of the portal shown in Figure 12. The current reinforcement failed to reduce the displacements on top of the portal. Moreover, the peak displacement of Model A is greater than that of Model O. Adding two more braces to Model A results in Model B that has much better performance as presented in the right image of Figure 11. These braces also helped to reduce peak displacement on top of the portal, as presented in the right image of Figure 12.

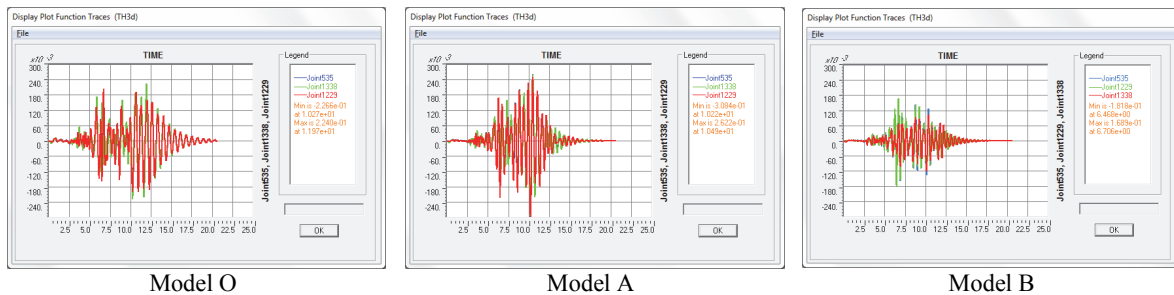
Fig. 12 – Displacements on top of portal (blue line – mid-span; green and red lines – outer sides)

peak displacement of Model A is greater than that of Model O. Adding two more braces to Model A results in Model B that has a better seismic performance.
