## **POST-EARTHQUAKE REHABILITATION OF HEALTHCARE BUILDINGS: THE CASE STUDY OF THE MIRANDOLA HOSPITAL**

**Giuseppe Ventura<sup>1</sup>, Giuseppe Santarsiero<sup>1</sup>, Angelo Masi<sup>1</sup>, Vincenzo Manfredi<sup>1</sup>, Andrea Digrisolo<sup>1</sup>**

School of Engineering, University of Basilicata, via dell'ateneo lucano, 10, Potenza, Italy

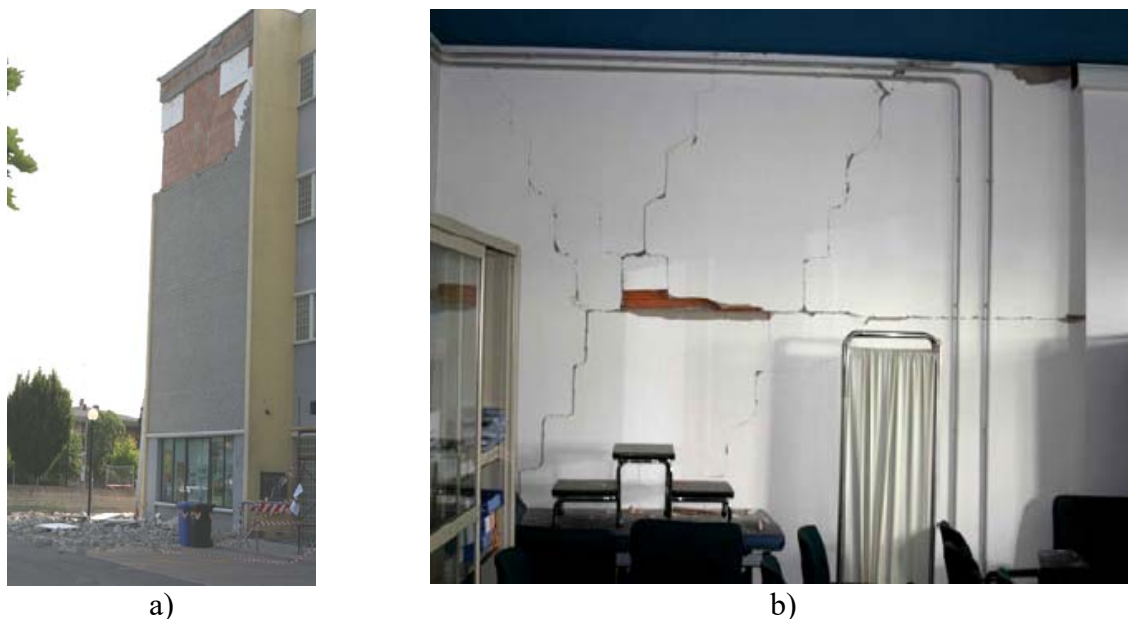
The building under study is named Service Centre whose infill panels, as a consequence of high vulnerability due to the outside position from the surrounding frame members and/or excessive slenderness [7], suffered out-of-plane collapse (Fig. 1a). In some cases, external failure of infills was also promoted by prior in-plane damage [8,9].

The same building also suffered significant damage in partitions made up of hollow clay bricks (Fig. 1b), while negligible damage to the structural components was observed. More details on building damage are reported in [4].

Figure 1: Example of damage to Service Centre: a) collapsed infills and b) cracked partitions .

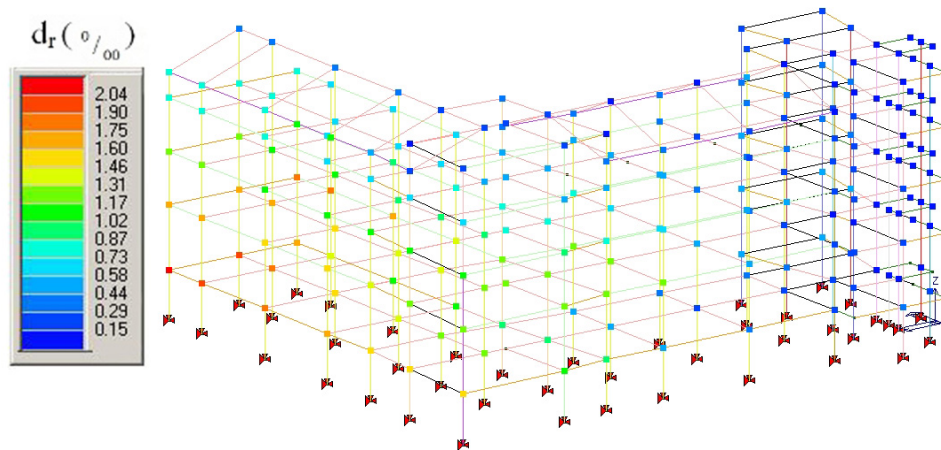
Figure 5: SLO results.

As can be seen from Figure 5, the SLO limit state is not satisfied. In particular, in some region of the structure, and consequently for the corresponding infill panels, located in the perimeter of the structure, far from the rigid staircase, drift values slightly exceed the drift threshold prescribed by the code (0.2%). As could be expected, these results have been evaluated at lowest storeys where higher values of interstorey drift are generally experimented [8,9].

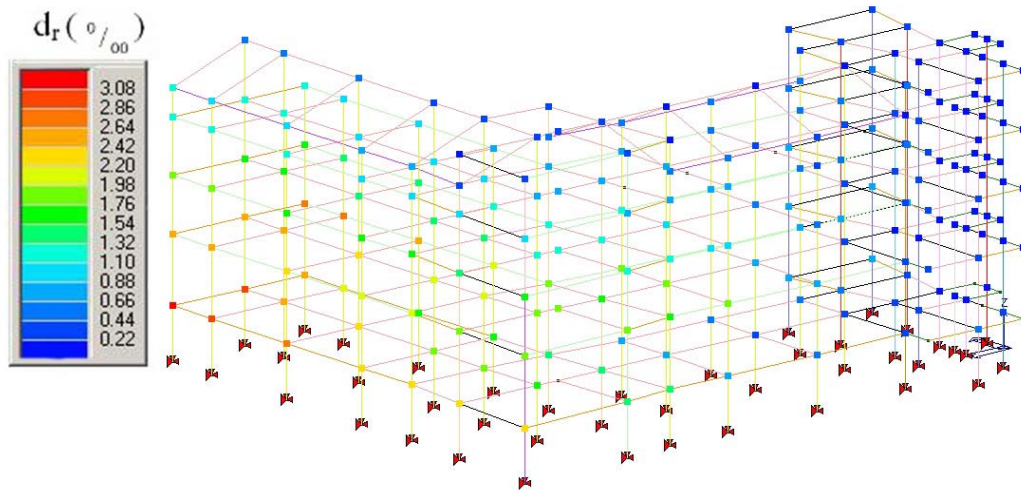
Figure 6: SLD results.

Similar results have been evaluated for SLD, as plotted in Figure 6. In fact, almost the same areas of the building show points where the interstorey drift is slightly higher than the code threshold (0.3%).

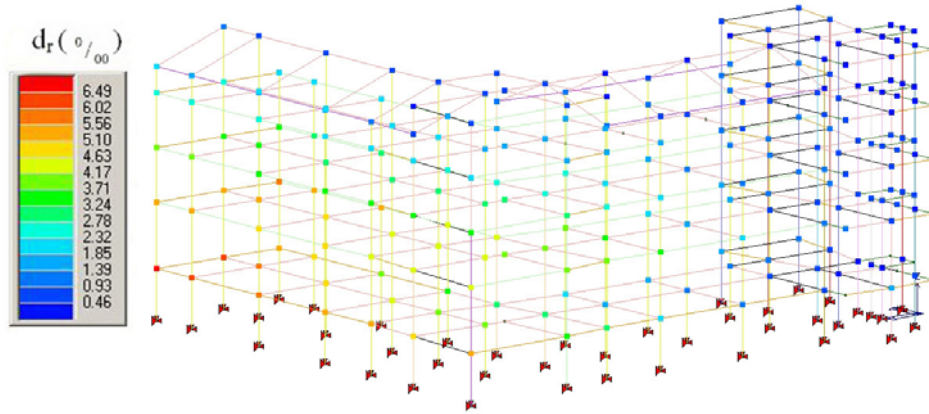
Figure 8: Interstorey drift results using the May 29 Mirandola earthquake

Figure 8 shows the results in terms of interstorey drift values under the May 29 Mirandola earthquake. As can be noted, the maximum drift (equal to 0.65%) is achieved at the peripheral area of the building plan opposite to the staircase (the stiffest zone of the building). This is in accordance with the results of the survey that revealed the wide presence of damage to non-structural components like partition and infills.

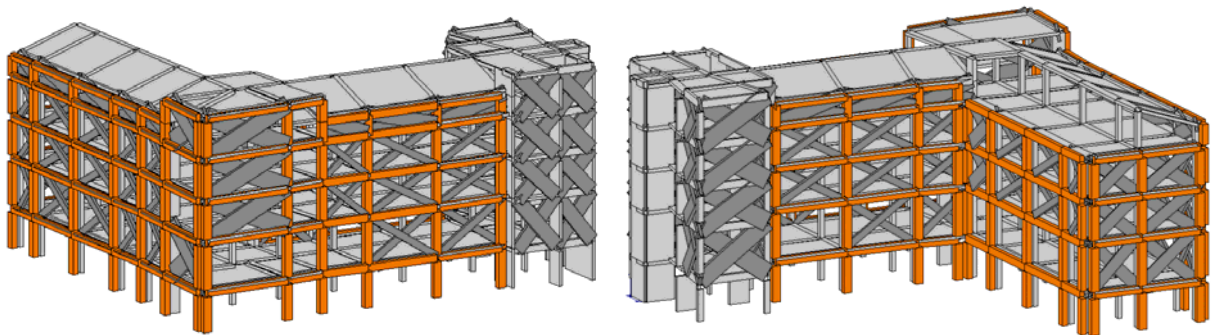
Figure 9: Building model with the upgrading system (orange colored members).

Due to these aspects, the upgrading system is made of RC frames located along the perimeter of the existing structure [15,16] and rigidly connected to it (Figure 9).

This intervention strategy comprises works to be carried out only from the outside with a strong reduction of demolitions and related reconstruction works. If the additional RC frame (auxiliary) structure is prefabricated, the time needed to perform works as well as disturbance to the occupancy are furtherly reduced.

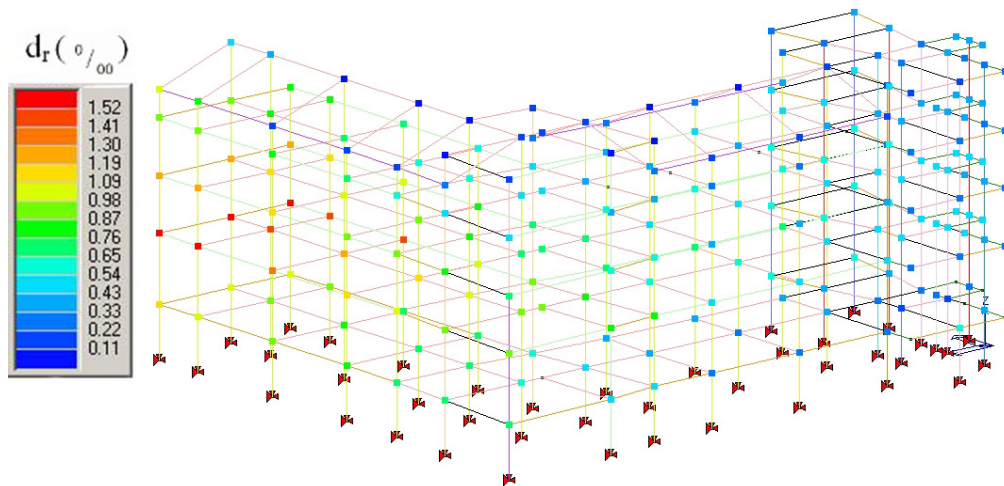
Figure 10: SLO results for the upgraded structure.

Figure 10 displays the verification of the structure in the upgraded condition. For the SLO, the maximum interstorey drift is achieved on the second floor almost in the same position as happens for the as-built structure. In this case the maximum drift is  $d_r = 0.0016 \cdot h < 0.0020 \cdot h$ .

For the damage limit state (SLD) the maximum drift is  $d_r = 0.0021 \cdot h < 0.0030 \cdot h$ . Therefore, both the serviceability limit states are satisfied.

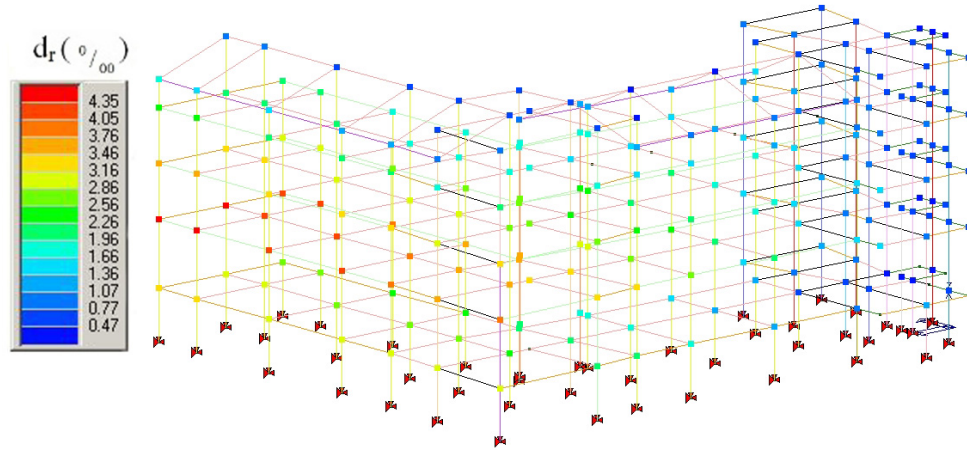
Figure 11: Interstorey drift under the Mirandola earthquake of May 29, 2012.

Considering the Mirandola spectrum obtained from the acceleration record of May 29, 2012, the structural response is quite different. Indeed the max interstorey drift (Figure 11) is  $d_r = 0.0047 \cdot h > 0.0030 \cdot h$ . This means that damage of the structure cannot be excluded in case a new earthquake (similar to that of May, 29) occurs again.
