AN ASSESSMENT OF THE STRUCTURAL BEHAVIOUR OF THE GARISENDA TOWER IN BOLOGNA THROUGH FINITE ELEMENT MODELLING AND STRUCTURAL HEALTH MONITORING

Simonetta Baraccani¹, Alessandro Piccolo¹, Giada Gasparini¹, Michele Palermo¹, Tomaso Trombetti¹

¹ University of Bologna
Viale del Risorgimento 2, Bologna, Italy
e-mail: simonetta.baraccani2@unibo.it

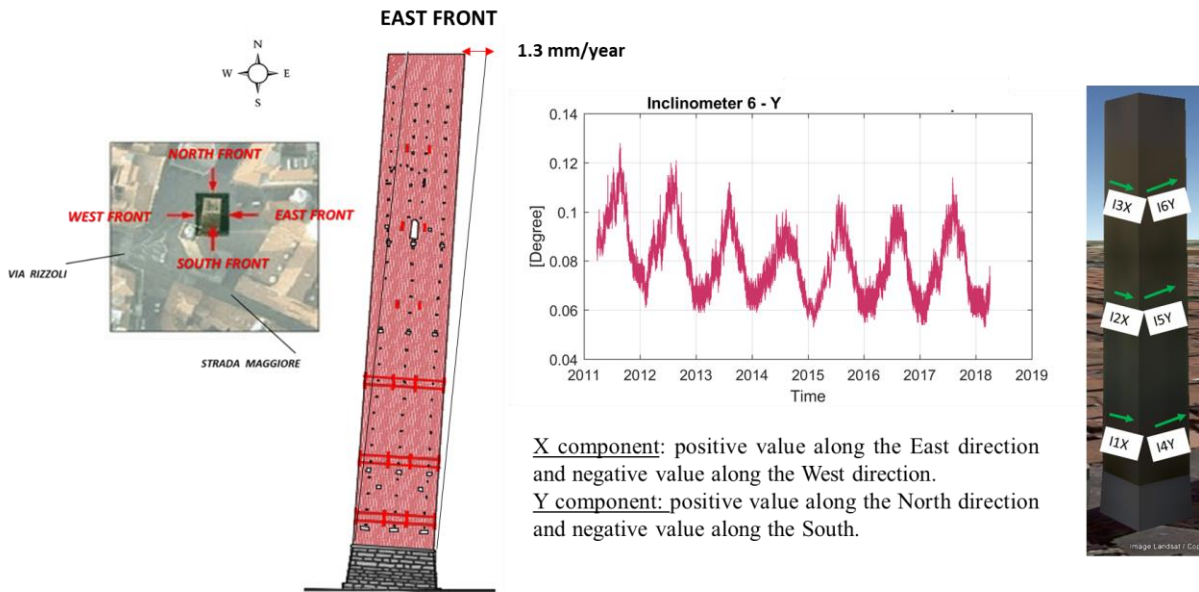
A static SHM system was installed on the Garisenda tower at the beginning of 2011. This system allows monitoring: movements of the main cracks, deformations of critical portions of masonry, inclination, strains along the steel ties (installed on the height of the tower to provide a lateral confinement to the masonry) and environmental parameter (such as temperature, wind speed). Additional details on the monitoring system are available in previous work developed by some of the authors [6], [7]. The results obtained from the analyses of the data recorded by the SHM system highlighted a slight evolutionary trend especially in relation to the inclination. Six inclinometers are installed in the East and South fronts at different levels (13.20 m, 30.65m and 43.3m). The data recorded show an increase in the Tower inclination toward East of around 1.3 mm/year and also a slight inclination northwards.

Figure 3-(a) Inclination detected toward East from the X-component of the inclinometers. (b) Inclination detected towards North Y-component of the inclinometers

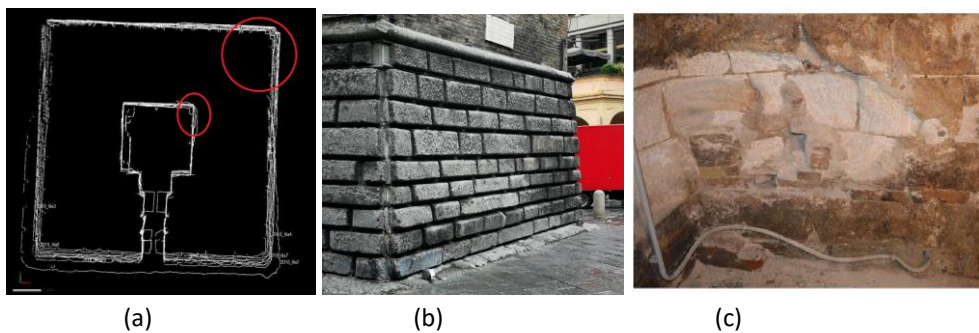
Over the last year, some surveys and visual inspections revealed that small portions of the selenitic layer are degrading and becoming chalk, with a significant reduction of the mechanical characteristics of the original stone. This phenomenon is observed at the base in the corner under slope, both on the outside and in the inner side (Figure 4a). Externally the selenitic blocks, that cover the first meters of the tower, have suffered relative displacements mainly concentrated on the East front (Figure 4b). The internal selenitic stones, on the other hand, show the presence of a deterioration process underway due to chemical processes linked to humidity. This phenomenon is particularly pronounced in the South-East corner (Figure 4c).

Figure 4-(a) Corner mainly affected by the degradation phenomenon. (b) Displacements of the selenitic blocks of the East front (c) Degradation of the internal selenite basement

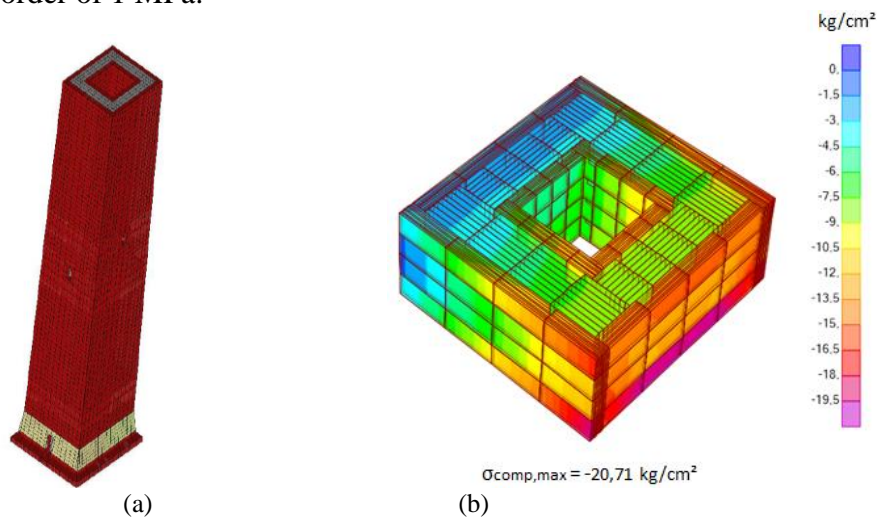
First, the stress levels as obtained from UNModel are reported in figure 5b. It can be noted that the maximum compressive stresses accumulates on the external selenitic blocks concentrated on the South-East corner (around 2 MPa), while the internal infill achieves compressive stresses of the order of 1 MPa.

Figure 5-(a) Three-Dimensional Finite Element Model of the Garisenda Tower. (b) Stress levels at the base of the tower considering the material not degraded.

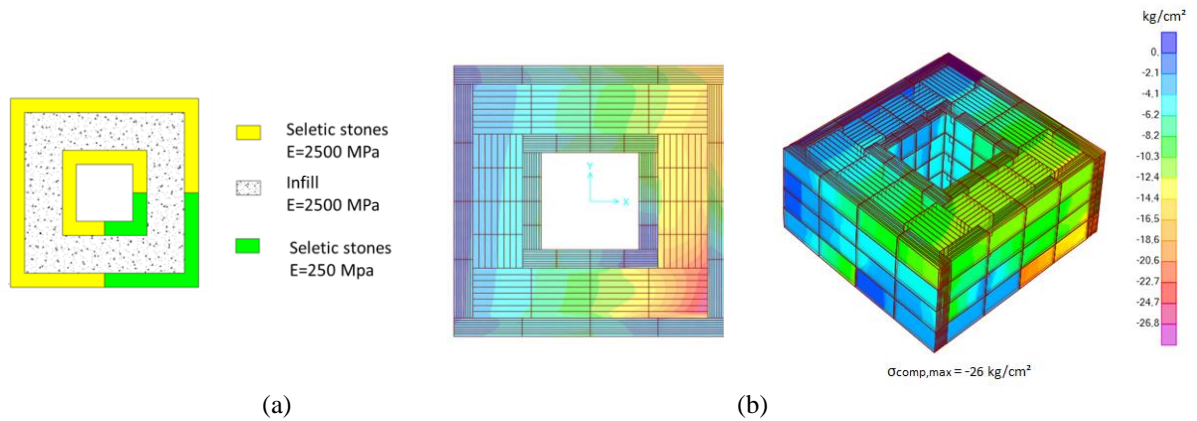
In model DEGmodel_1, the degradation detected in the external and internal perimeter constituted by blocks of selenite has been simulated progressively decreasing the elastic modulus of the material in the South-East corner, evidenced in green in Figure 6a (in particular several analyses have been carried out reducing the elastic moduli from 2500 to 250 MPa). The analyses have been conducted considering only the self-weight. The results obtained in terms of contour maps, considering an elastic modulus of the corner equal to 250 MPa, are presented in figure 6b. It can be noticed that the maximum value of the compressive stress in selenitic blocks remains of the same order of magnitude whilst increase in the infill (reaching values of the order of 2.6 MPa).

Figure 6-(a) Identification of the areas interested by the reduction of the Elastic modulus. (b) Contour maps, considering an elastic modulus of the corner equal to 250 MPa

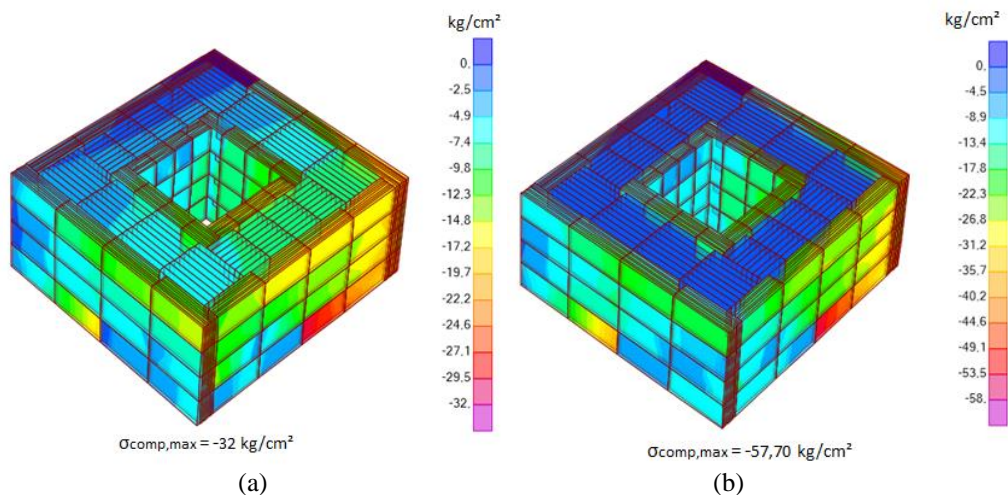
DEGmodel_2 includes the effect of a possible deterioration in the infill material through 2 reductions in the elastic moduli: (i) from 3000 MPa (initial value) to 1500 MPa, (ii) from 3000 MPa (initial value) to 300 MPa. Figure 7 displays the contour maps of the stresses levels in the selenitic stones and infill for the two cases. It can be noticed that the degradation of the infill causes a redistribution of the tension moving the maximum stresses in the selenitic stones close to the deteriorate corner (peaks of the order of 3.2 MPa and 5.7 MPa).

Figure 7-(a) Contour maps of the stress level at the base section obtained reducing the infill Elastic modulus by: (a) 50% and (b) 90%
