COMPREHENSIVE NONLINEAR ANALYSIS OF FAILURES OF A FIRE-SPRINKLER SYSTEM BASED ON FINITE ELEMENT MODELLING AND AMBIENT VIBRATION TESTS

Shakhzod M. Takhirov¹ and Amir S. Gilani²

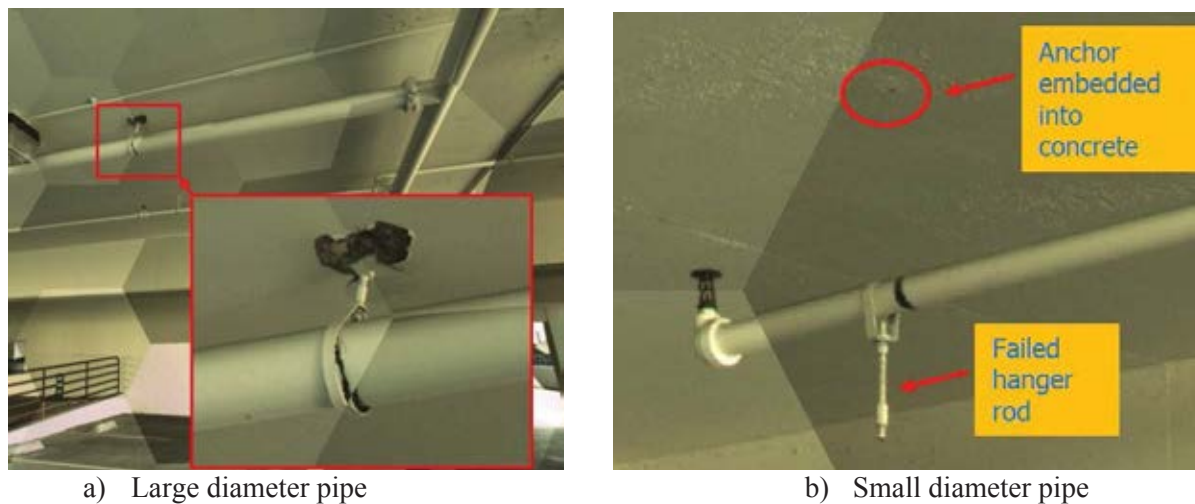
Based on the results of the time history analysis of the elastic FE element model, it was concluded that the bending stress in a few supporting rods is below the yielding stress of mild steel. Nevertheless, failures of the supporting rods were observed as presented in Figure 9.

Figure 9: Typical failures of supporting rods [1].

The failure in the right image is related to the low-cycle fatigue capacity of the smaller rods in bending. As opposed to that, the left image shows a failure of the larger supporting rod that resulted from the failure of the anchoring part of the rod. The anchor's depth was not sufficient to avoid a failure of the concrete. These nonlinear effects will be modelled in the next stage of the finite element modelling. This part of the finite element modelling is ongoing. In this stage a number of component tests will be performed to generate a realistic model.
