**ASSESSMENT OF DAMAGE TO MODERN REINFORCED
CONCRETE BUILDINGS – ENGINEERING ANALYSIS OF THE M6.4
ALBANIA EARTHQUAKE, 26th OF NOV. 2019**

Abstract

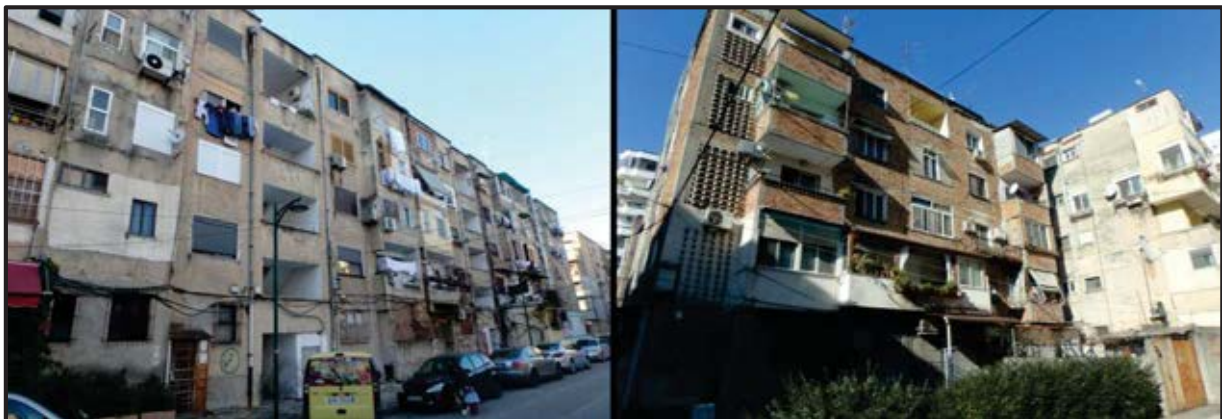
Figure 8: Undamaged multi-story masonry structures in Durrës.

It is worth mentioning that no significant structural damage to low-rise multi-story unreinforced masonry structures was observed in the surveyed city areas during the reconnaissance mission (see Figure 8).

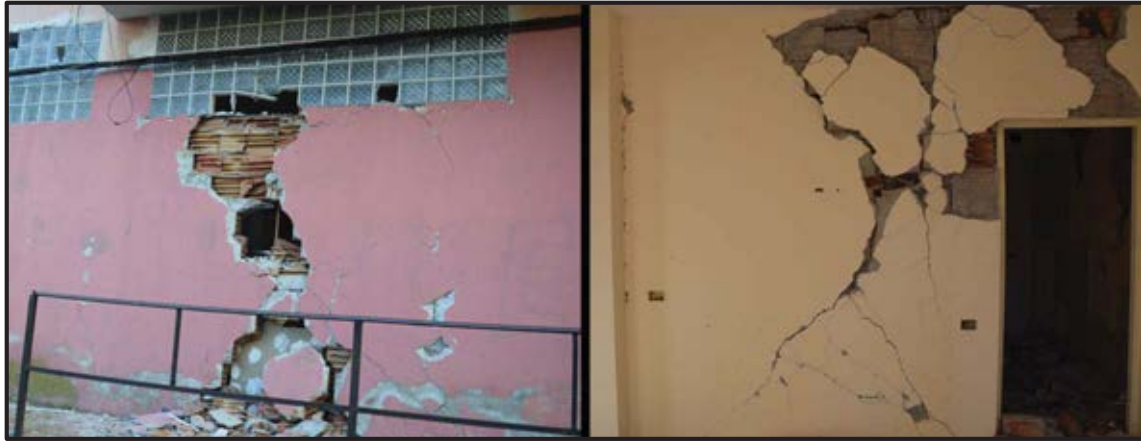
Even though the structural safety in many of the observed buildings was met, the serviceability conditions of the observed buildings were poor. Considerable damage was observed in the infill walls, (see Figure 9 for in-plane failure samples). Usually, the damage was proportional to the number of stories. As expected, the ground floors were the most heavily damaged. The damage level was reduced with increased height. One of the most dominant characteristics of the damaged infill walls was observed to be poor workmanship and the lack of a proper connection between the masonry units. In all the cases, standard clay blocks with high volume horizontal voids were used (Group 4 in compliance with EC6).

Figure 9: Infill in-plane failure.

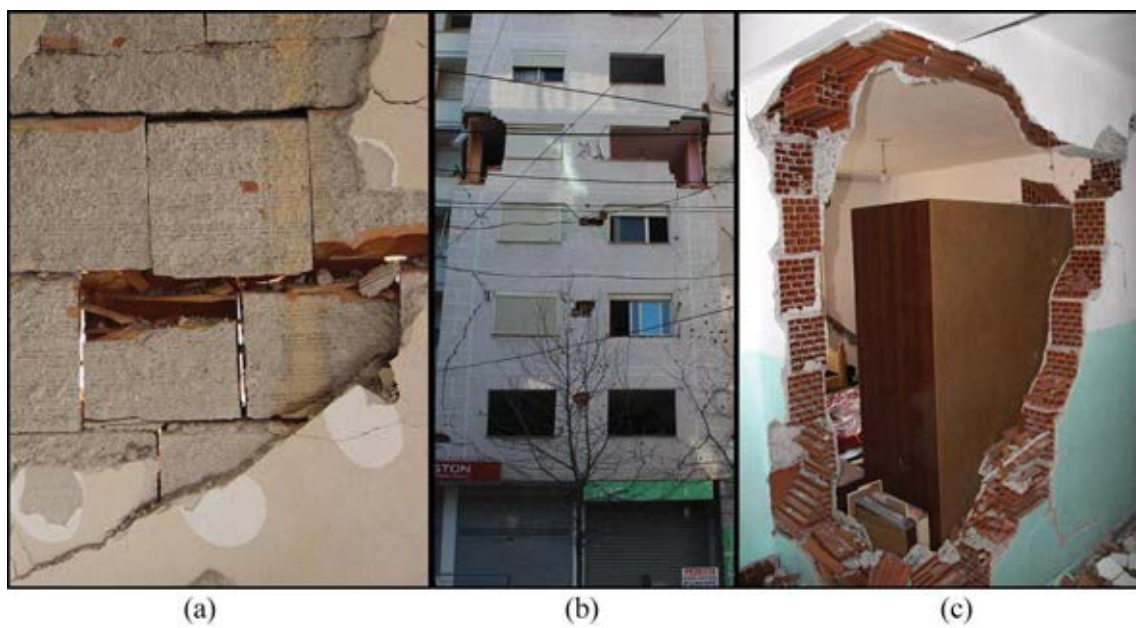
It was observed that there was a lack of head joints in some of the inspected buildings. The brick-laying practice mainly consisted of the application of a bed joint and leaving the bricks unconnected with mortar vertically as shown in Figure 10 (a). Lack of vertical confinement at walls intersections was also observed, as in Figure 10 (b and c).

Figure 10: Poor workmanship for infill walls (a) Lack of head-joints (b) and (c) Lack of vertical confinement at walls intersection.

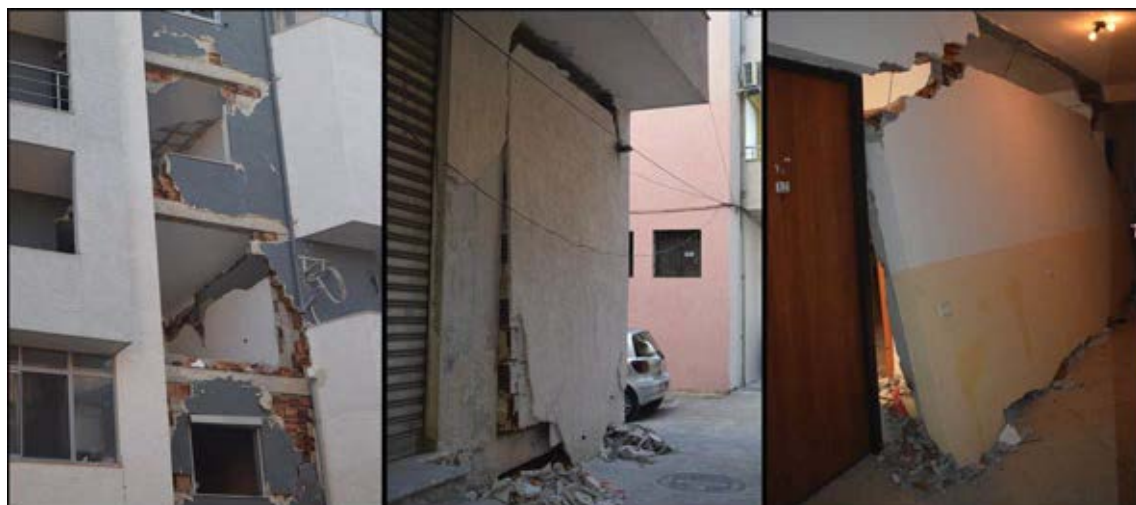
Figure 11: Infill out-of-plane failure.

At the same time, many out-of-plane damages could also be observed on the upper and lower floors (see also [25,26]), caused by the influence of bi-directional loading and IP damage, where the two components of a floor movement are of similar importance. The magnitude of the loads in-plane decreases at the upper floors, while the forces acting perpendicular to the plane increase due to the increase in acceleration over the height of the building.

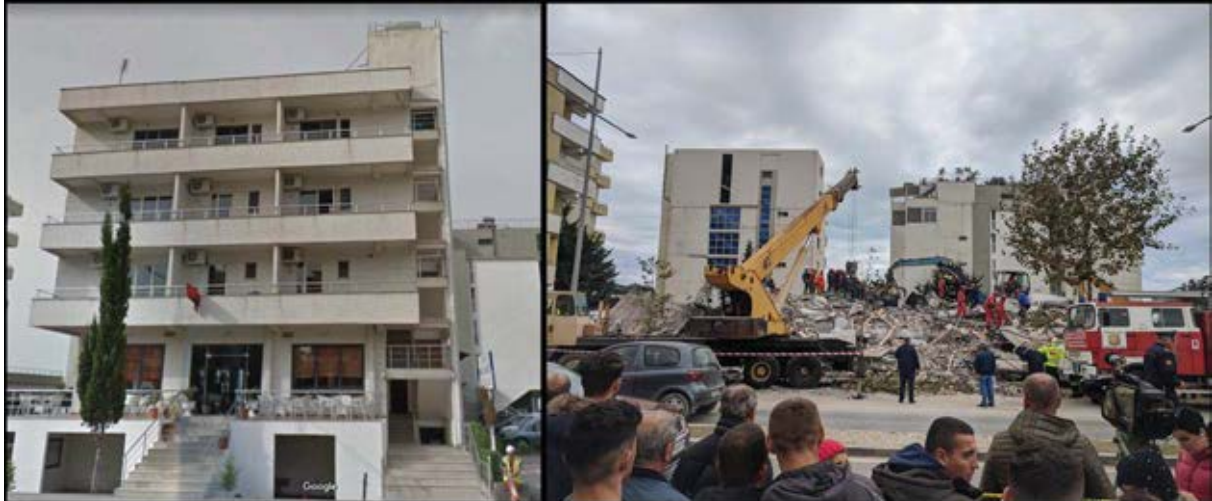
Besides the surveyed buildings, it was reported that 7 buildings collapsed in Durrës due to the earthquake [19]. Figure 13 and Figure 14 show collapsed 4-story and soft-story buildings respectively. The collapse of these buildings could be attributed to the high shaking effects, poor construction practice, and the insufficient respect of the building code requirements.

Figure 13: 4-story collapsed building in Durrës (Left photo: [27], Right photo: courtesy of C. McKenney [28]).

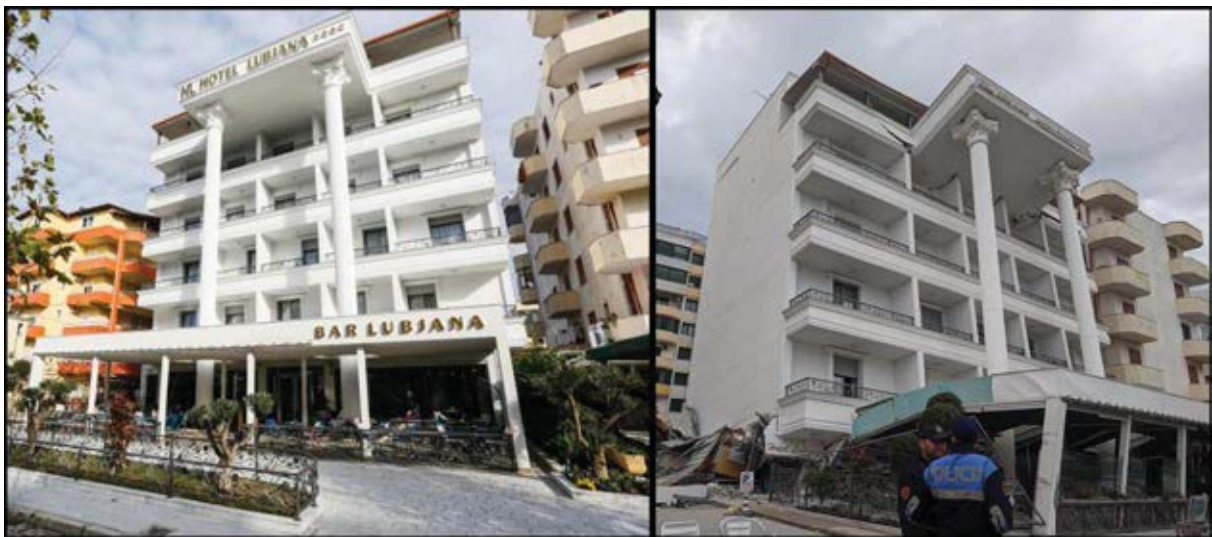
Figure 14: Collapsed Lubjana Hotel in Durrës (Left photo: [29], Right photo: courtesy of C. McKenney [28]).

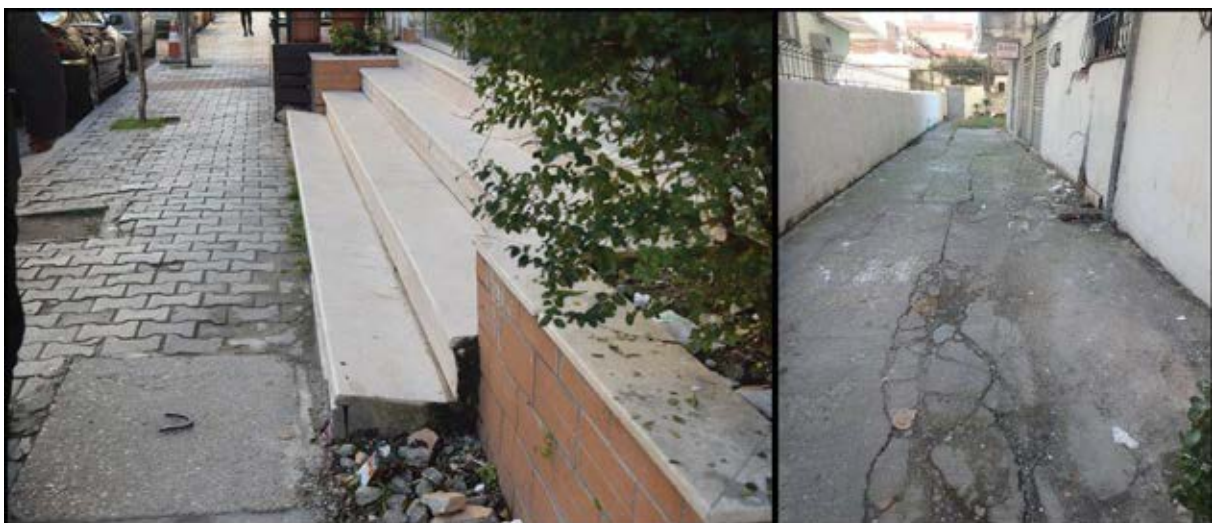
Figure 15: Soil settlement in buildings.

The ground conditions in the near coastal part were susceptible to liquefaction, which was observed during the survey in few buildings as shown in Figure 15. It was reported that extensive soil liquefaction was observed along the coastal side of Durrës city [30]. This settlement caused tilting of buildings, which could be visually observed.
