ANALYTICAL AND NUMERICAL ANALYSIS OF S. MARTINO'S DEI GUALDESI CHURCH DAMAGED DURING THE 2016 CENTRAL ITALY SEISMIC SEQUENCE

Elvis Cescatti¹, Michol Rampado¹, Veronica Follador², Francesca da Porto¹, Claudio Modena³

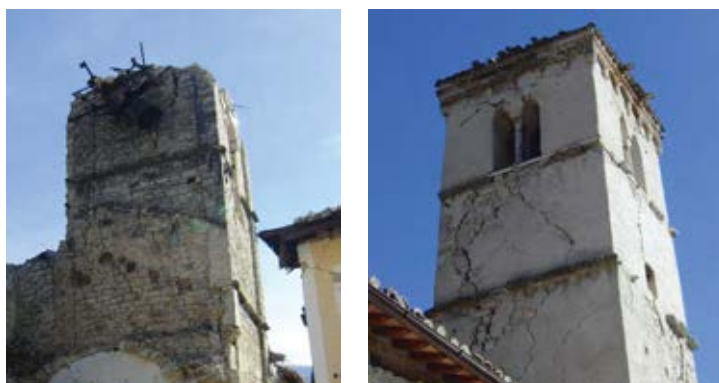
Figure 1: S. Stefano's tower (left) and San Martino's bell tower (right) after the 30th of October 2016

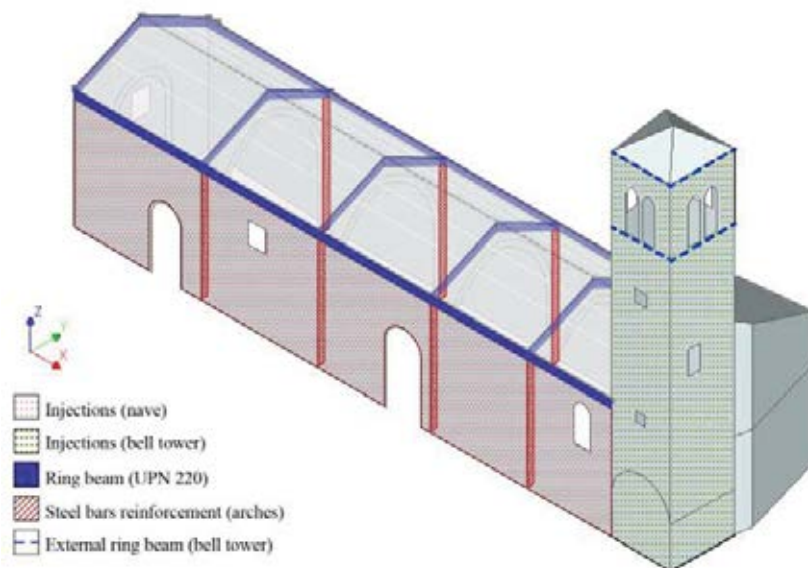
In 2014 interventions, a systematic demolition of the top of the wall was carried out with subsequent reconstruction of it for a height of 30-50 cm. In addition, a UPN 220 metal profile

has been inserted and anchored with the underlying wall with a $\phi 16$ bar 85 cm long, every 50 cm. The bars were inserted inside perforations (with a diameter of 24 mm) and subsequently injected with lime mortar (blue line in Figure 3). A further intervention was the injection of a fluid hydraulic lime mortar on the walls. Four holes per square meter with a diameter of 22 mm were injected (red dot fill in Figure 3). A final and significant structural intervention performed on the nave concerns the execution of a series of steel bars reinforcement between the longitudinal walls of the nave and the internal arches. Twelve stainless steel bars with a diameter of 16 mm were inserted and injected with epoxy resin inside drillings of 24 mm of diameter (red strip hatch in Figure 3). Regarding the bell tower, in 2000, two orders of metal hooping beams have been inserted in elevation under the belfry and at the level of the mouldings (blue dashed line in Figure 3). Finally, about 20 perforations per wall were made on the tower's walls with subsequent insertion of steel bars presumably with a diameter of 20 mm (green dot mesh in Figure 3).

Figure 3: Representation of interventions implemented in 2014 and 2000 to the San Martino's dei Gualdesi church.

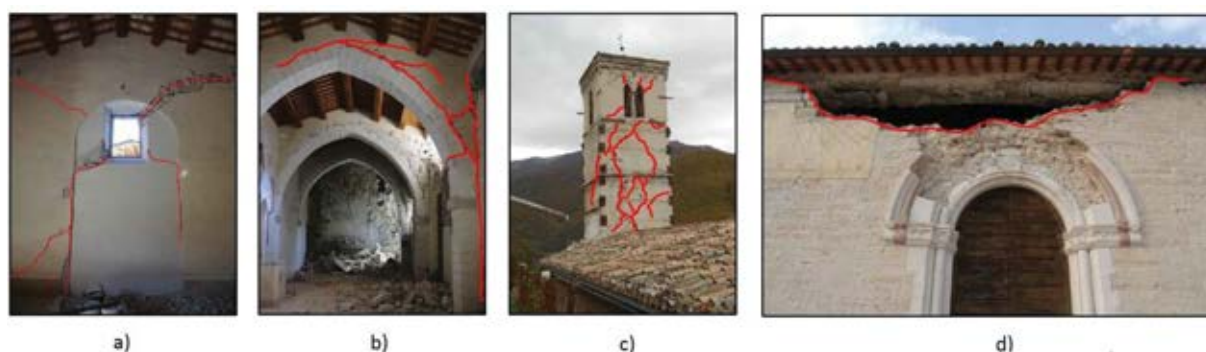
The cracks affecting the internal part of the church are mainly located between the longitudinal walls and the central arches. From the structure of the church, it is clear that the pointed arches, placed transversely to the nave, support the roof and transmit the loads to the side pillars and to the perimeter walls. Figure 4b highlights some cracks between pillars and the longitudinal wall probably due to the weak connection in shear between the two. Moreover, it seems that some interactions in traction are present since some sliding in first voussoirs is present, probably due to the introduction of rebars and a consequent movement of the pillar according to the out-of-plane of the lateral wall.

More cracks are located at the interface between the extrados of the arch and the masonry, due to the absence of connection between the two different materials. In the same pictures (Figure 4b), reduced cracks are observed even at the level of the roof, perhaps due to the insertion of the metallic ring beam that may have limited their opening but also promoted the detachment.

Other cracks were located in the transverse walls of the nave, in particular in the north-west facade, which still has the shape of the original door. The distribution of the cracks follows the intersection between the original wall and the added element showing the typical shear cross shape (Figure 4a).

Lastly, deep cracks were found on the bell tower (Figure 4c). The position of these cracks is related to the presence of windows and small openings. The windows and the little columns of the upper level represent the weakest. However, although characterized by widespread cracks, the bell tower did not show the collapse of masonry parts or other elements. This proves the effectiveness of the past hooping interventions, which have defined a better connection between the orthogonal walls ensuring the box behavior during the seismic events.

Unlike the other facades of the church, the longitudinal wall located to the south shows a loss of the curtain wall with the detachment of the upper portion of the masonry (Figure 4d). The collapse of this masonry portion seems to be promoted by the reinforcement (of the past interventions) at the top. Indeed, if the metallic beam presents excessive stiffness, it can generate damages related to the tangential stresses in the contact area with the masonry and therefore a detachment between the parts. Moreover, the entire wall suffered from an out-of-plane displacement in the order of 15-20 cm. The overall displacement of that seems to be provided by the monolithic behavior probably promoted and enhanced by injections.

Figure 4: Damages observed on the north-west facade (a), central arch (b), bell tower (c) and on the south-west facade.

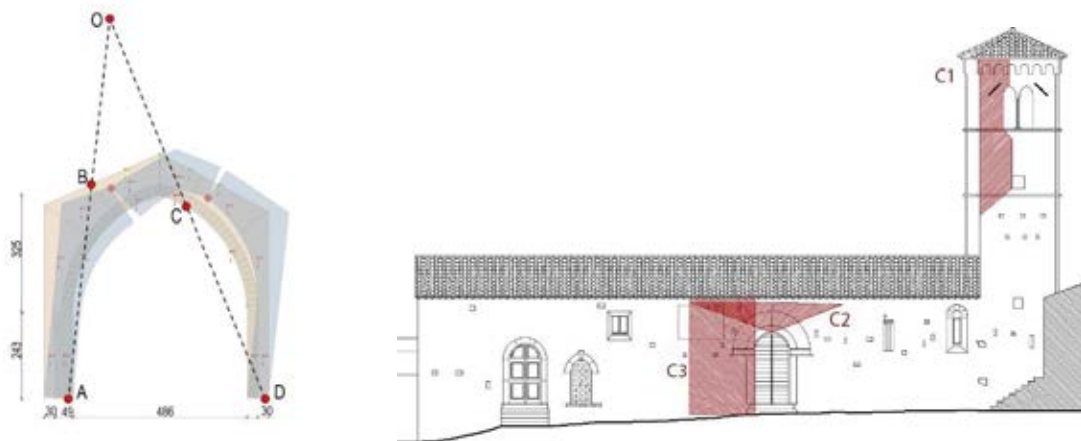
The out-of-plane limit analysis was guided by the actual crack pattern observed, and hence evaluating those mechanisms activated during the earthquake (Figure 5). In detail, the south-west wall of the nave and the north-west corner of the tower were analyzed as out-of-plane mechanisms, while the central arch as in-plane mechanisms.

Figure 5: In-plane (left) and out-of-plane (right) analysis of the church.

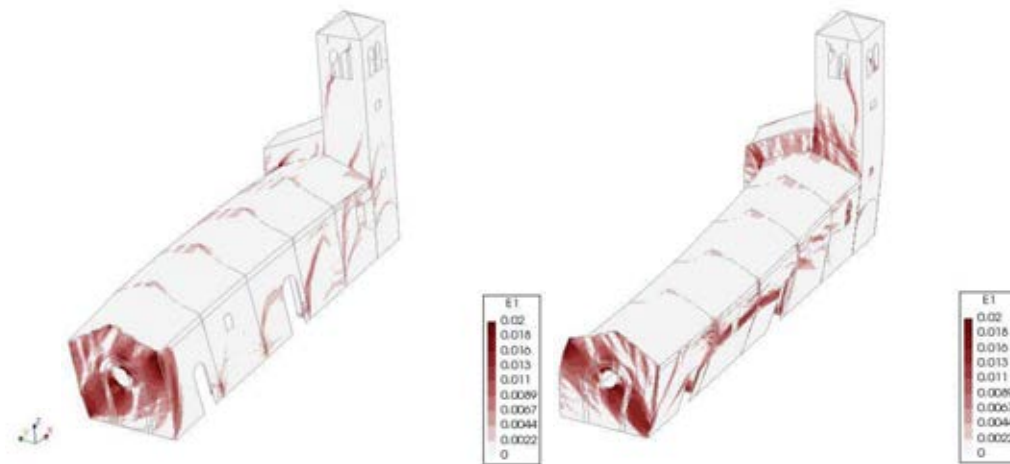
Results show greater deformations and displacements refer to the analysis with transverse direction of the seismic action (+Y, -Y). In the first case (+Y, mountain dir.), the displacements of the control nodes positioned at the top of the central arch are approximately equal to 0.20 m in agreement with the actual observations. Analyzing the results relating to strains, the main stresses are located on the transversal walls. However, high cracks are also located on the longitudinal facades of the church and on the tower's walls (Figure 6).

Figure 6: Major principal strain for the analysis in the +Y direction (left) and -Y direction (right).

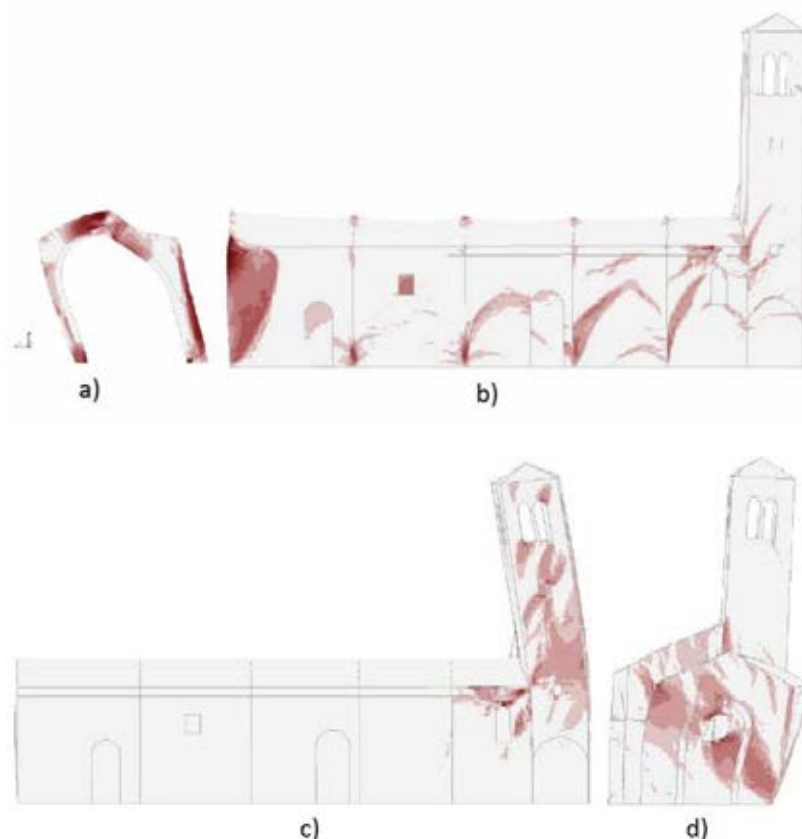
Figure 7a shows that strains, and thus cracks concerning the internal arch, are mainly located between its lateral part and the longitudinal part of the south-western masonry and in the interface between the extrados of the arch and the masonry above. From this crack pattern, the four hinges location for the limit analysis presented above was defined (§4.2). Moreover, damages and cracks coincide with the damages observed in the on-site survey (Figure 4b), confirming the reliability of this type of analysis.

The longitudinal south-west wall showed significant damage due to the longitudinal action. Figure 7b shows cracks on the entire wall and in particular near the transverse arches and openings. More cracks are located in the interface between the wall of the bell tower and in the upper part of the nave facade. These damages coincide also with the current state of the church.

Figure 7: Localized deformations in the central arch (a), south-west wall (b), tower (c) and north-west wall (d).

The north-west facade is characterized by significant damages in the case of transverse seismic action. Cracks obtained from the numerical model provide almost the same pattern observed in the structure. The distribution of cracks follows the intersection between the original wall and the added element.

Lastly, the south-western wall of the bell tower shows significant deformations due to the longitudinal action (-X). The principal strains, obtained from the numerical model, are located near the mullioned windows, in the small openings below and lastly in the contact area between the roof of the church and the belfry. These critical points are also observed on the damage picture (Figure 4c).
