REVIEW OF RETROFIT AND STRENGTHENING STRATEGIES USED IN BUILDINGS IN MEXICO CITY AFTER STRONG EARTHQUAKES

Arturo Tena-Colunga¹, Héctor Hernández-Ramírez¹, and Eber A. Godínez-Domínguez²

Keywords: Retrofit, strengthening, jacketing, steel bracing, exoskeletons.

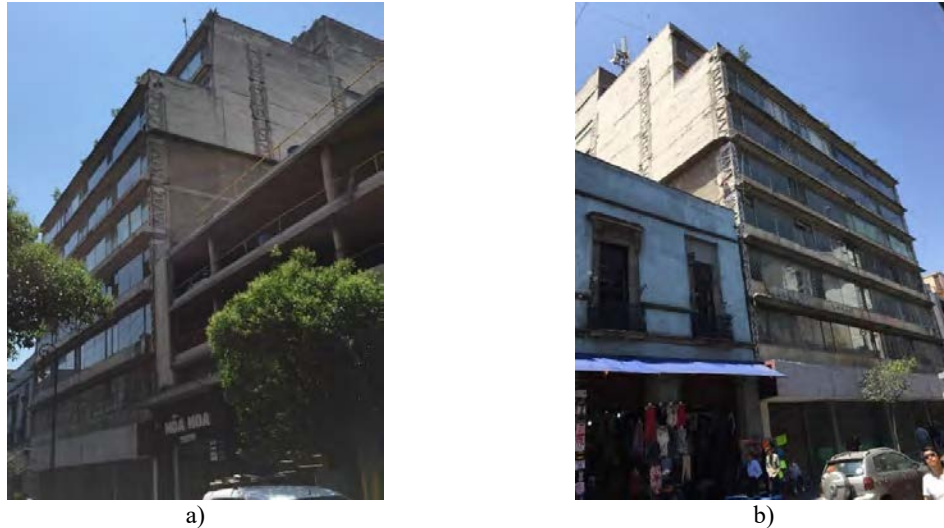
Figure 9: Observed seismic performance of Uruguay 73-Bis building, retrofitted with latticed steel jacketing after the 1957 earthquake. Pictures were taken after the September 19, 2017 earthquake.

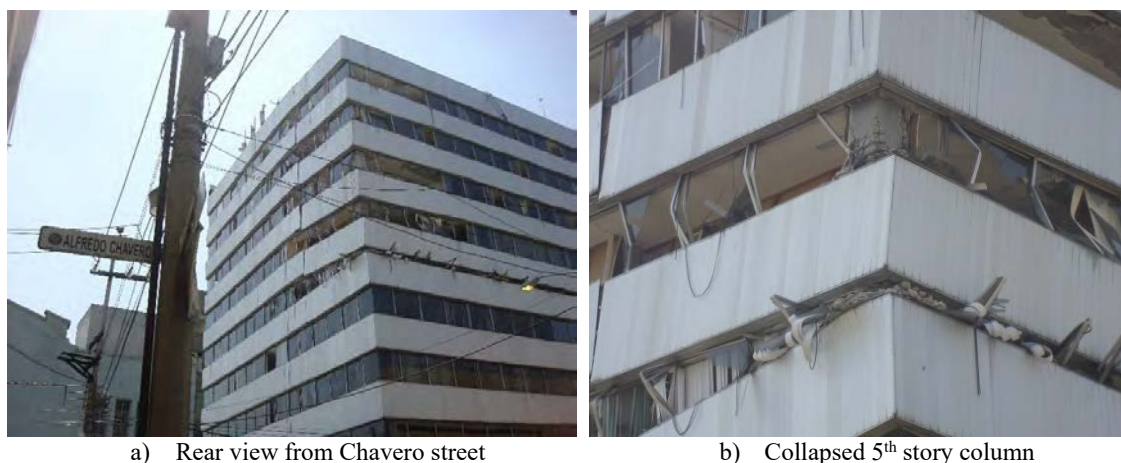
Figure 11: Rear views of the partial collapse of the 9-story San Antonio Abad corner office building during the September 19, 2017 earthquake.

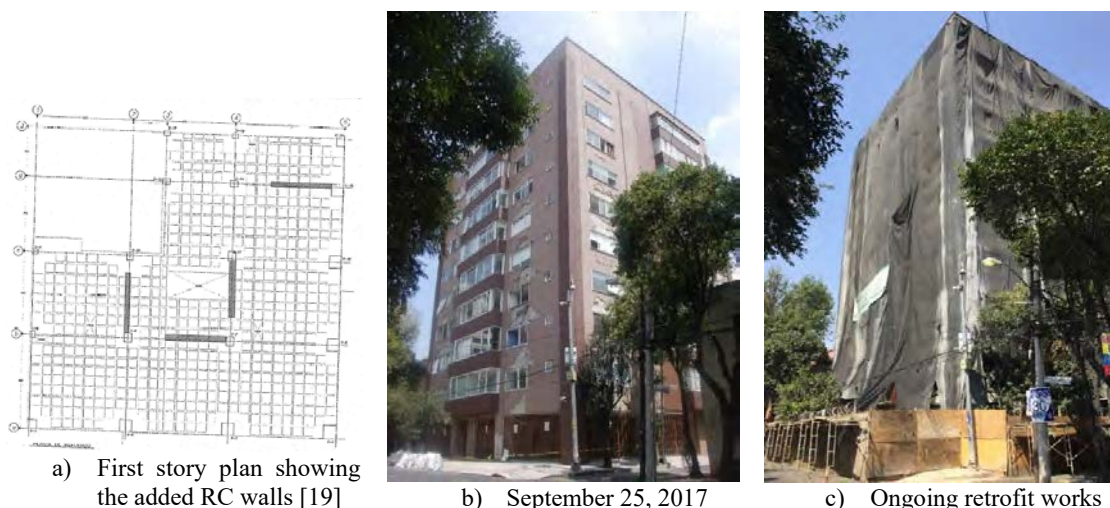
Figure 12: Observed seismic performance of Cozumel 52 corner building, retrofitted with RC shear walls at the first story only after the 1985 earthquake. Pictures were taken after the September 19, 2017 earthquake.

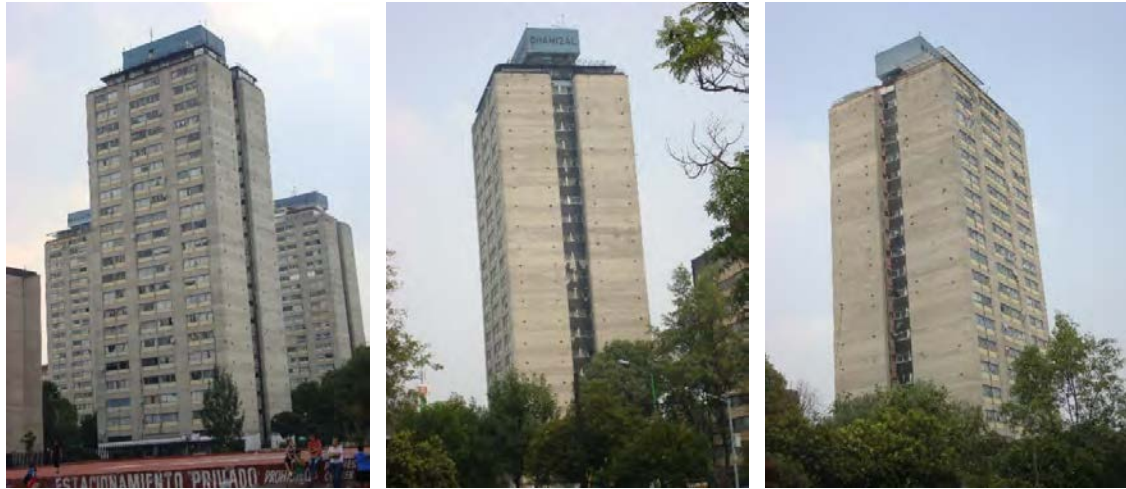
years. The tilting increased during the 2017 earthquake. Only minor shear cracks were observed in few masonry partition walls.

Figure 13: Observed seismic performance of Nonoalco-Tlatelco Towers, retrofitted with RC shear walls. Pictures were taken after the September 19, 2017 earthquake.

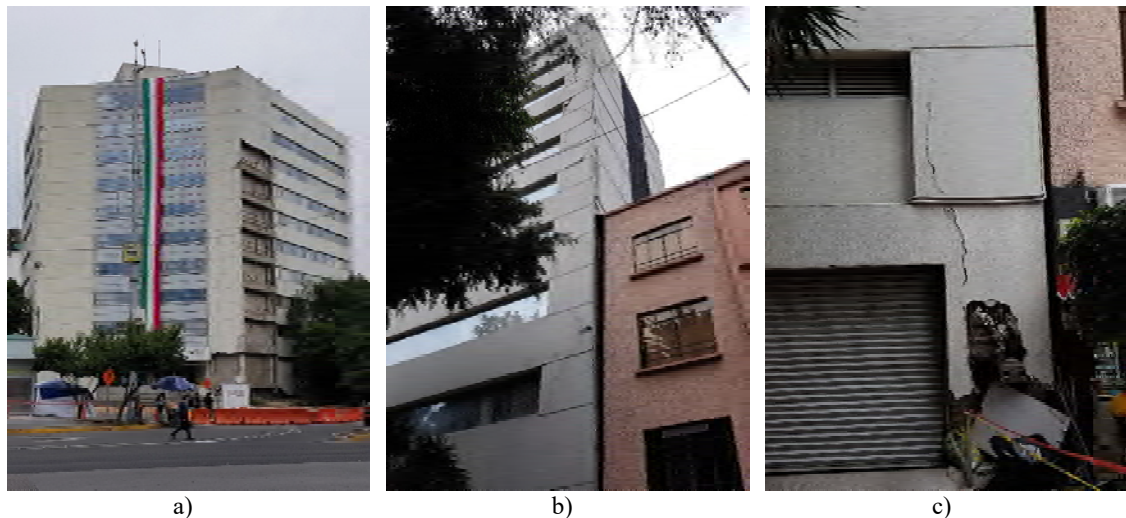
Figure 15: Observed seismic performance of Glorieta de Etiopía office building, retrofitted with RC shear walls. Pictures were taken after the September 19, 2017 earthquake.

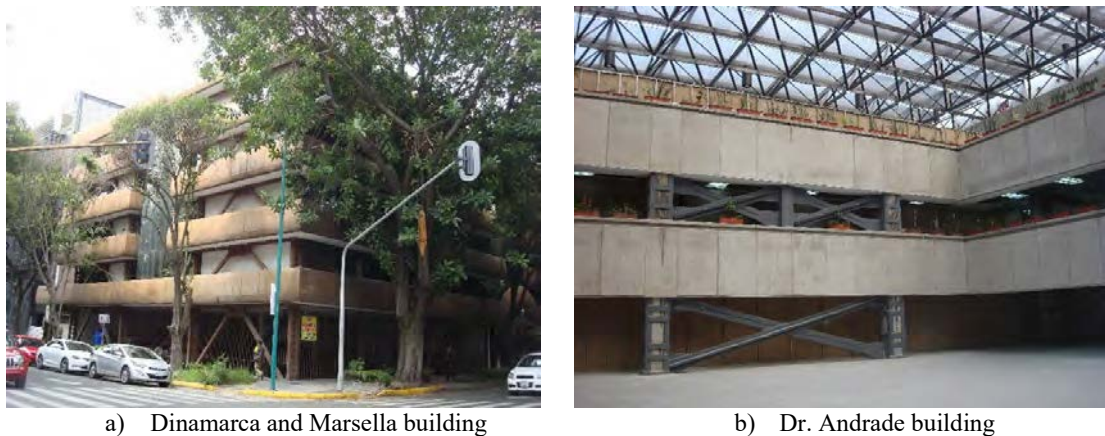
Figure 16: Observed seismic performance of low-rise buildings, retrofitted with concentric steel bracing. Pictures were taken after the September 19, 2017 earthquake.

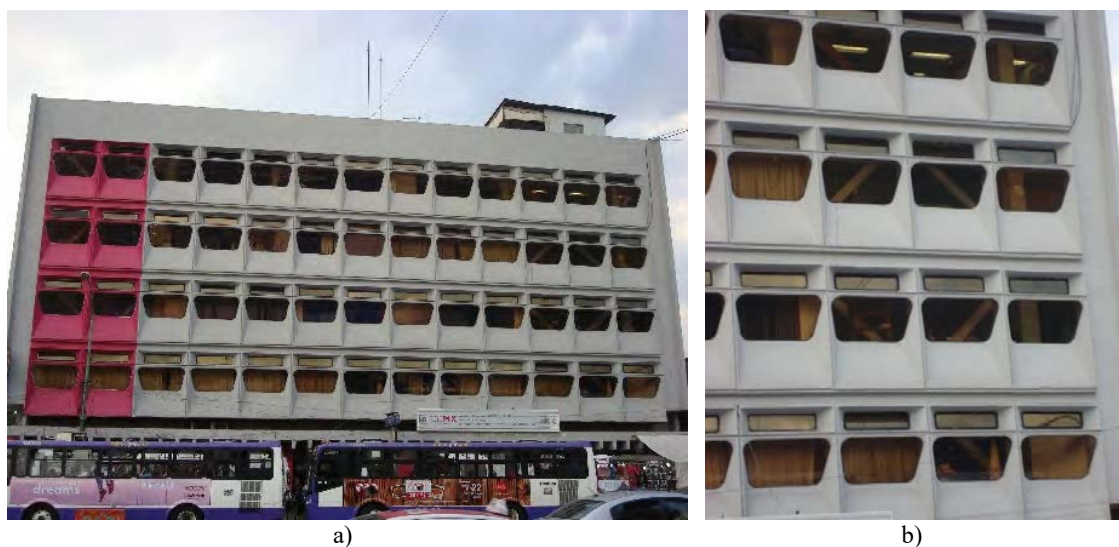
Figure 17: Observed seismic performance of San Cosme Subway Station low-rise office building, retrofitted with concentric steel bracing. Pictures were taken after the September 19, 2017 earthquake.

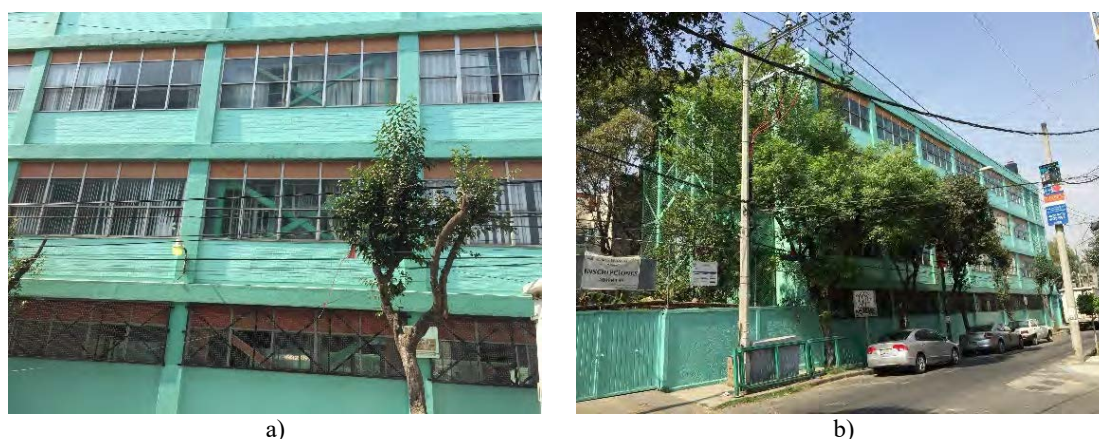
Figure 18: Observed seismic performance of Public Primary School Pedro Ascencio (San Simón Ticumac), retrofitted with concentric steel bracing. Pictures were taken after the September 19, 2017 earthquake.

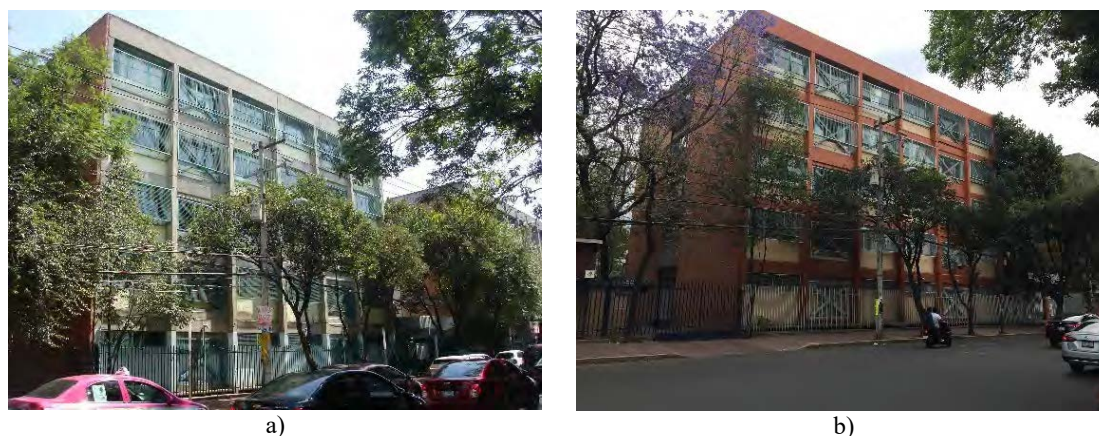
Figure 19: Observed seismic performance of Public Secondary School 187 (Tránsito District), retrofitted with concentric steel bracing. Pictures were taken after the September 19, 2017 earthquake.

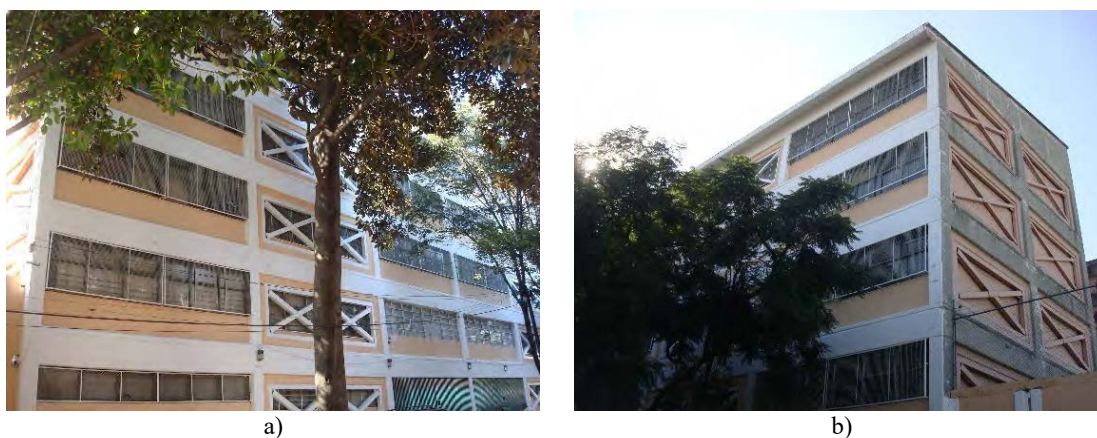
Figure 20: Observed seismic performance of base-isolated Public Secondary School 168 (Legaria), strengthened with concentric steel bracing. Pictures were taken after the September 19, 2017 earthquake.

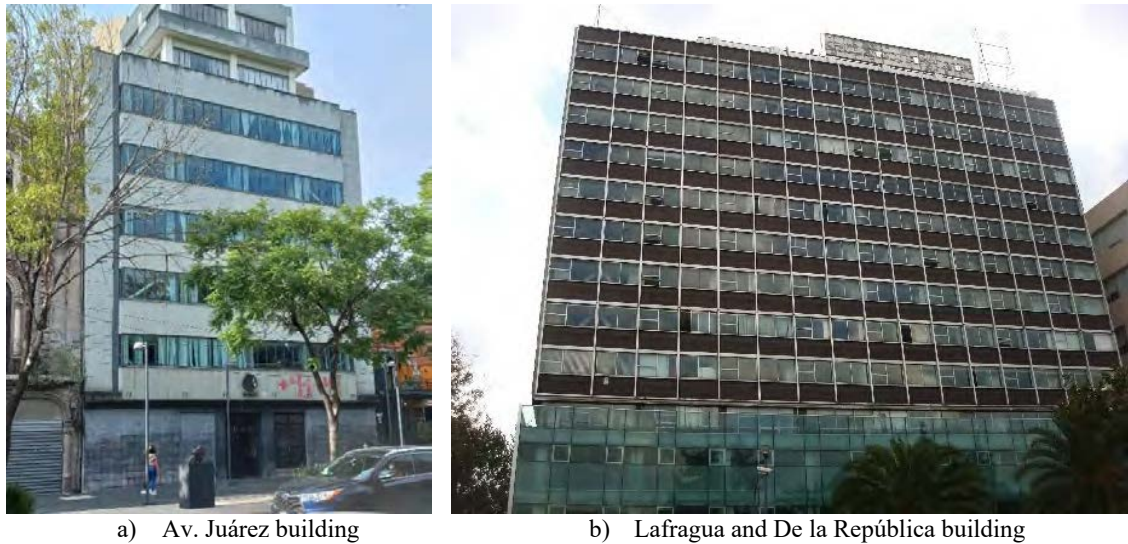
Figure 22: Observed seismic performance of midrise buildings, retrofitted with concentric steel bracing. Pictures were taken after the September 19, 2017 earthquake.

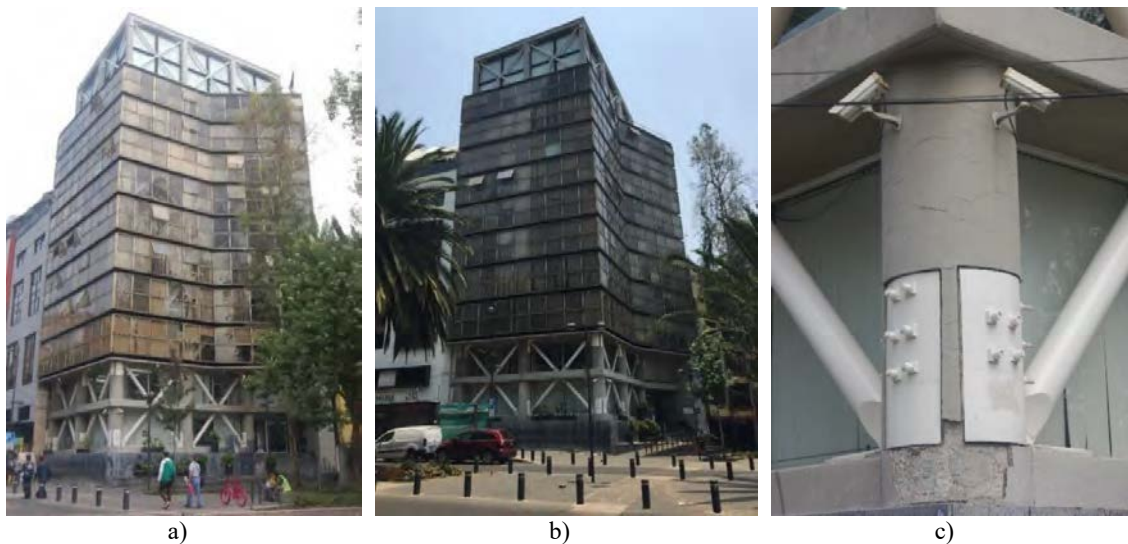
Figure 23: Observed seismic performance of Plaza Villa de Madrid midrise office building, retrofitted with concentric steel bracing. Pictures were taken after the September 19, 2017 earthquake.

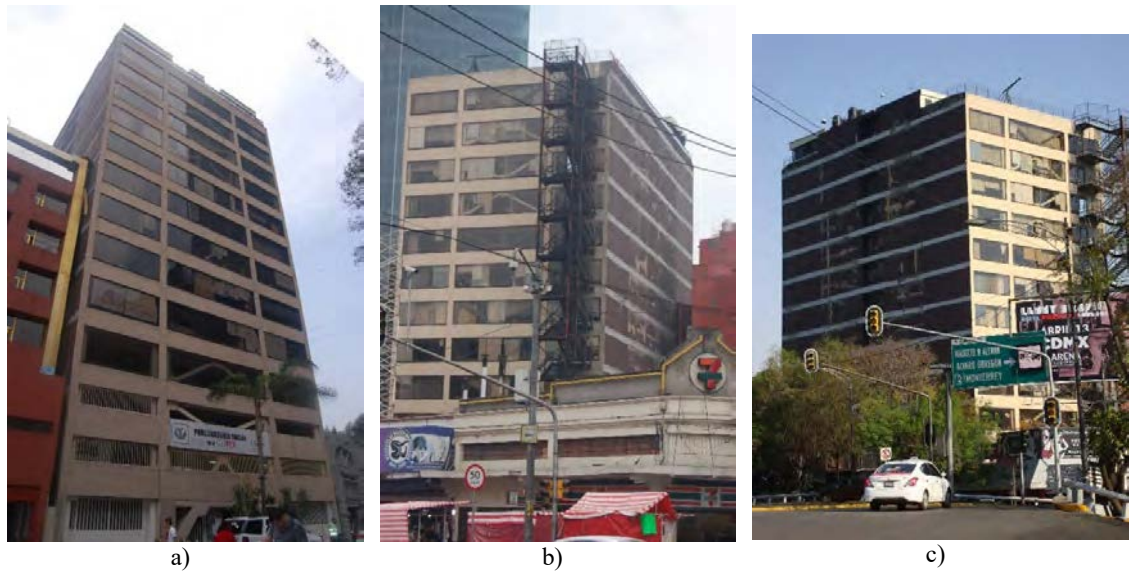
Figure 24: Observed seismic performance of Jalapa (JAL) midrise office building, retrofitted with concentric steel bracing. Pictures were taken after the September 19, 2017 earthquake.

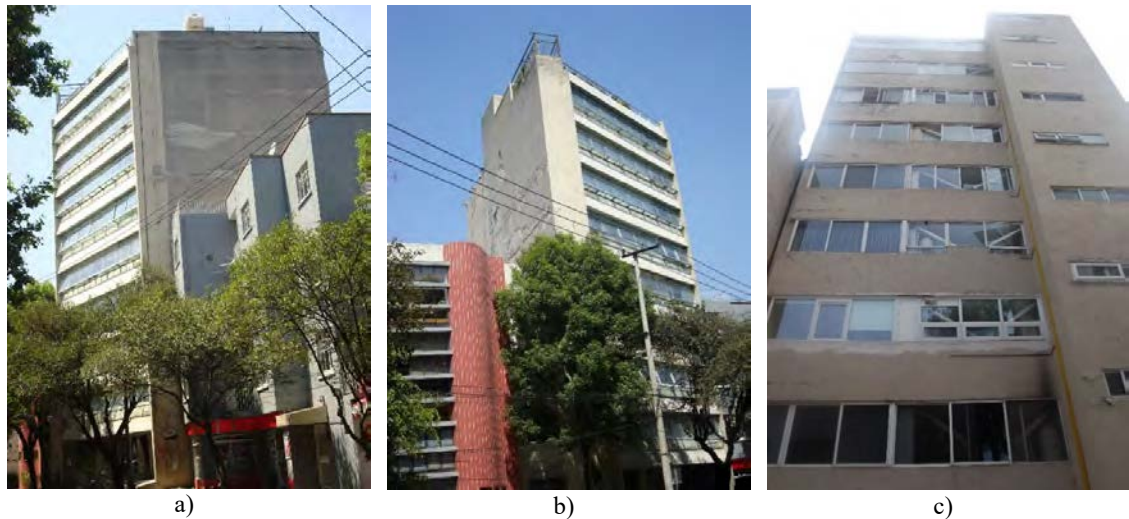
Figure 25: Observed seismic performance of Park España midrise apartment building, retrofitted with concentric steel bracing. Pictures were taken after the September 19, 2017 earthquake.

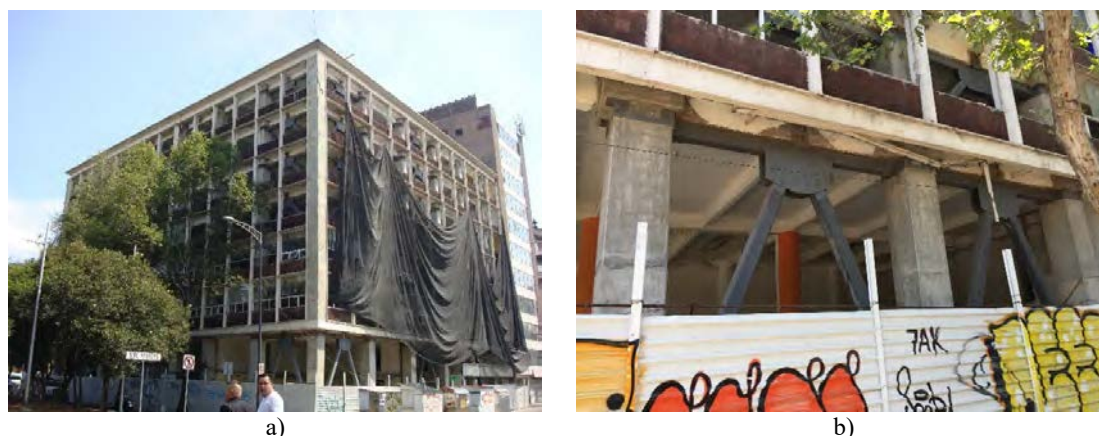
Figure 26: Observed seismic performance of Fray Servando and 5 de Febrero midrise office building, retrofitted with concentric steel bracing. Pictures were taken after the September 19, 2017 earthquake.

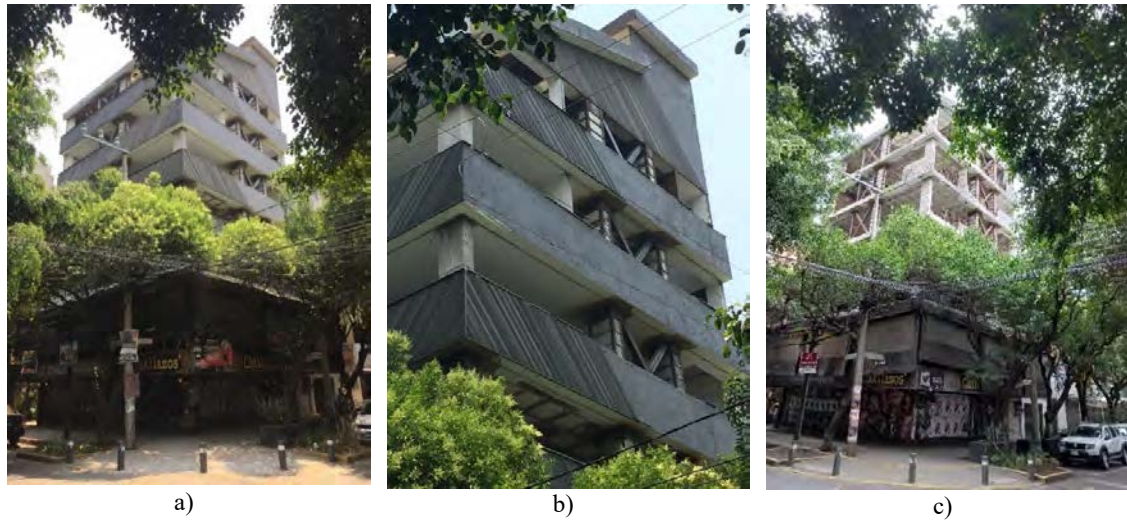
Figure 27: Observed seismic performance of Amsterdam and Teotihuacán midrise apartment building, retrofitted with concentric steel bracing. Pictures were taken after the September 19, 2017 earthquake.

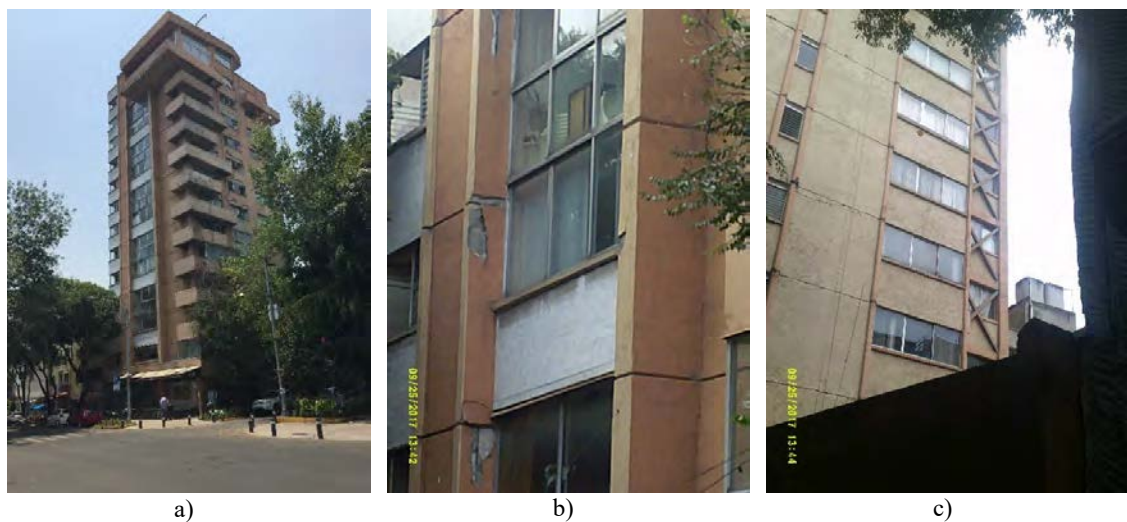
Figure 28: Observed seismic performance of Amsterdam and Sonora midrise apartment building, retrofitted with concentric steel bracing. Pictures were taken after the September 19, 2017 earthquake.

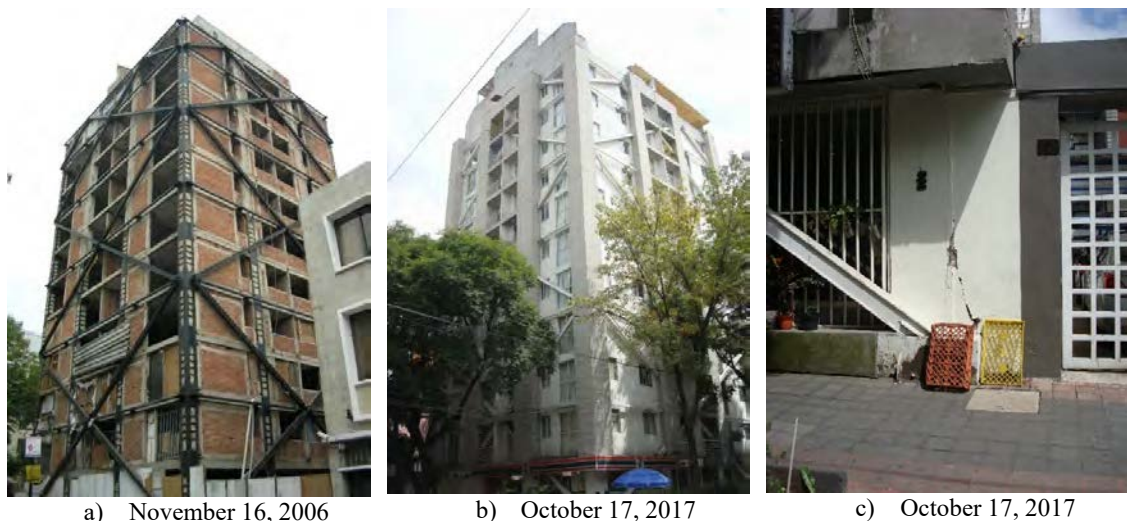
Figure 32: Observed seismic performance of Londres and Berlin apartment building retrofitted with steel exoskeletons.

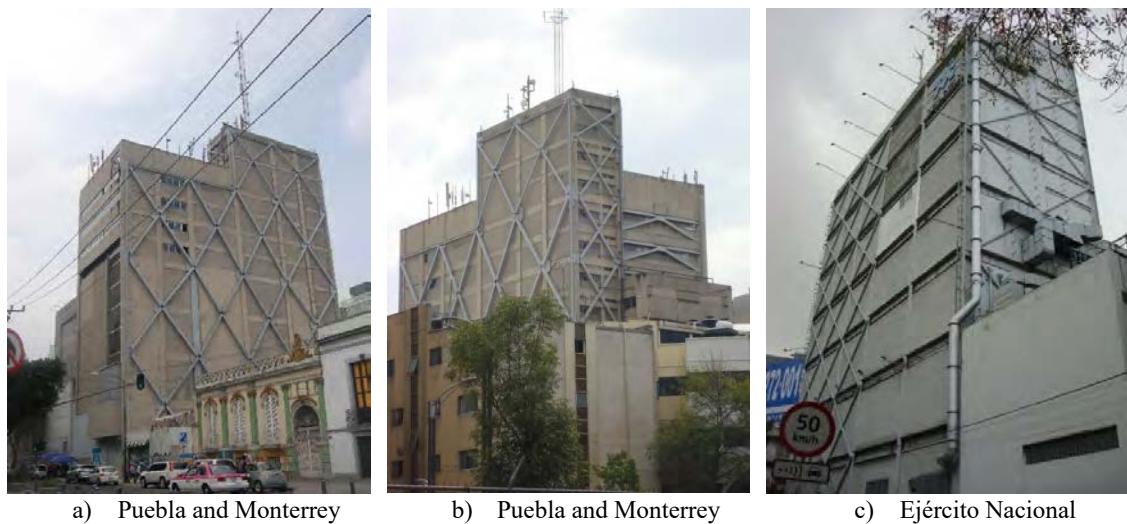
Figure 33: Observed seismic performance of Telephone Company buildings retrofitted with steel exoskeletons. Pictures were taken after the September 19, 2017 earthquake.

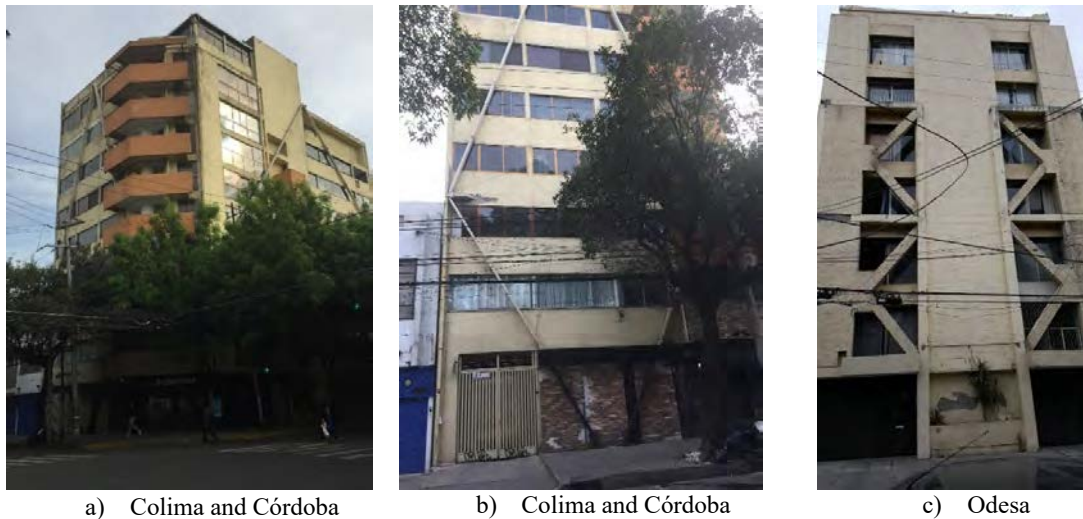
Figure 34: Observed seismic performance of midrise buildings retrofitted with steel exoskeletons. Pictures were taken after the September 19, 2017 earthquake.

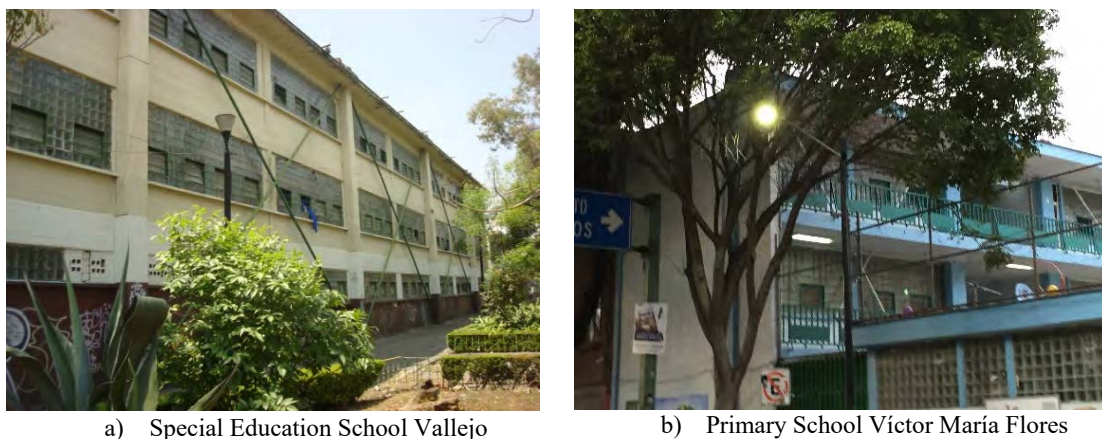
Figure 35: Observed seismic performance of public-school buildings retrofitted with post-tensioned steel bracing. Pictures were taken after the September 19, 2017 earthquake.

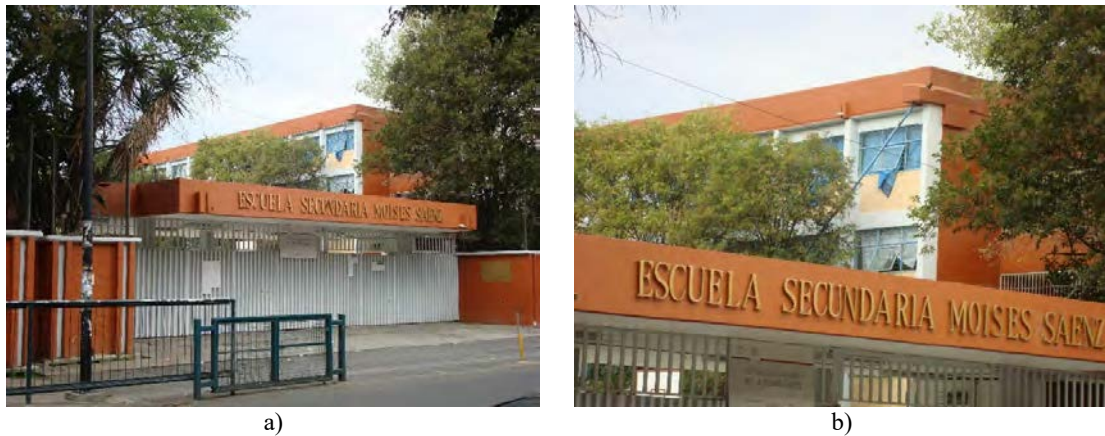
Figure 36: Observed seismic performance of public Secondary School No. 4 Moisés Sanz at Santa María La Ribera District retrofitted with post-tensioned steel bracing. Pictures were taken after the September 19, 2017 earthquake.

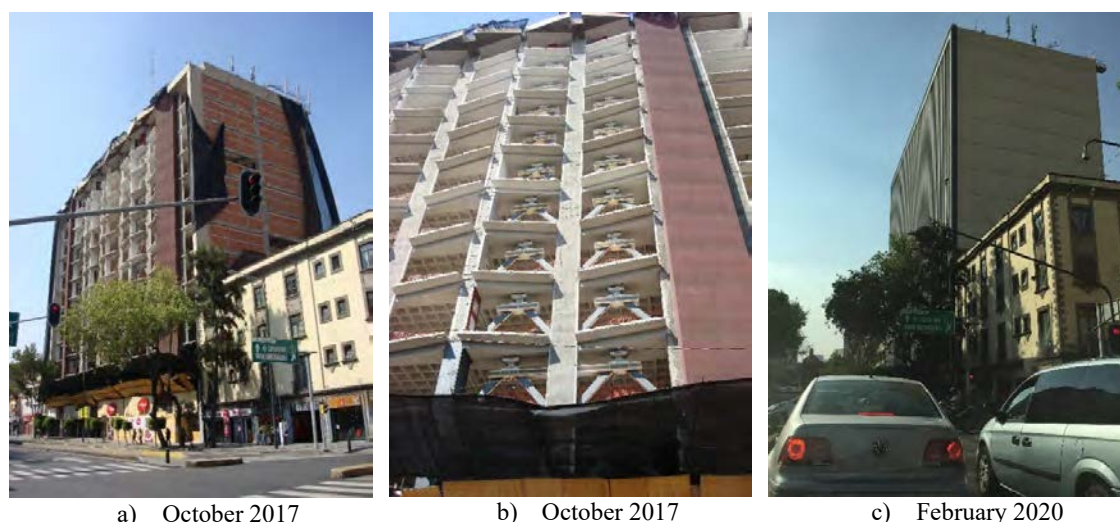
Figure 39: Observed seismic performance of Izazaga commercial building retrofitted with ADAS devices during the September 19, 2017 earthquake

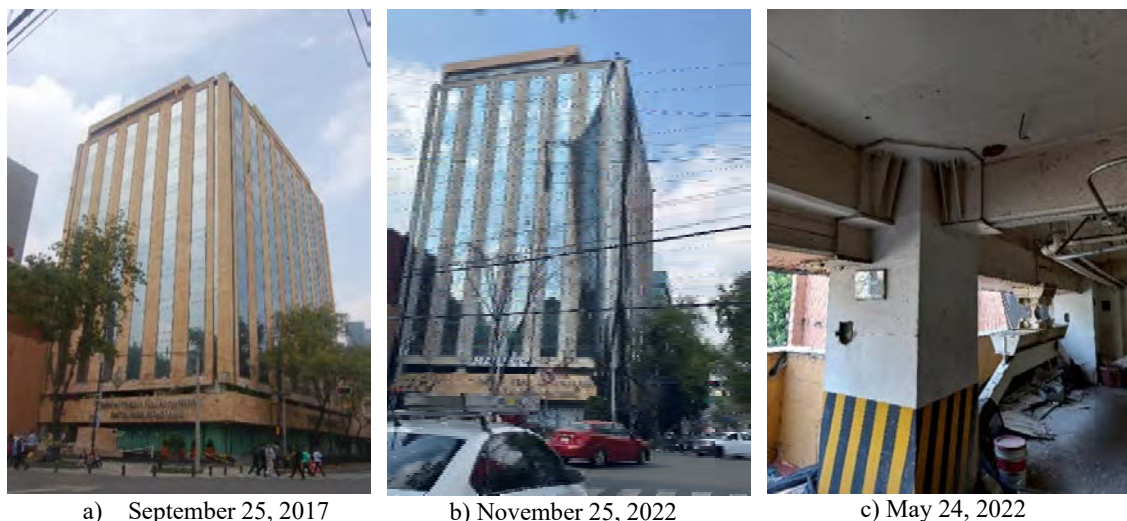
Figure 42: Observed seismic performance of Torre Monterrey office building, retrofitted with ADAS devices.

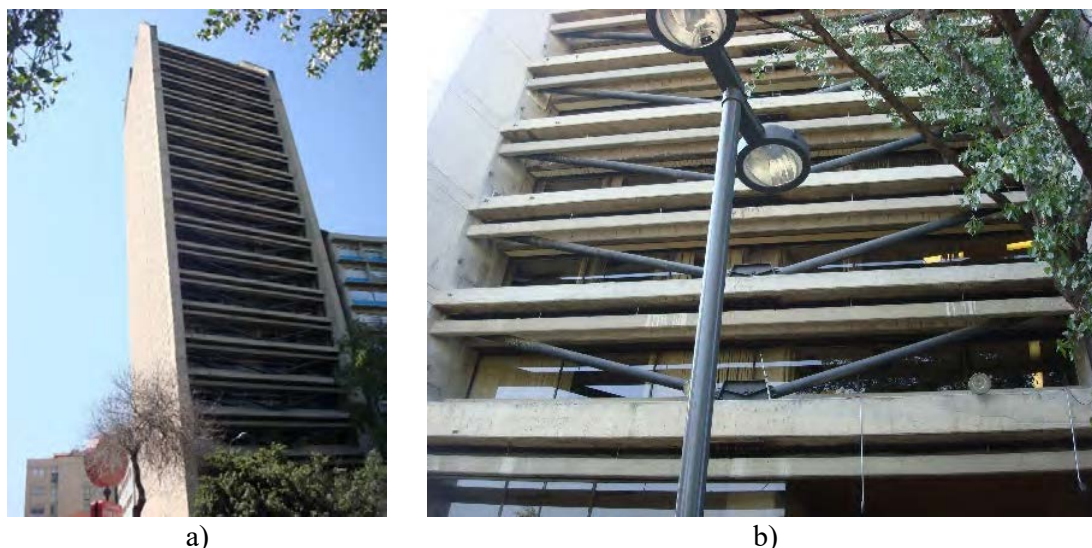
Figure 43: Observed seismic performance of SAGAR office building, retrofitted with DV devices. Pictures were taken after the September 19, 2017 earthquake.

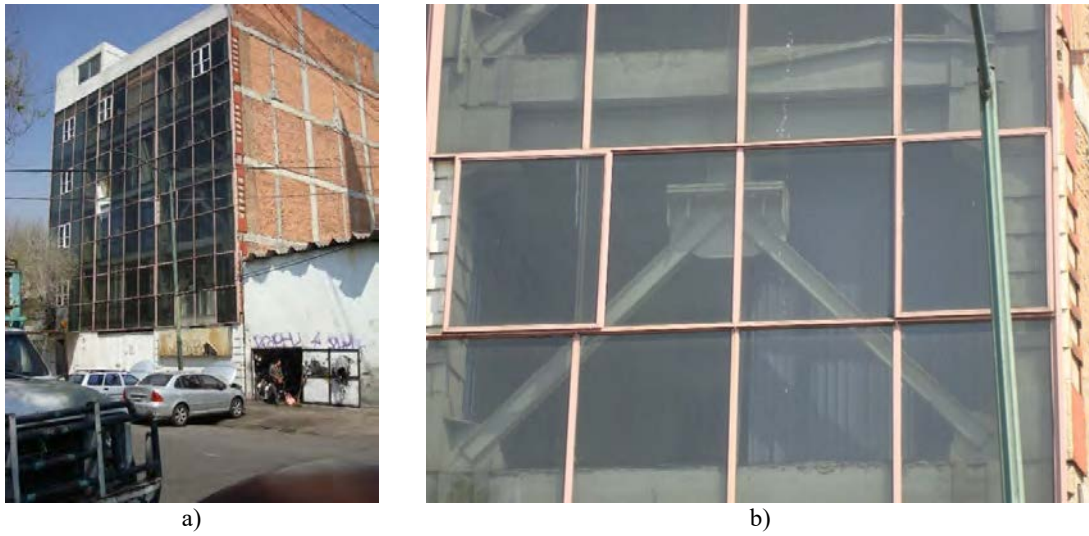
Figure 44: Observed seismic performance of Dr. Gómez Santos Health Center Building for elderly people, retrofitted with low-yield steel shear panels. Pictures were taken after the September 19, 2017 earthquake.

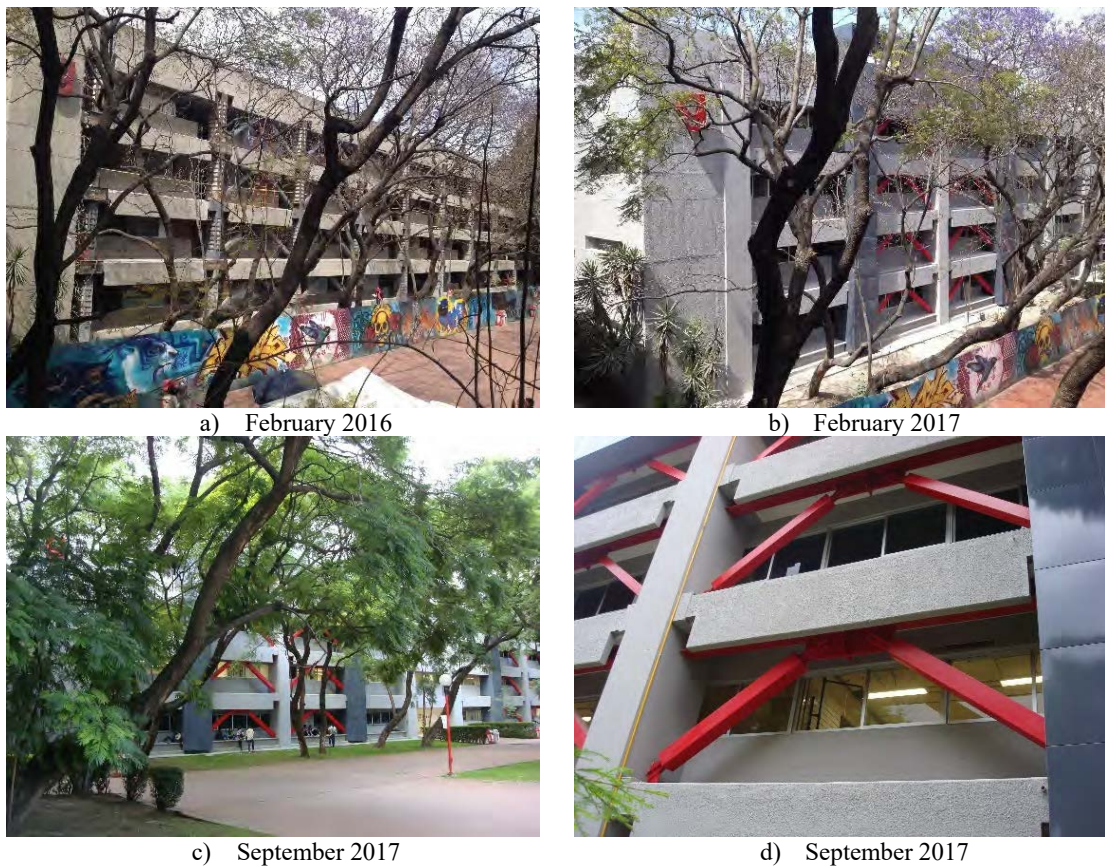
Figure 45: Observed seismic performance of Building G of Universidad Autónoma Metropolitana, Azcapotzalco Campus, retrofitted with BRBs.

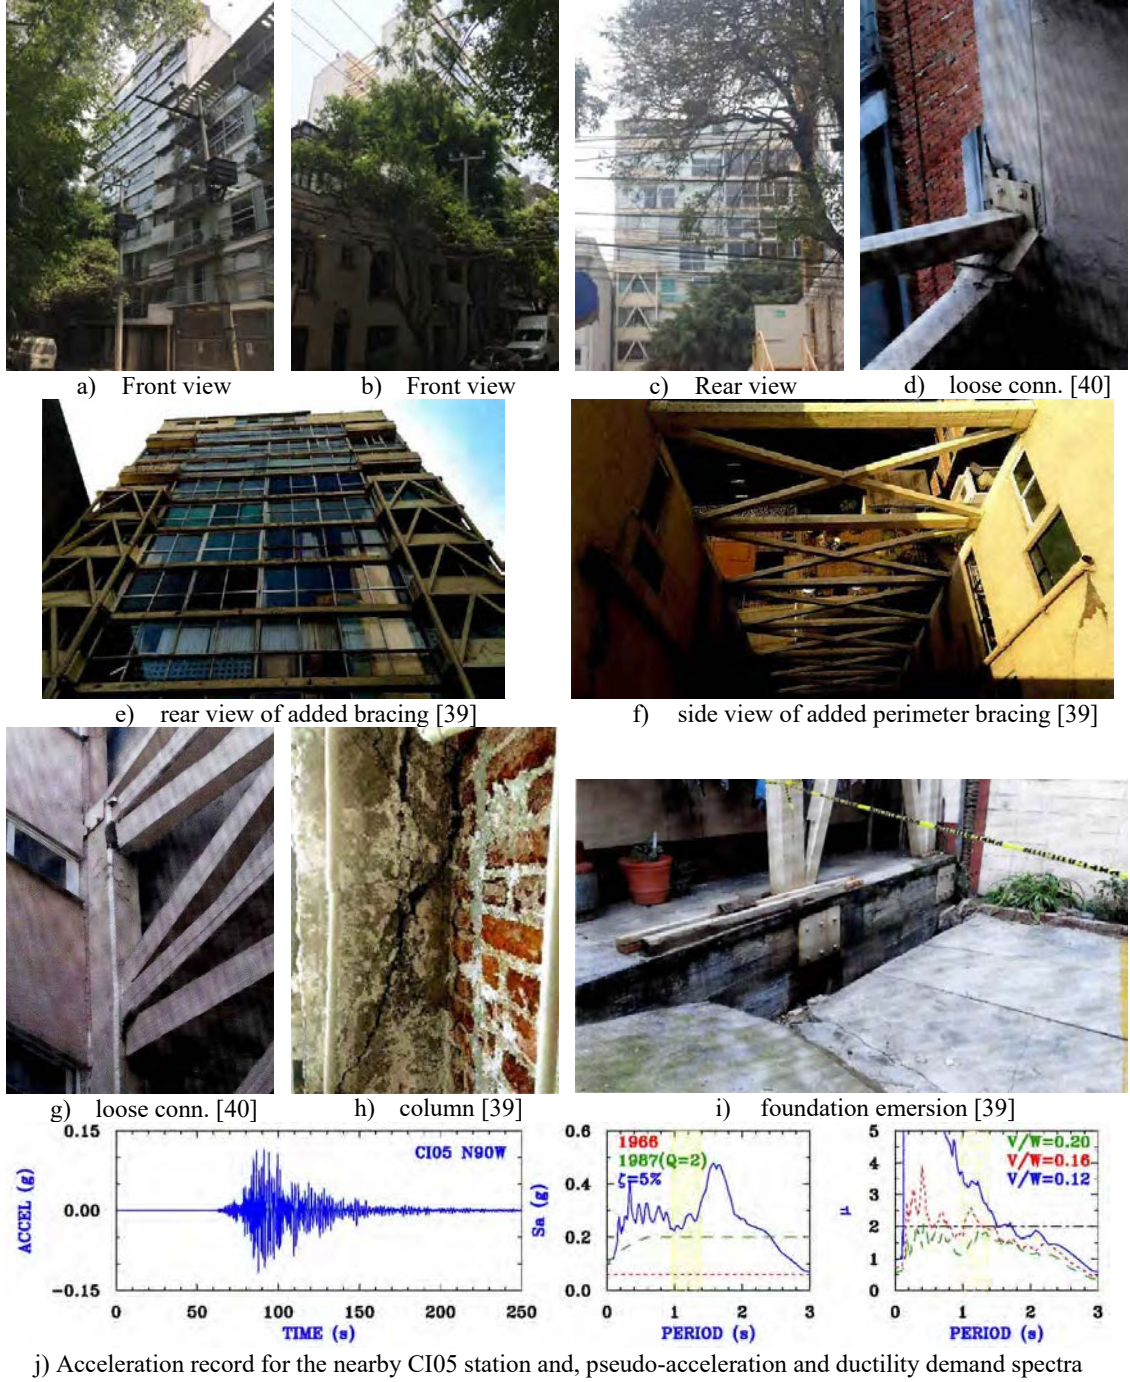
Figure 51: Observed damage for the 12-story Amsterdam apartment building during the September 19, 2017 earthquake

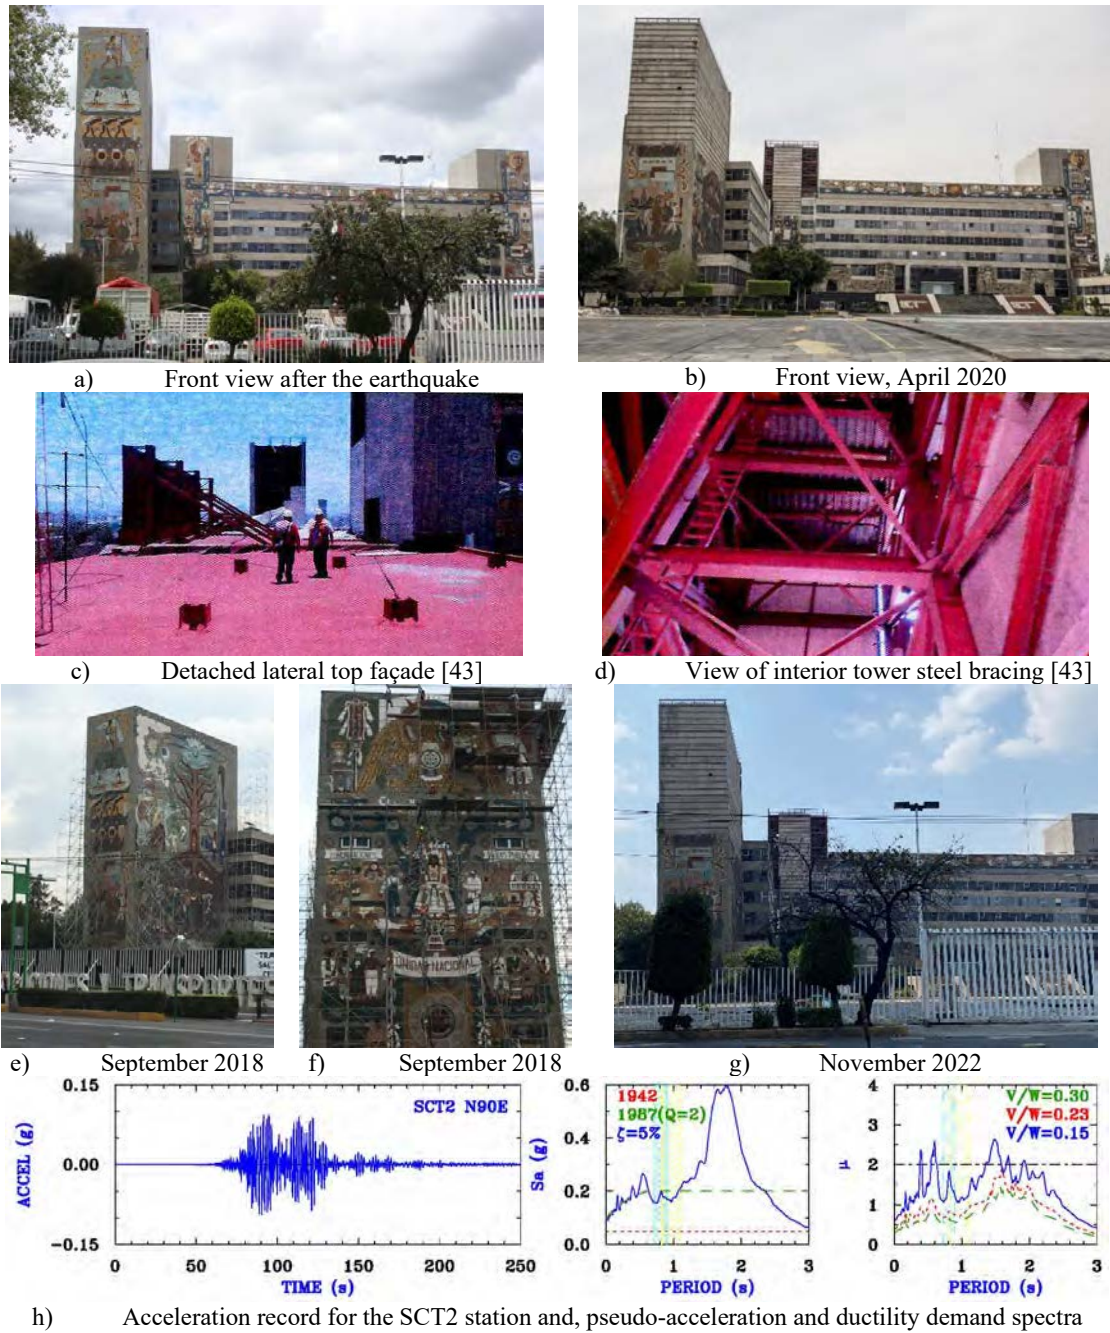
Figure 52: Observed damage for the SCT buildings (A, A1, A2, B, B1 and B2) during the September 19, 2017 earthquake.

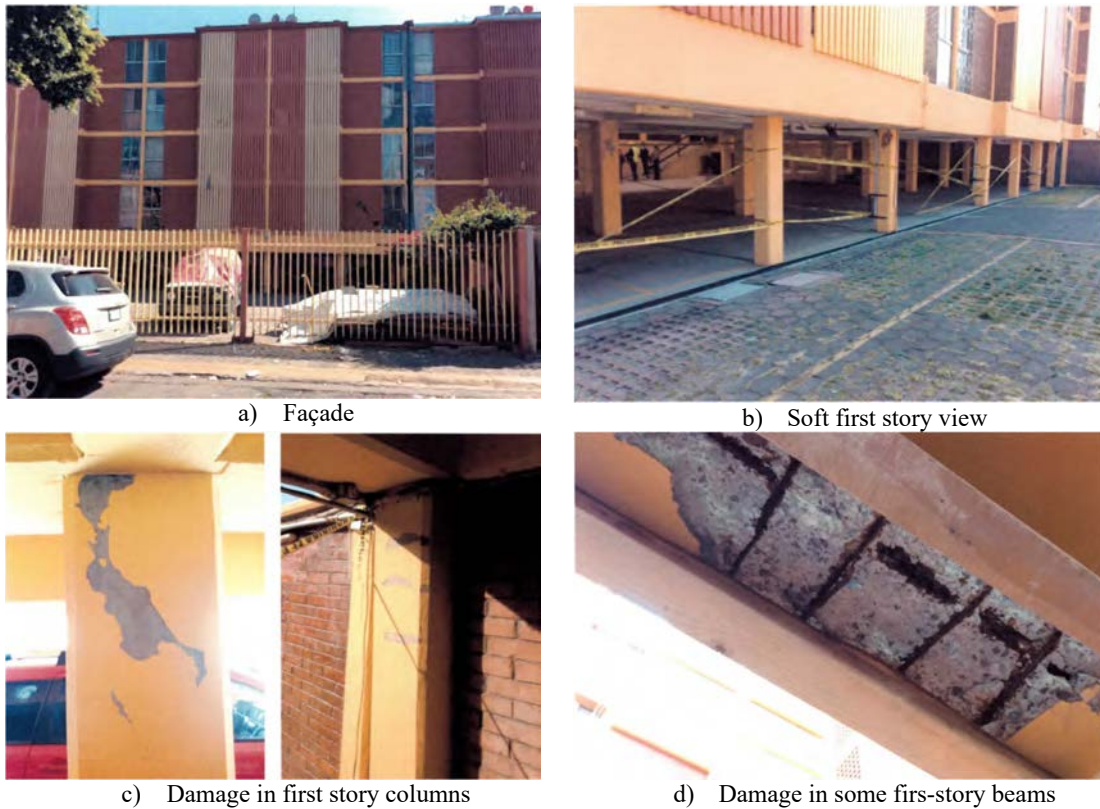
Figure 86: Observed damage of Los Girasoles III housing complex (Rancho San Lorenzo street apartment buildings, during the September 19, 2017 earthquake. All pictures taken from reference [57].
