RETROFITTING OF AN EXISTING BUILDING WITH CONCRETE WALLS AND STEEL FRAMES FOR GRAVITY LOADS AND PROGRESSIVE COLLAPSE RESISTANCE

Florea Dinu^{1,2}, Calin Neagu¹, Dan Dubina^{1,2}, and Constantin Stanciu³

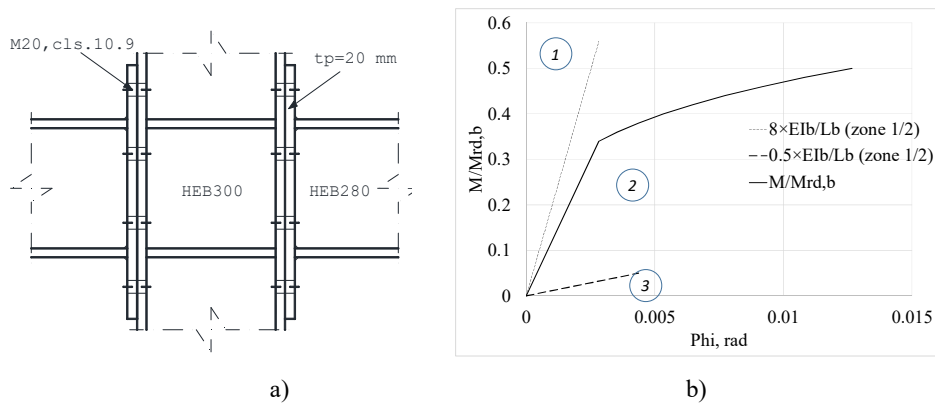
The columns are made from HEB300 profiles, main beams from HEB280 profiles, and secondary beams from HEA180 profiles. Beam-to-column connections in the steel frames are extended end plate bolted connections with 4 rows of bolts M20, class 10.9 and 20 mm thick endplates, see Figure 4a. Connections are designed as partially restrained (partial strength, semi-rigid), see Figure 4b.

Figure 4: Beam-to-column connections in steel frames: (a) detail of the connection; (b) characteristics of the connections according to EN 1993-1-8 [3]

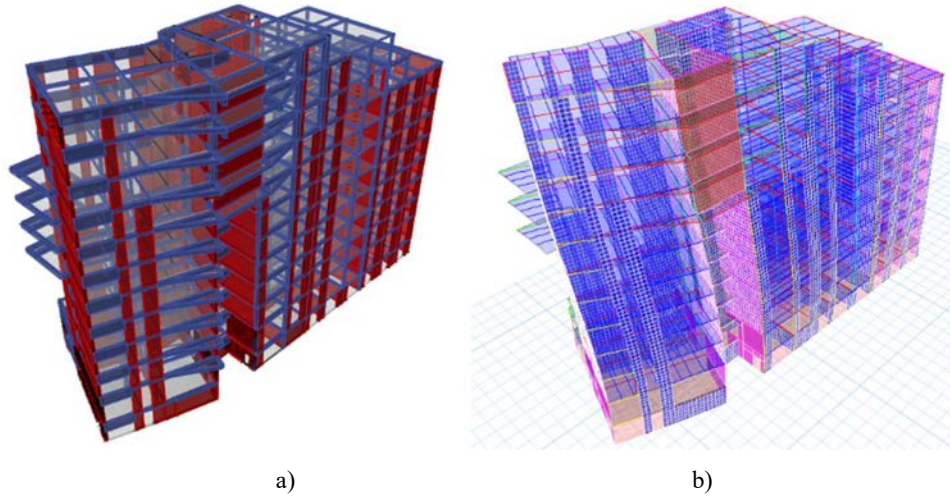
The main structure has been completed in 2003, but without execution of the building enclosure and roofing. The structural assessment commenced with the evaluation of the existing building, the structural condition, and the code compliance. To verify the condition of execution, the state of damage in the elements, and the properties of the materials (concrete class in walls, frames, and slabs, steel grade in elements and bolts), site inspections and experimental tests were employed. The results confirmed the reinforcement and concrete class are those indicated in the project. For the steel structure, due to a mixed use of two steel grades, a single class, i.e., S235, was to be considered. The modal analysis was done using Etabs program. The results showed that the first three fundamental modes of vibrations have significant torsional components ($T_1 = 0.74$ s, $T_2 = 0.64$ s, $T_3 = 0.44$ s), due to high structural geometric irregularities both in plane and in elevation, see Figure 5.

Figure 5: Structural analysis of the existing structure: (a) 3D structural model; (b) first mode shape

- The first modal shapes are predominantly torsional. This has a detrimental effect and increases the seismic demands on some members.
- The concrete walls and coupling beams are designed with safety margins for persistent and seismic design situations.
- The bearing capacity of the steel columns in the lower stories and of the beam-to-column connections are exceeded in the persistent design situation (note that they are designed for gravity loads only).
- The vertical deflections in the area 10-12/I-IV exceed the serviceability limit state conditions, i.e., $L/250$ for secondary beams and $L/350$ for the main beams (where L is the beam span) (see Figure 7a).

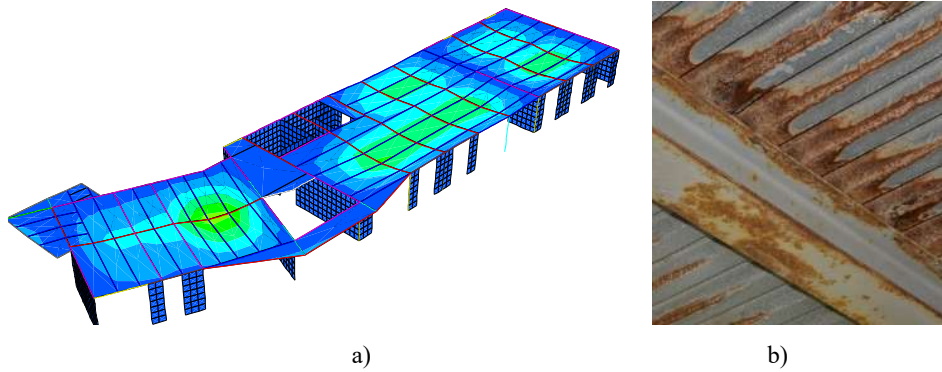
In addition, the aggressive site conditions (seaside) and absence of building enclosure caused extensive deteriorations of the profiled steel sheeting and localized corrosions in steel beams, columns, and bolted connections (see Figure 7b).

Figure 7: Deformed shape due to gravity loads, current floor (a) and extensive corrosion in the steel sheeting, localized corrosion in the steel beams (b)

The basis for the intervention were the structural deficiencies and the deteriorations caused over time by the insufficient corrosion protection. Additionally, the completion of the setback was required by the client, and this would bring more gravity and seismic loads on the structure. As a result, the proposal for structural interventions included the following:

- Strengthen the main beams in the axes II/10-12 with a T section welded at the bottom flange.
- Due to the varying positions of the reinforcement and the extensive deterioration of the profiled steel sheet (which serves as the bottom reinforcement under sagging moments), the concrete slab was proposed for strengthening by pouring an additional concrete layer. The interaction between the existing slab and the new concrete slab would be done by means of chemical/mechanical anchor bolts. The strengthening solution and the experimental results may be found in [7].

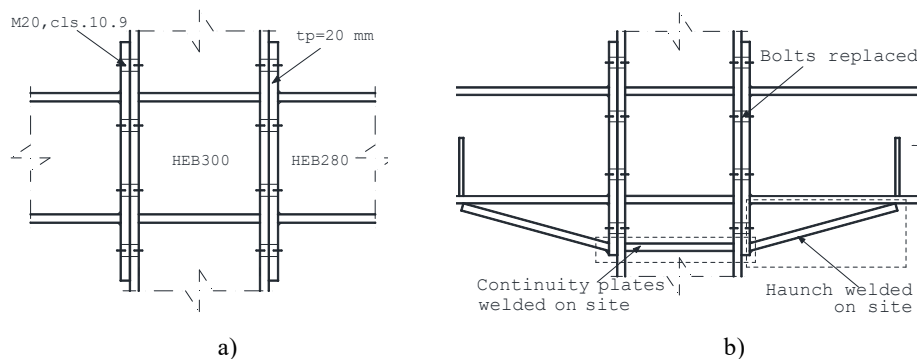
Figure 8: Strengthening/repairing of the beam to column connections: a) actual beam-to-column connection; (b) connection strengthened with additional haunches, continuity plates, and partial length beam stiffeners

- Strengthen the beam-to-column connections by means of haunches and continuity plates in the columns (see Figure 8); the bolts have also been proposed for replacement with new ones. The size of the haunch was limited such that, after the intervention, the column remains stronger than the beam.

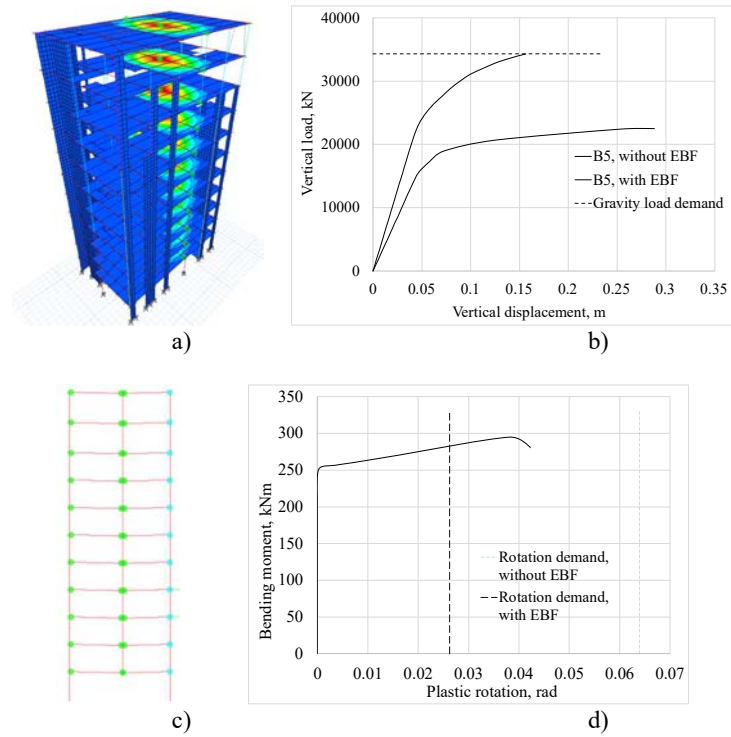
Figure 12 shows the results for B5 column loss scenario. The loss of an internal column leads to the failure of the directly affected part, which is the area between axis 4 and 6, see Figure 12a. The force - displacement curve plotted in Figure 12b shows that the structure does not resist the gravity loads calculated using eq. (1) and eq. (2). The plastic mechanism is global (see Figure 12c) but the partial strength connections do not provide adequate continuity to prevent the progressive collapse (Figure 12d). Similar results are obtained for A5 column loss scenario, see Figure 13. The loss of the perimeter column leads to the failure of the direct affected part A4/A6 – B4/B6.

For scenario B5, the maximum top displacement reduces from 288 mm to 156 mm and the plastic rotation in beams reduces from 42 mrad (allowable capacity) to 26 mrad. For scenario A5, the maximum top displacement reduces from 300 mm to 95 mm and the plastic rotation in beams reduces from 42 mrad (allowable capacity) to 12 mrad.

Figure 12: Column loss scenario B5: a) failure mode, retrofitted structure but no EBF; b) vertical load vs vertical displacement; c) plastic mechanism at failure, transversal frame in axis 5, retrofitted structure but no EBF; d) maximum plastic rotation demand at most loaded beam end in axis B5-D5, without and with EBFs

As the building is already constructed (excepting the completion of the setback), there are limited options for interventions. Because the haunches and the beam-to-column connections cannot be further increased, the solution was to provide additional redistribution capacity in the new structure from the last story by introducing eccentric vertical braces, EBF, in the longitudinal frames. The long links were preferred to stiffer and more ductile short links as they provide wider clear spaces unobstructed by bracing. These braced frames at the top of a structure are also called *hat trusses*. To cover all possible column loss positions, the new braces were inserted in axes A4/A6, B1/B9, and D4/D7, see Figure 14.

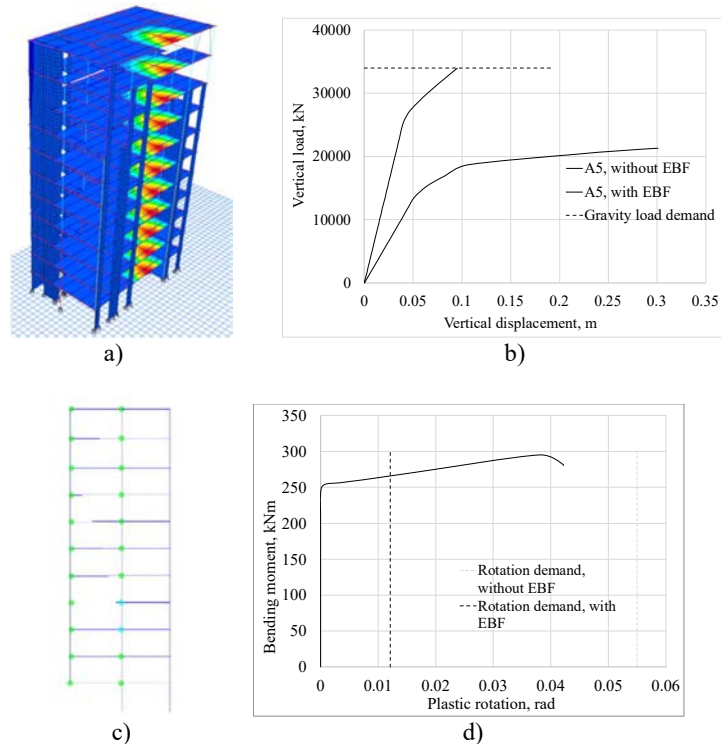
Figure 13: Column loss scenario A5: a) failure mode, retrofitted structure but no EBF; b) vertical load vs vertical displacement; c) plastic mechanism at failure, transversal frame in axis 5, retrofitted structure but no EBF; d) maximum plastic rotation demand at most loaded beam end in axis A5-B5, without and with EBFs
