MODELLING THE COLLAPSE OF A MASONRY TOWER DURING THE 2015 NEPAL EARTHQUAKE WITH SUPPORT FROM A VIDEO- CAMERA RECORDING

José V. Lemos¹, Carlos Sousa Oliveira², and Rajesh Rupakhety³

Abstract

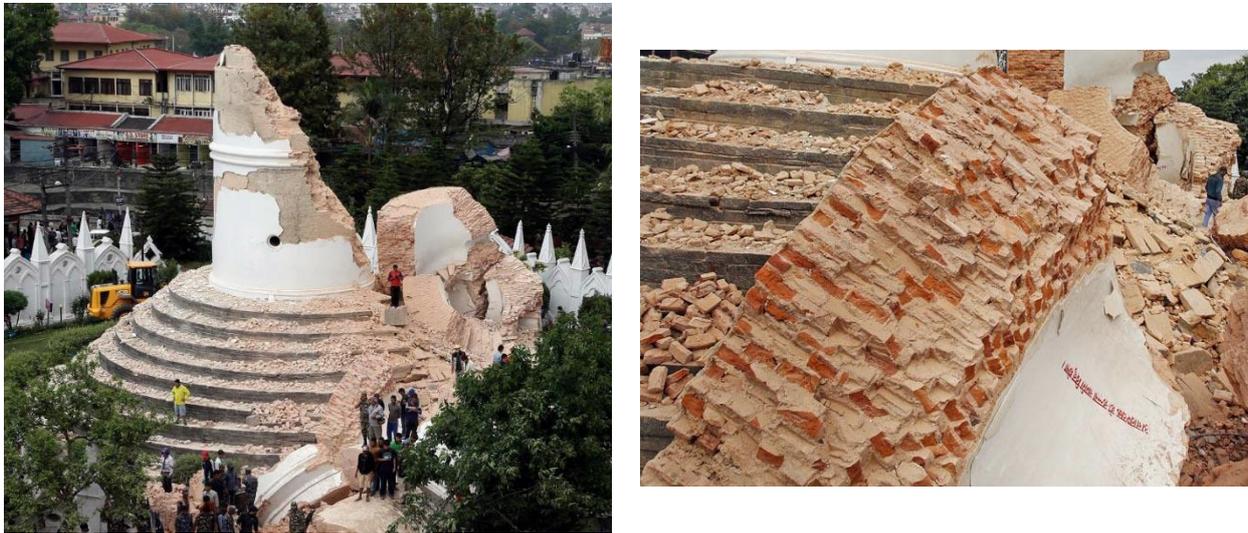
The collapse can be understood through images and video-camera footage. The post event images show many of the material features, the brick arrangement, the stairway, the entrance door, and the final disposition of all elements after impact on the ground (Figure 4). From the images, we see that the collapse was almost total with two essential features: the formation of an almost planar shearing surface at the first few meters of the tower at an angle of 65° with the horizontal. The remains of the tower below this plane remained intact. The tower seems to

have first slipped down this plane before overturning sideways in relation to the plane, disintegrating almost entirely into many pieces (bricks and brick walls segments). The plane dips Southeast with the lower tip near the entrance. The main debris rubble is located in the Southwest. The pulpit was destroyed in front of the sliding plane and several bulky volumes of bricks can be seen still forming cemented blocks.

Figure 4. (left) The remaining part of the tower after the 2015 earthquake; (right) detail of the brick wall.

The part of the structure which remained standing after the earthquake suggests that shear failure took place along an inclined plane reaching the base of the tower (see photo in Figure 4). When using rigid block models, failure through the blocks can be simulated using the “bonded-block model” approach [22]. In this type of model, rigid blocks are split into an assembly of smaller blocks bonded together. The bond strength is based on the intact material properties, and can be represented by the Mohr-Coulomb parameters cohesion, friction angle and tensile strength. The interfaces between the sub-blocks define the potential failure planes. If the stresses along these interfaces reach the strength envelope, the bonds break and the sub-blocks start to slide or move apart.

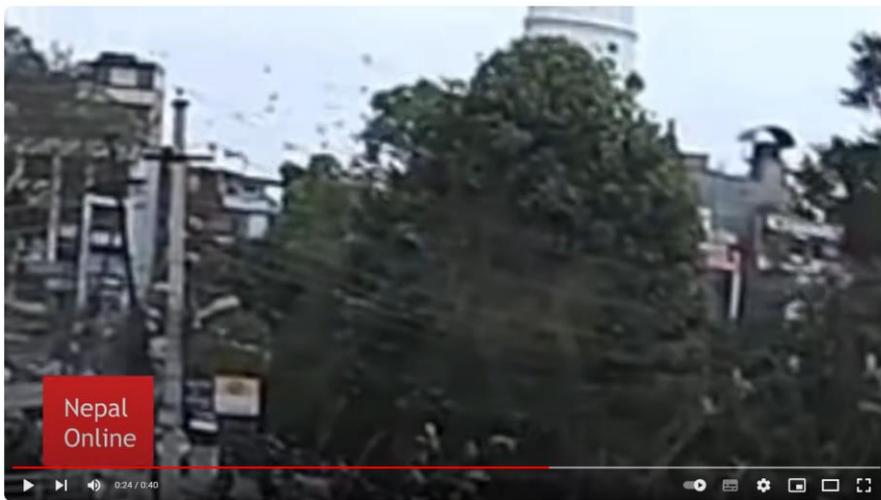
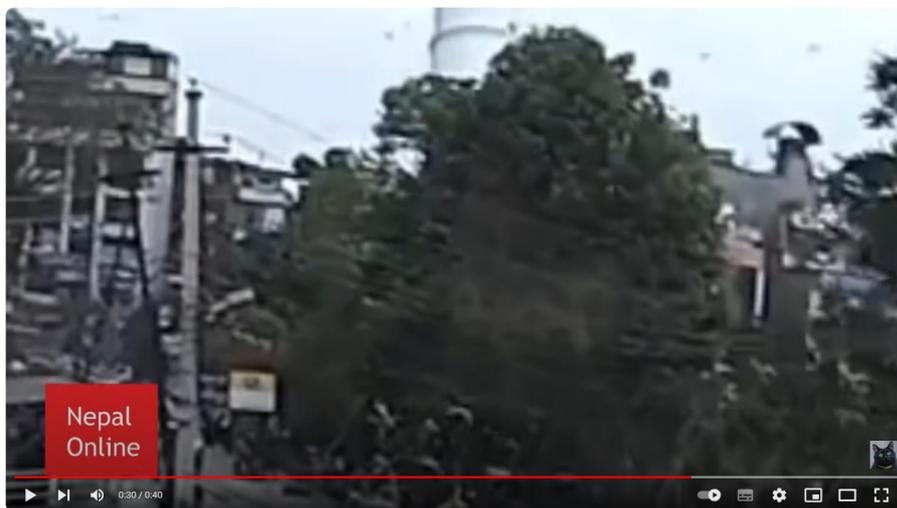
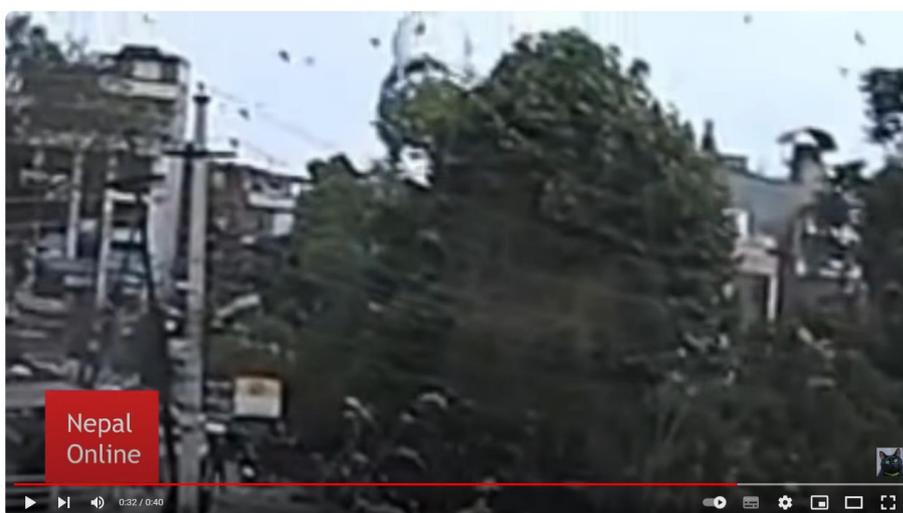
The video camera recording [3], shot from the Southeast through a zone of trees and bushes, shows the collapse in its initial phase and the overturning of the tower (Figure 5). It does not show the crushing of the collapsed tower on the ground. This video, even though of poor quality, shows two important stages. The first is the vertical descent of several meters of the upper part of the shaft with a small translational movement to the Southwest; then, after an instantaneous stop, the shaft starts to overturn towards the back. The structure's shaft is divided vertically into 8 main segments, marked by peripheral salient rings, with an average height of about 6 m (Figure 2). The video shows that, in the initial stage of collapse, 3 of these segments move down almost vertically, before the overturning movement initiates (Figure 5).

Figure 5. Video images of the collapse. a) b) Top of tower shaft moving down several meters and slightly westwards; c) overturning.

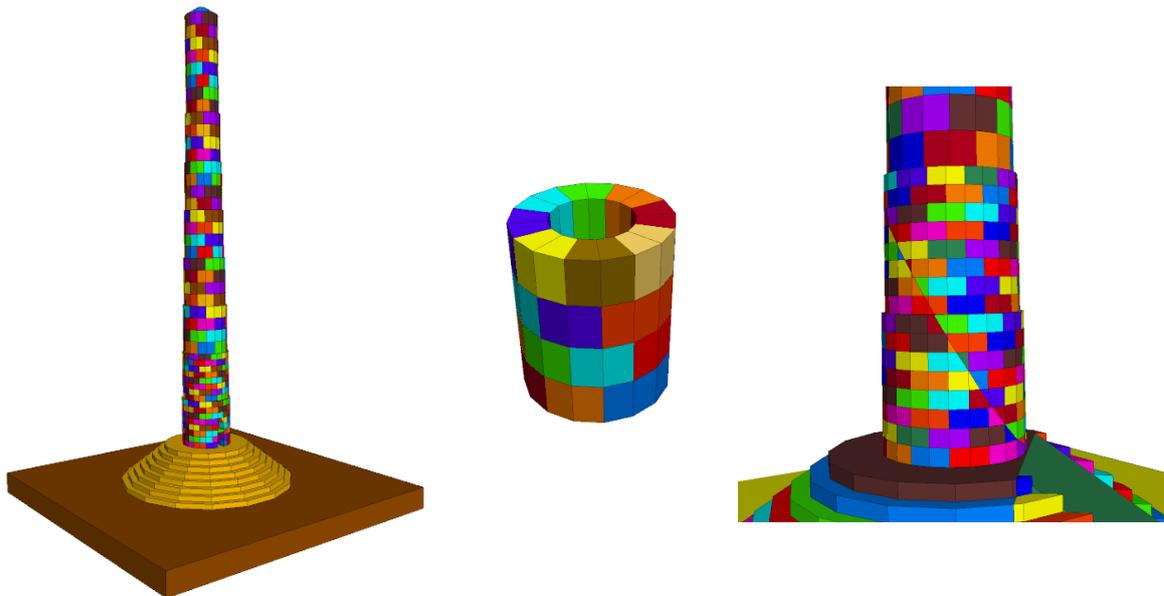
Figure 6. Discrete element model of Dharadara Tower. Global view; detail of the wall blocks; and, detail of the lower part with the potential shear failure plane.

The discrete element base model was modified by introducing a potential shear failure plane in the lower part of the tower, according to the geometry of the remaining part (Figure 6). The properties of the contacts along the inclined plane were taken as the brick strength listed above (uniaxial compressive strength of 10 MPa; friction angle of 30° ; cohesion of 2.88 MPa; tensile strength of 1.44 MPa). Failure on this plane only takes place if the stresses reach the failure envelope of the intact material.

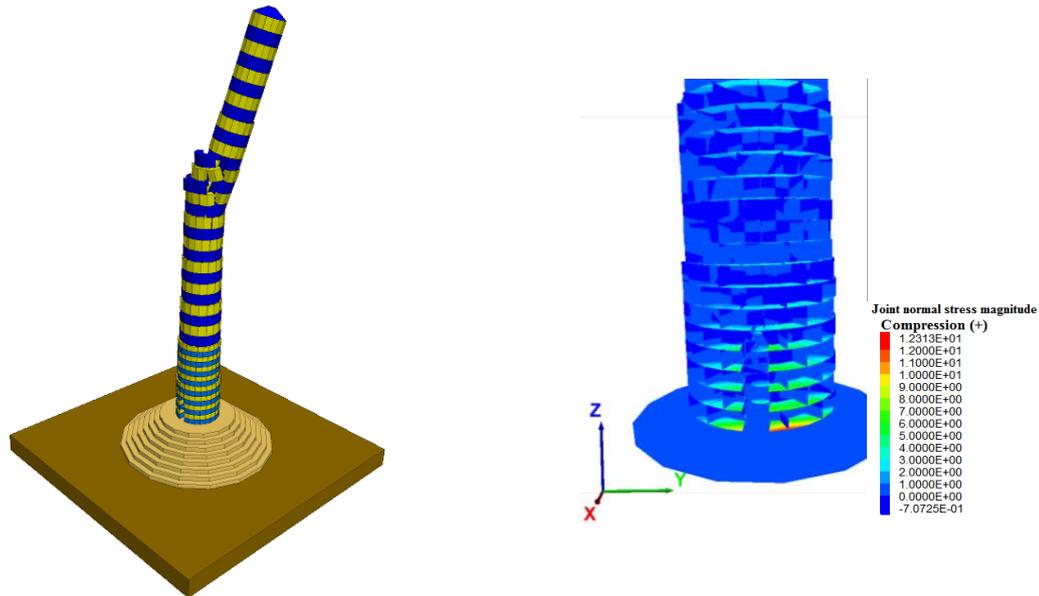
similar to the one obtained in the previous study, also involving bending and breakage of the tower about mid-height (Figure 7). As explained in the previous section, this failure mechanism does not fit the movement observed in the video, which shows the upper part of the tower going down vertically for a few meters.

Figure 7. Base model, without considering the shear failure plane. (left) Collapse mode; (right) Vertical stresses at the base of the tower at $t = 46$ s (max. 12.3 MPa).

Inspecting the joint stresses which develop at the lower joints of the tower during the seismic event, we see that the vertical component exceeds the brick strength, as shown in Figure 7. At $t=46$ s we have a peak of 12 MPa and at $t=47$ s, it increases to 17 MPa. This suggests the possibility of compressive crushing or shear failure of the material near the base of the structure, which was investigated as explained in the next section. The orientation of the plane showing larger stresses dips downwards, passing through the door of the tower, emphasizing the role of that weak structural region in the overall behaviour of the tower.

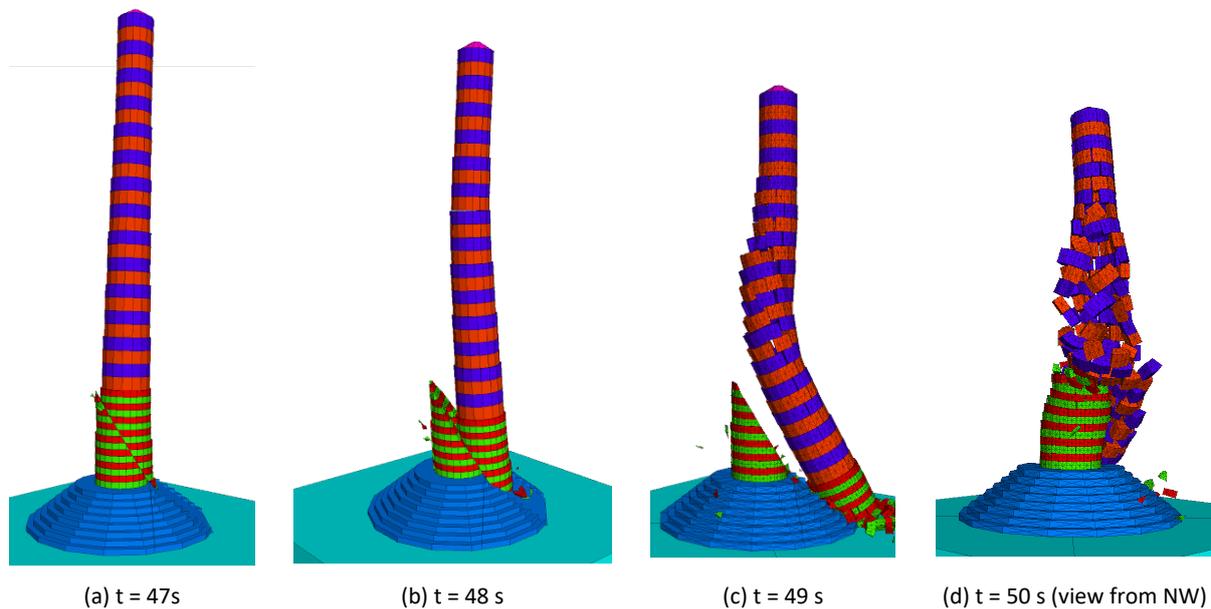
The sequence of the structural collapse process is shown in Figure 8. At $t=48.5$ s, sliding of several meters along the shear failure plane brings the top of the tower vertically down, as seen in the video. The sliding continues, and at $t=48.5-49$ s the tower wall starts to disaggregate. Finally, at $t=50$ s, the tower overturns falling over the triangular portion. This final movement does not agree with the observed result, as in reality the tower moved further sideways, essentially to the left, and did not destroy the triangular part. This disagreement is understandable, as much simplified numerical models always have difficulty in reproducing the events after very large movements take place. Sliding down the shear plane, a rough surface involving brick breakage, as well as the impact on the lower steps of the pulpit, are complex phenomena which cannot be simulated accurately with the available data. Therefore, the final part of the numerical simulation may vary significantly if we change the geometric and mechanical properties of the model. This is typically the case for analyses involving very large displacements, where the outcome starts to depend on model details, e.g. how smooth is the sliding plane cutting through the bricks. In addition, the process of breakage of the walls, seen developing at $t=49$ s, also depends on how sharp is the impact of the sliding body on the ramp at the model base, which is governed by damping and base properties difficult to estimate. Moreover, we are using as input the ground motion recorded approximately 1.3 km away from the location of the Tower. Actual ground shaking at the site, especially in terms of their relative intensities and phases in the two horizontal directions is probably different from what was recorded at KATNP. Due to these uncertainties, it is not possible to simulate properly the final stages of the collapse process. However, the important observation that failure started along a shear plane along which the upper portion slid for a few meters before hitting the ground and toppling is accurately simulated by the numerical model.

Figure 8. Numerical simulation of collapse: (a) $t=47$ s, (b) $t=48$ s; (c) $t=49$ s; (d) $t=50$ s, view from NW.
