## MULTILEVEL SEISMIC VULNERABILITY ASSESSMENT OF AN ITALIAN MEDIEVAL BELL TOWER

**Maddalena Della Pietra<sup>1</sup>, Mattia Zizi<sup>1</sup>, Corrado Chisari<sup>1</sup> and Gianfranco De Matteis<sup>1</sup>**

<sup>1</sup> Department of Architecture and Industrial Design, University of Campania “Luigi Vanvitelli”  
Via San Lorenzo, 81031, Aversa (CE), Italy  
{maddalena.dellapietra, mattia.zizi, corrado.chisari, gianfranco.dematteis}@unicampania.it

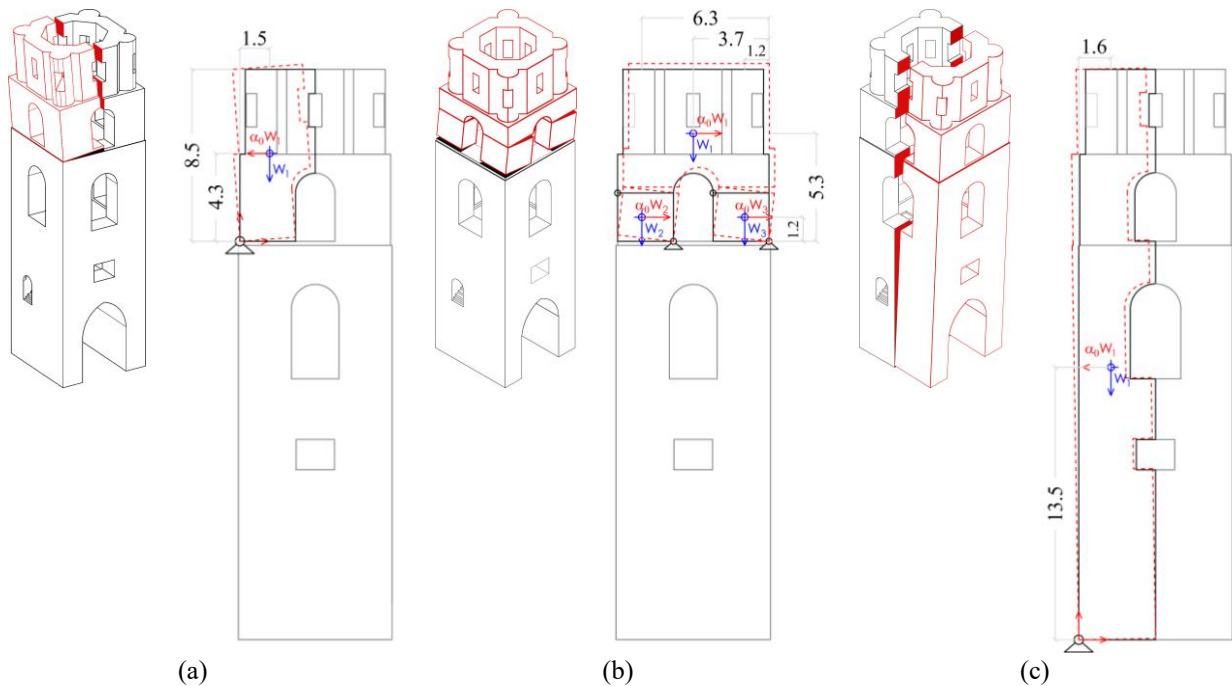
- Overturning of the upper portion of the structure, with the formation of a hinge line at the stiffness transition occurring at the end of the reinforced concrete frame (Figure 3a);
- Simultaneous rotation of the belfry piers, with the development of plastic hinges at the ends (Figure 3b);
- Overturning of an entire portion of the west side of the structure, along the existing cracks and the preferential paths provided by the openings (Figure 3c).

Figure 3. The analysed collapse mechanisms for EL2: (a) overturning of the upper portion; (b) rotation of the belfry piers and (c) overturning of the west side portion.

EL2 returned positive values of acceleration factors, confirming the safety of the tower under the design-level earthquake. The most critical collapse mechanism was the third one ( $f_{a,SLV} = 1.08$ ), characterized by the formation of a rotational hinge at the base of the tower. It is worth noting that the presence of the embedded reinforced concrete frame could potentially inhibit the activation of this failure mode, a condition that was not considered in the assessment. Therefore, the analysis was conducted under highly conservative assumptions.

As for the other collapse mechanisms, the overturning of the upper portion of the structure (first mechanism) resulted in lower acceleration factors compared to the typical belfry collapse (second mechanism). However, in both cases, the seismic demand remained below the threshold required to activate the mechanisms.

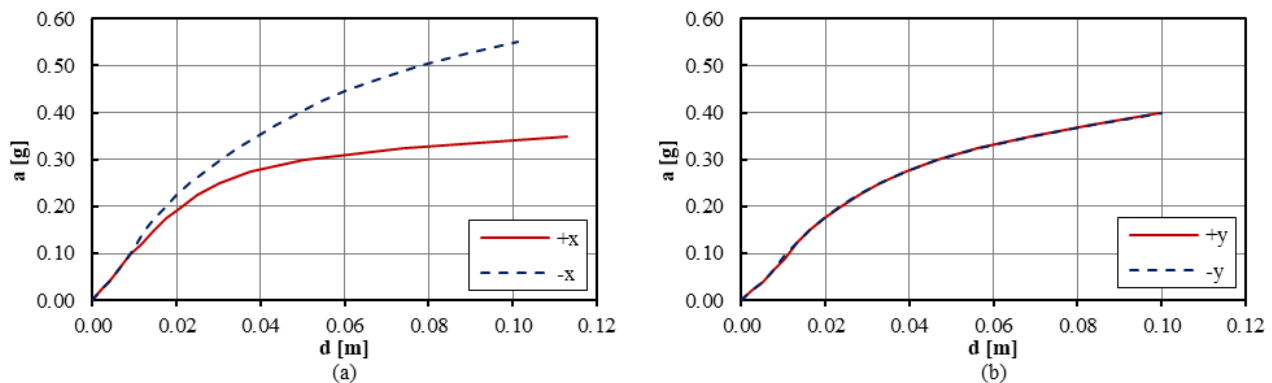
The tower generally demonstrated good performance against lateral loads, as indicated by the load multipliers. Under seismic action along the x-direction, load multipliers ranged from 0.35g (in the -x direction) to 0.55g (in the +x direction). The capacity curves in the x-direction show notable differences in initial stiffness, primarily due to the interaction between the tower and the adjacent church. Under seismic loads in the y-direction, the structural response was coincident, reflecting the tower's symmetry and the fact that the interaction with the church in this direction was neglected.

Conversely, the tower exhibited limited deformability, with ultimate drift values remaining below 0.35% in all analysed directions. This behaviour is primarily attributed to the high stiffness of the tower, provided by the reinforced concrete elements and their interaction with the surrounding masonry. It must also be mentioned that, due to the force-controlled character of the simulation, the numerical curve is limited to the ascending branch and possible ductility reserves are then disregarded. However, at the assumed failure points extensive damage were observed in both masonry and concrete elements.

Figure 5. Results of pushover analyses in terms of load multiplier-displacement curves: (a) x directions and (b) y directions.

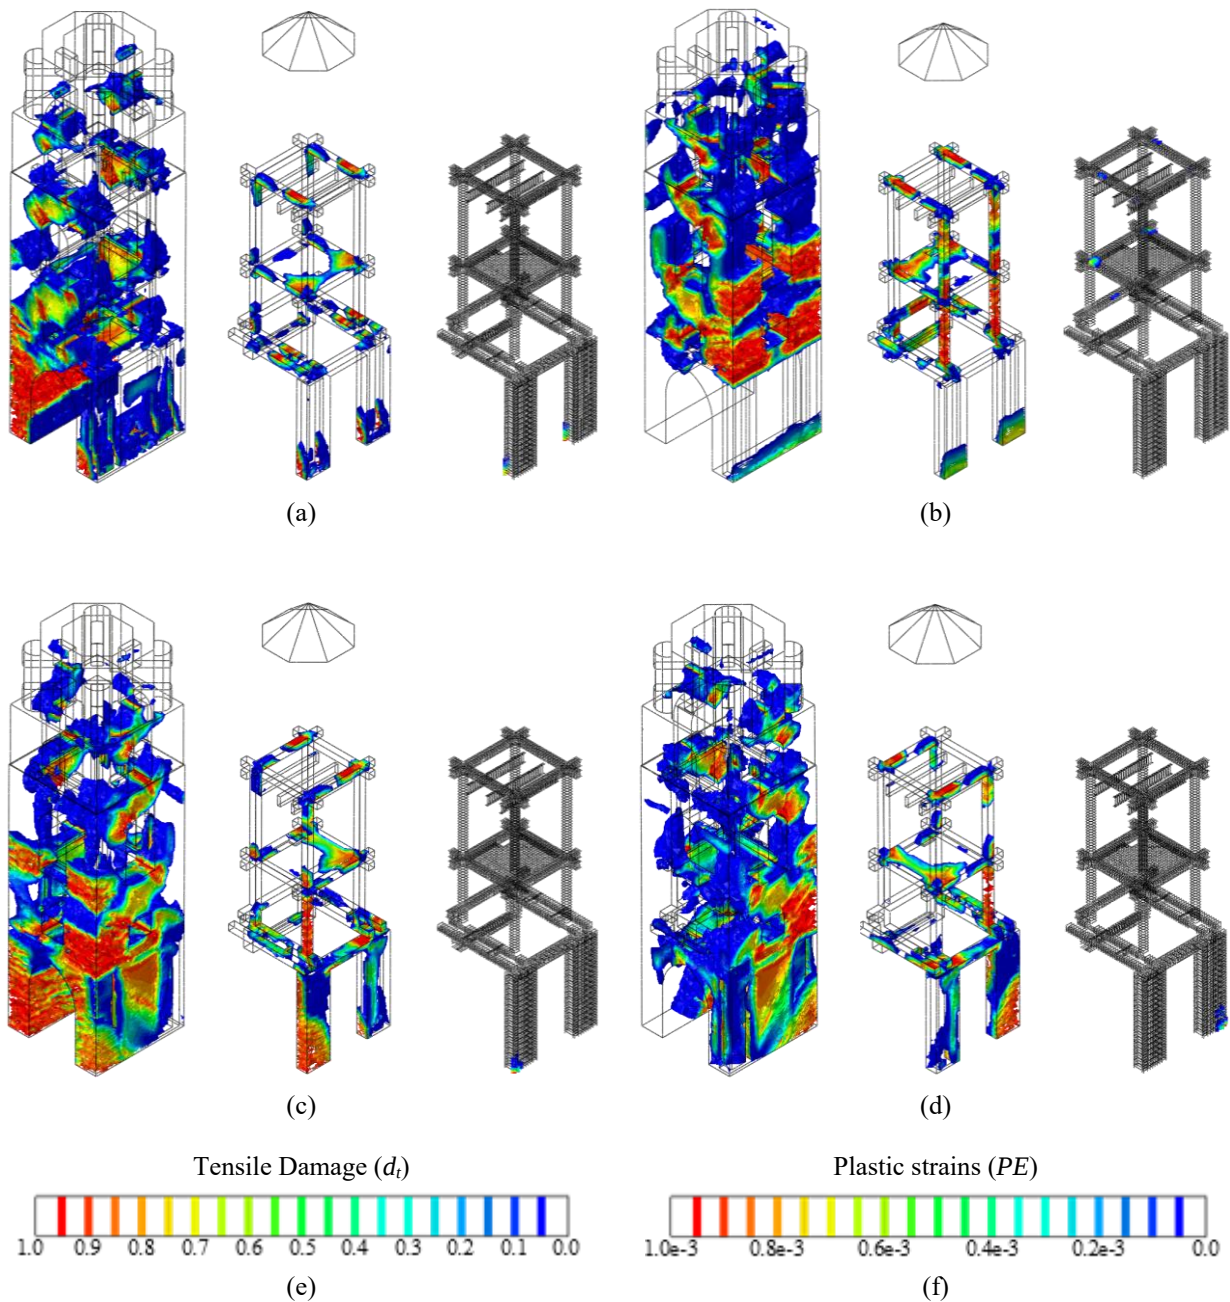
Based on the observed damage patterns, both masonry and concrete components sustained significant damage in the final step of the analyses. Typically, the masonry elements exhibited flexural failure at the base and shear mechanisms in the upper sections of the tower.

In the case of the -x direction, damage at the base was relatively limited, with no evident failure in the masonry piers. This confirms the significant structural contribution of the reinforced concrete elements, as well as the beneficial influence of the interaction with the adjacent church structure. In this configuration, the most severely affected area was the second sector, where both masonry elements and concrete columns experienced notable damage. The concrete slab was also highly stressed by seismic loads, as demonstrated by the extensive damage distribution.

On the other hand, the steel reinforcement remained largely within the elastic range throughout all analyses, with only localized plastic strains observed in the most highly stressed tensile regions.

Figure 6. Results of pushover analyses in terms of damage patterns (tensile damage  $d_t$  parameter for masonry and concrete and plastic strains  $PE$  for steel elements): (a) +x direction and (b) -x direction, (c) +y direction, (d) -y direction, (e) legend for tensile damage (masonry and concrete) and (f) legend for plastic strains (steel).
