## **ASSESSMENT AND RESTORATION OF THE HISTORIC TEMPLE OF THE DORMITION OF THE THEOTOKOS AND THE PERIMETRIC FORTIFICATION WALLS AT PETRA, LESVOS IN GREECE**

*This paper presents the results of the analysis regarding the assessment of the historic temple of the Dormition of the Theotokos at Petra on the island of Lesbos, the perimetric fortification walls as well as the rock on which they are constructed. The temple, the fortification walls and the rock have been declared as monuments.*

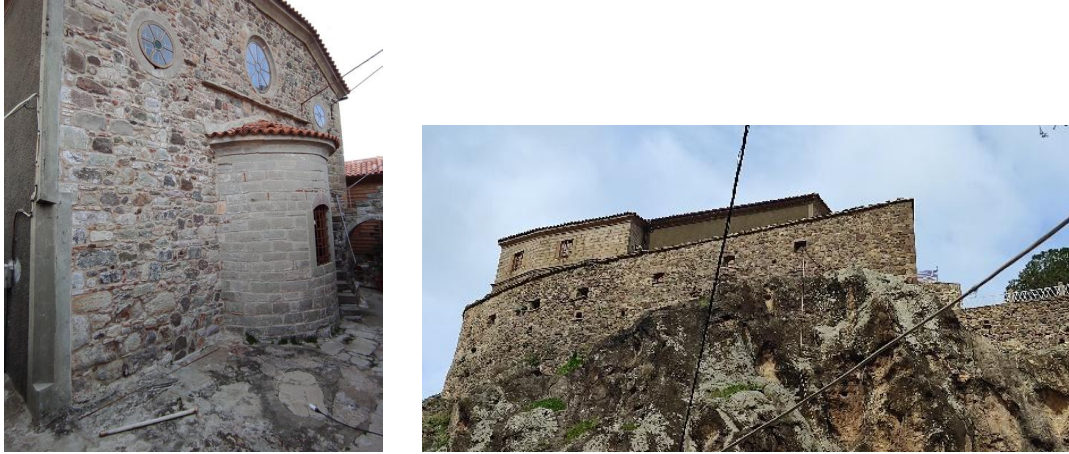
Figures 3 and 4: East view (three-leaf masonry and apse made of carved stone masonry) of the temple. South view of the perimeter fortification walls.

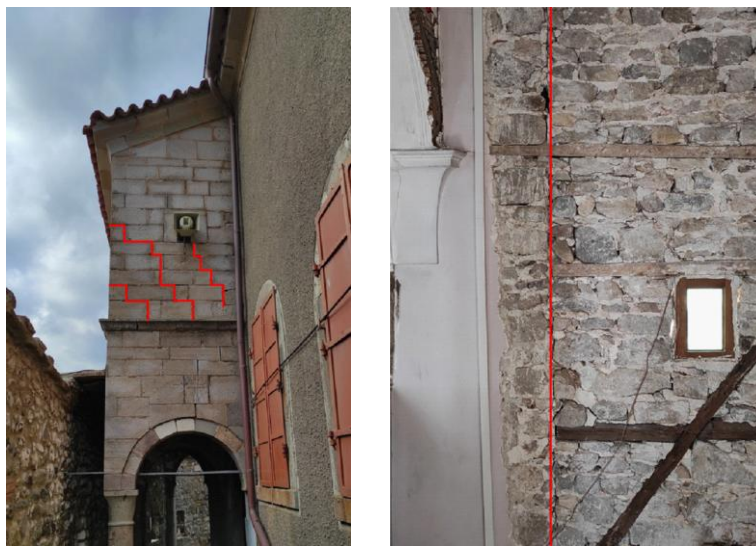
For the case of the temple, cracks were observed at the external and/or internal layer of load bearing walls of the gallery, as well as at the area of the connection between the gallery and the main temple. Cracks were also observed at several wooden columns at the interior of the temple, having approximately vertical orientation. Furthermore, deterioration of material was also observed at other elements of the temple, like, integrated wooden elements at the internal layer of the masonry of the gallery, wooden elements that are forming the cross vaults and iron tie rods that connect the columns between them and with the load bearing walls. In Figures 5 – 6 representative cases of the most significant cracks observed are presented.

Figures 5 and 6: Cracks at the external layer of the masonry of the gallery. Insufficient connection and detachment of the gallery from the main temple.

For the cracks of the stone masonry walls, jointing and stapling with a non-corrosive metal alloy horizontal bars will be applied (Figure 12). For the cracks of the wooden columns, external confinement with stainless steel plate elements will be applied (Figure 13). For the detachment between the main walls of the temple and those of the gallery, stainless steel tie rods will be applied. This way, the pier will also be strengthened in shear (Figure 14). For the corroded wooden elements of the masonry of the gallery and those of the cross vaults, replacement with new wooden elements will be applied. For the corroded iron tie rods, replacement by stainless steel tie rods will be applied. For the cracks of the stone elements at the base of the arches, they will be sealed with the application of mortar injections.

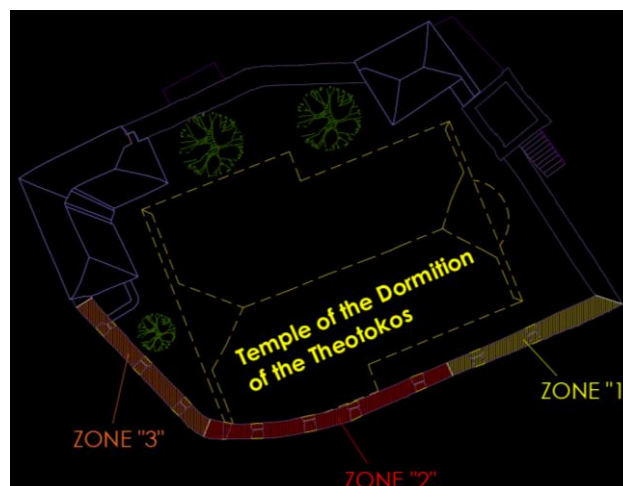
At the external layer of the south, the west and the north side of the fortification walls deterioration of the mortar of the joints is observed. Also, at the north side of the fortification walls the extreme deterioration of the mortar at certain areas has led to disconnection between the stones of the masonry. The most significant damage is the existence of very wide cracks around all the openings of the south side of the fortification walls, as well as at a part of those of the west side. These cracks are observed approximately in the middle of the thickness of the walls, have a vertical orientation and are visible at the left, right and upper side of the openings and their existence indicates the gradual disconnection of the external layer of the masonry from the internal.

In order to distinguish the damage of each area of the fortification walls according to its severity they were separated in three zones: (i) Zone 1 where the damage is less severe in comparison to the other zones, (ii) Zone 2 where the damage is more severe than any other part of the structure and (iii) Zone 3 where the damage is more severe than Zone 1 and less severe than Zone 2. In Figure 7 the exact area where each Zone is extended is presented.

Figure 7: Zones 1, 2 and 3 of the fortification walls.

- Jointing at all the surface of the masonry, except those at which it has already been applied at an earlier state.
- Homogenization of masonry, in order to fill the internal voids and warrant its behavior as a unified structural element.
- Improvement of the connection between the external and the internal layer of masonry by applying non-corrosive metal alloy bars perpendicular to the surface.

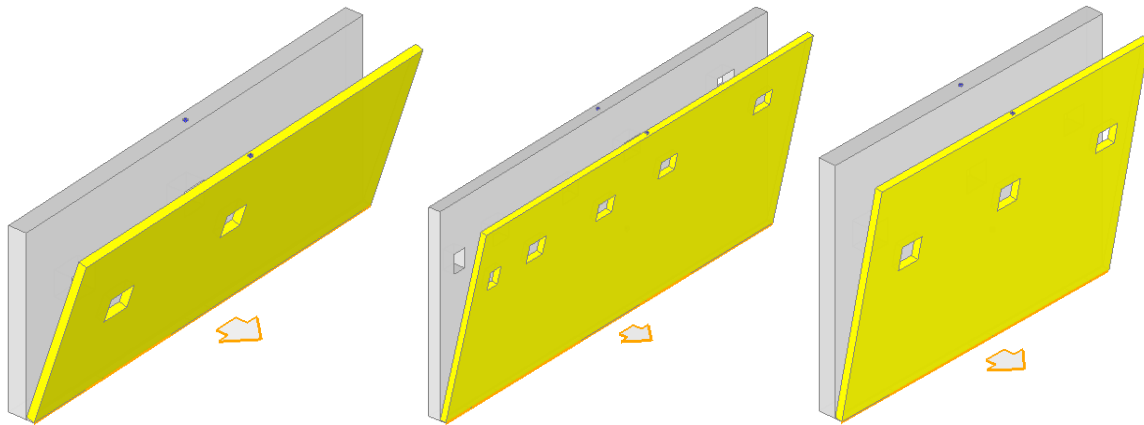
Figures 9, 10 and 11: Kinematic analysis structural models of Zones 1, 2 and 3, respectively, of the fortification walls. Detachment and overturning of the external layer of stone masonry.

For Zone 1 the collapse multiplier of the mechanism is  $a_0 = 0.045g$ . The ground acceleration that causes failure of the mechanism is  $PGA_{SD} = 0.076g$ . The safety factor is  $\lambda = 0.220 < 1.0$ . For Zone 2 the safety factor is  $\lambda = 0.145 < 1.0$ . For Zone 3 the safety factor is  $\lambda = 0.145 < 1.0$ . It should be noted that a partial out-of-plane mechanism fails if its safety factor is lower than 1 ( $\lambda < 1.0$ ).

As a result, for all cases the structure fails for the considered mechanism and proper strengthening interventions should be applied.

For Zone 1 the collapse multiplier of the mechanism is  $\alpha_0 = 0.311$ . The ground acceleration that causes failure of the mechanism is  $PGA_{SD} = 0.524g$ . The safety factor is  $\lambda = 1.516$ . For Zone 2 the safety factor is  $\lambda = 1.047$ . For Zone 3 the safety factor is  $\lambda = 1.007$ . As a result, for all cases the strengthened fortification walls are sufficient.
