PALAZZO LA SAPIENZA IN PISA: STRUCTURAL ASSESSMENT AND RETROFIT OF AN HISTORICAL MASONRY BUILDING IN ITALY

S. Caprili¹, F. Mangini¹, N. Mussini¹ and W. Salvatore²

Abstract. *Palazzo La Sapienza, historical seat of the University of Pisa since the XVI century, represents one of the most important examples of the Tuscany cultural heritage, nowadays not in use due to several problems related to maintenance and structural deficiencies. The building, in its current form, is the result of several modifications, enlargements, elevations, connection with adjacent parts, resulting finally more similar to a “structural aggregate” - made up of single units connected together without specific scheme and organization - than to a single unitary building. After the earthquake of May 2012, the Palace was temporarily closed in relation to the ordinance issued by the Major’s Office and then subjected to wide in situ investigations aiming at analyzing in a very detailed manner all the criticisms related to structural, nonstructural, geotechnical and maintenance problems; the deep in situ survey campaigns allowed to reach a very deep knowledge of the building, of its progressive morphological evolut

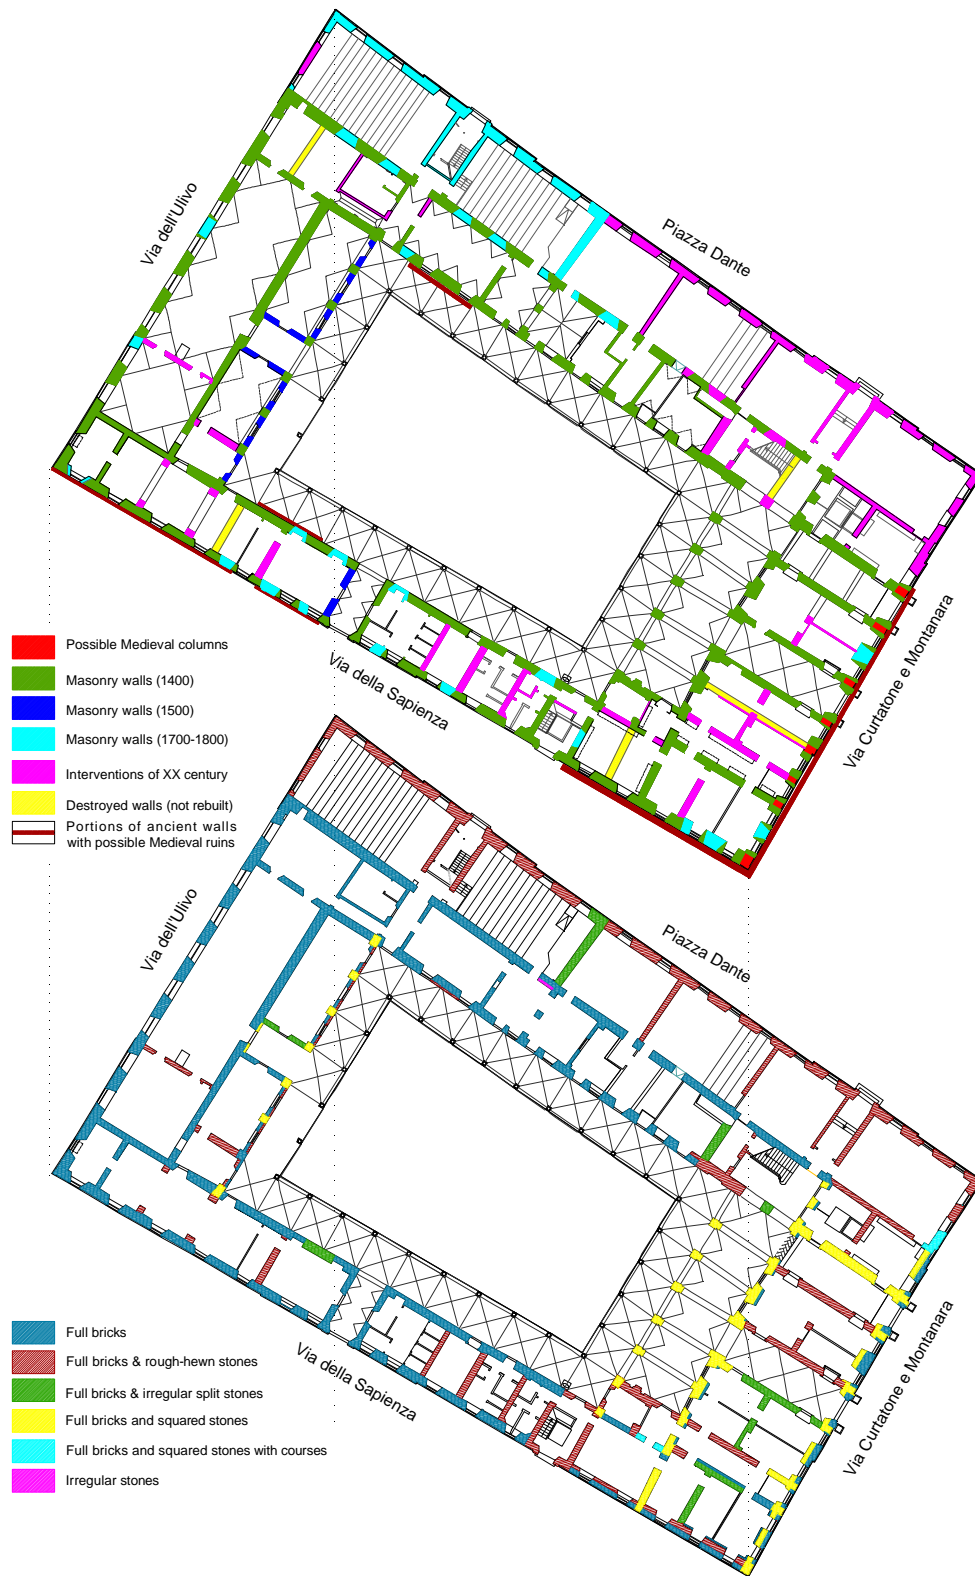
Figure 2: Hypothesis of the evolutive development of the building and plan of ground floor with indications of the various types of masonry.

1. *Corner between Via Curtatone e Montanara and Via della Sapienza.* As visible from Figure 2, pillars characterized by the presence of full bricks and squared stones demonstrate the pre-existence of ancient tower houses incorporated and connected to adjacent masonry structures during the centuries. The discontinuity and heterogeneity of masonry belonging to different constructive typologies, realized in different periods and not connected to one another yielded, during the years, to the development and to the progressive spreading of a diffused cracking scenario visible both in vertical elements and in horizontal structures, allowing the clear identification of this structural unit.

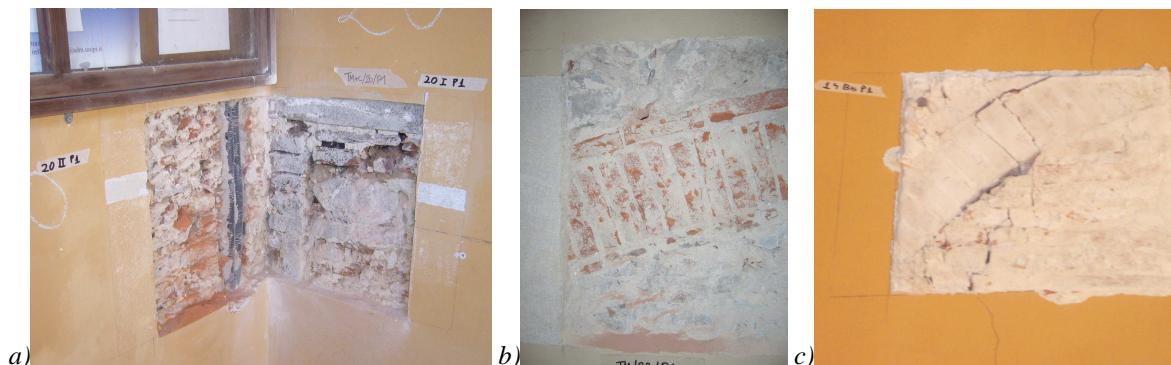
A diffused lack of connection between masonry walls was evidenced (Figure 4a) and different masonry typologies were revealed even in the same element: Figure 4b and Figure 4c, for example, show the presence of masonry arches of ancient openings nowadays closed due to the modified functional needs. The heterogeneity of masonry walls is higher at the ground and first floors (i.e. corner Via Curtatone e Montanara / Via della Sapienza, Figure 2) respect to the second level, realized at the beginning of the 19th century.

Figure 4: Discontinuities of vertical masonry walls: a) absence of connection between perpendicular walls, b-c) arches identified in correspondence of the first floor level, probably old windows currently closed.

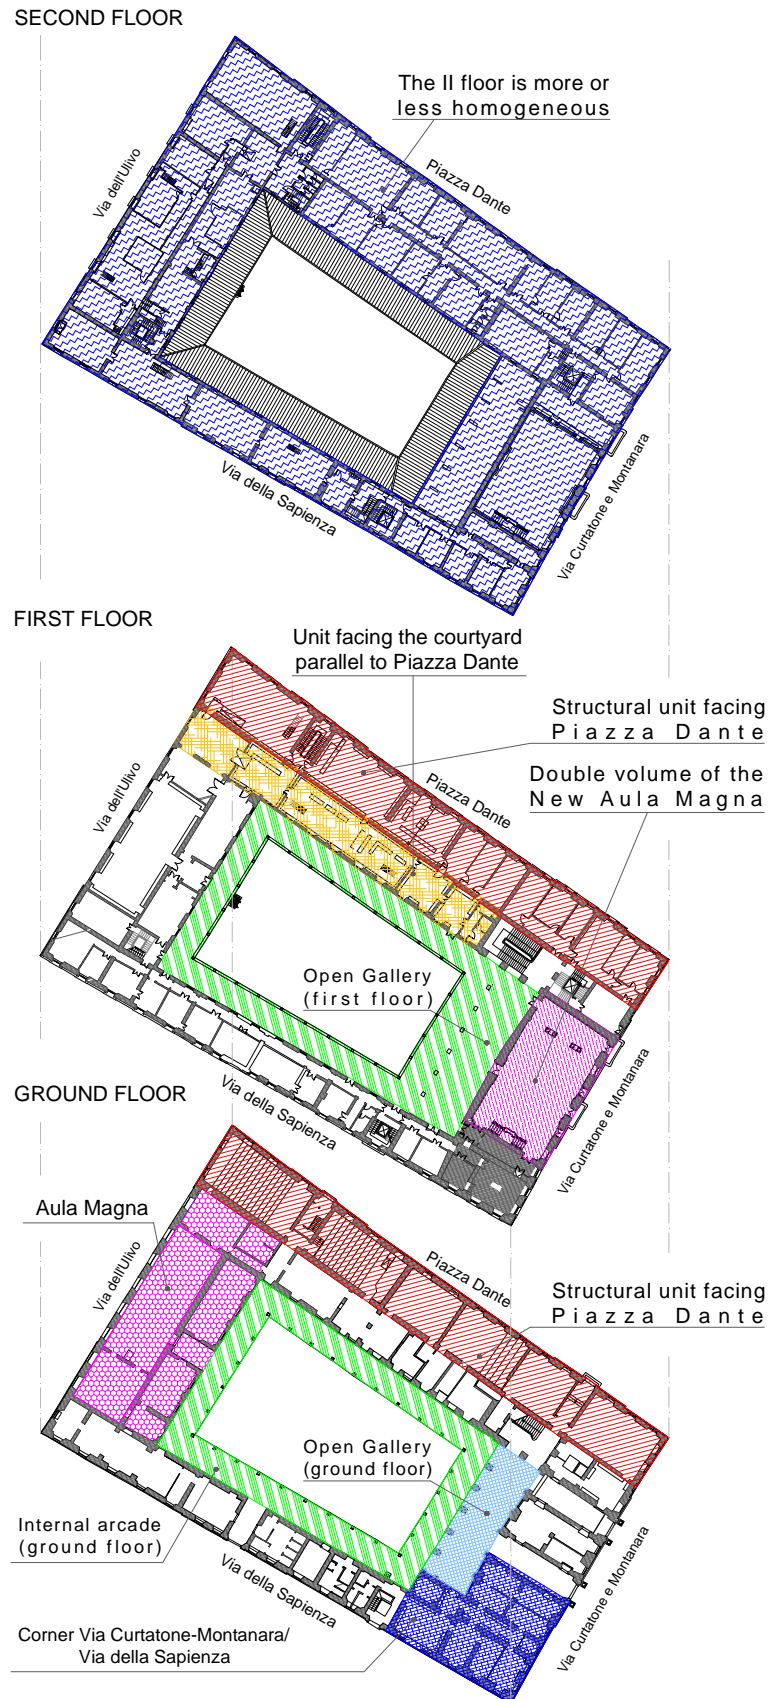
Figure 5: Structural units that can be determined as independent parts of the aggregate.

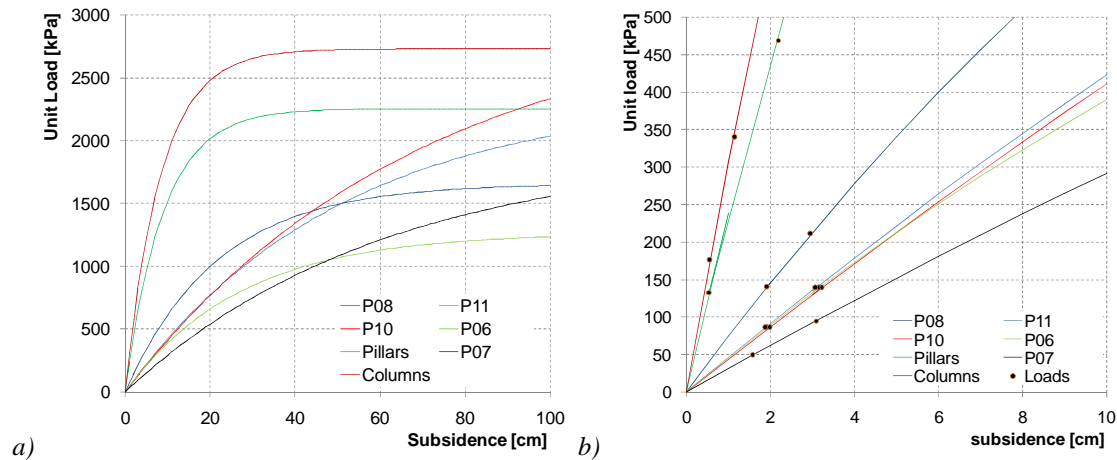
The relative displacements evidenced in correspondence of the wooden elements of the colonnade at the 1st floor and the masonry walls, as well as the diffused cracking scenario revealed in the crossed vaulted surfaces of the ground floor are the direct consequence of the differential subsidence due to the different typologies of foundations (Figure 3). The foundations of columns of the internal arcade are not connected to one another and lay at different levels respect to the masonry walls facing the courtyard: these differences result in relative subsidence evidencing the non uniformity of the overall mechanical response of the foundation system, the variability of soil stiffness and of ultimate loads. The structural analysis of foundations considering actual loads (permanent, live and seismic action) allowed the determination of the unit load-subsidence diagrams of the foundation-ground assemblage of the various analyzed sections (Figure 6a): the difference between the building's perimeter and its interior (i.e. colonnade and pillars of the interior courtyard) can expose the whole structure to considerable damages in those areas where significant differences in stiffness and loads were measured (Figure 6b).

Figure 6: a) Unit load-subsidence curves for the different sections investigated, b) estimates of the subsidence of different building zones as a function of the applied loads.

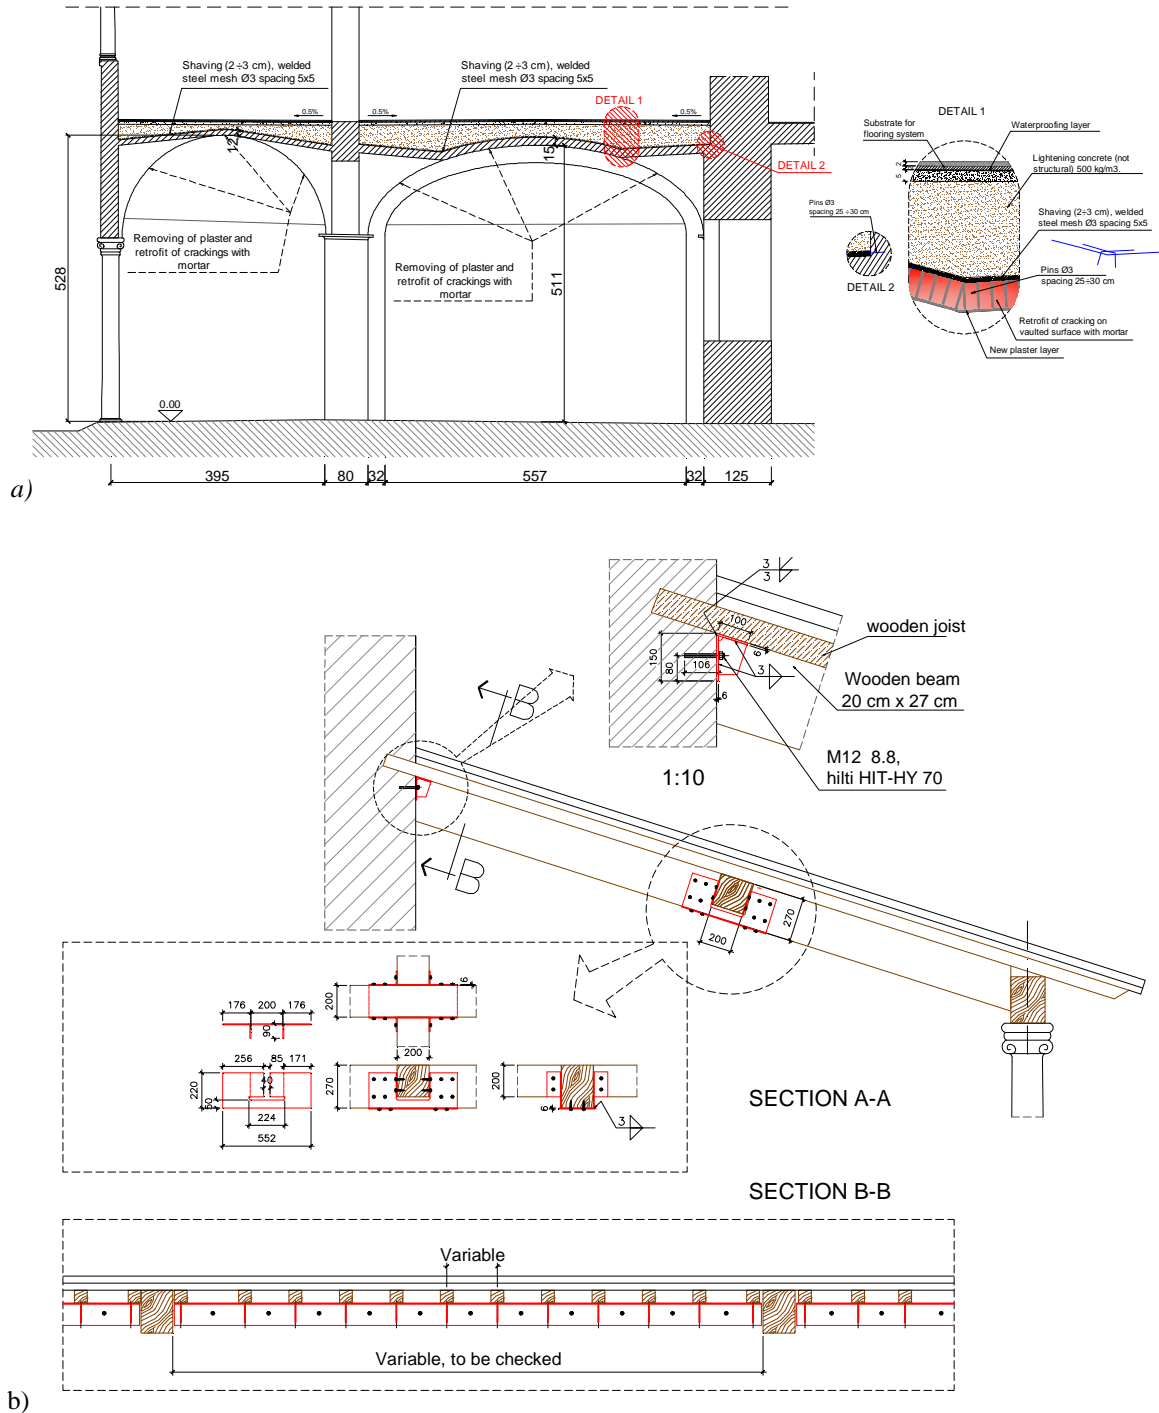
Figure 7: a) Example of the intervention foreseen for the retrofit of the vaulted surfaces of the ground floor arcade; b) retrofit intervention foreseen to provide adequate support to the wooden elements of the first floor colonnade.

The retrofit of the vaulted surfaces consisted in the removal of the filling material on the extrados of the vaulted surfaces – with the following decrease of the dead load – and in the restoration of cracks using specific materials for historical masonry buildings (Figure 7a); a similar retrofit procedure was also adopted for cracks present at the intrados of the vaults. A thin shaving layer of 2-3 cm of thickness with welded steel mesh (ϕ 3 mm and spacing 50x50 mm) was also foreseen provide a global behaviour without altering the structural feature of the aggregate. Some problems were revealed also in correspondence of the 1st floor colonnade, with relative displacement between the wooden secondary elements of the roof and the masonry wall, with support length equal, in some cases, only to few centimeters; in order to prevent the pull out of such elements, an additional steel profile was positioned in correspondence of the whole perimeter of the colonnade (Figure 7b), providing a final support length of about 10 cm. Several additional retrofit interventions were designed for damaged elements of the roofing system.

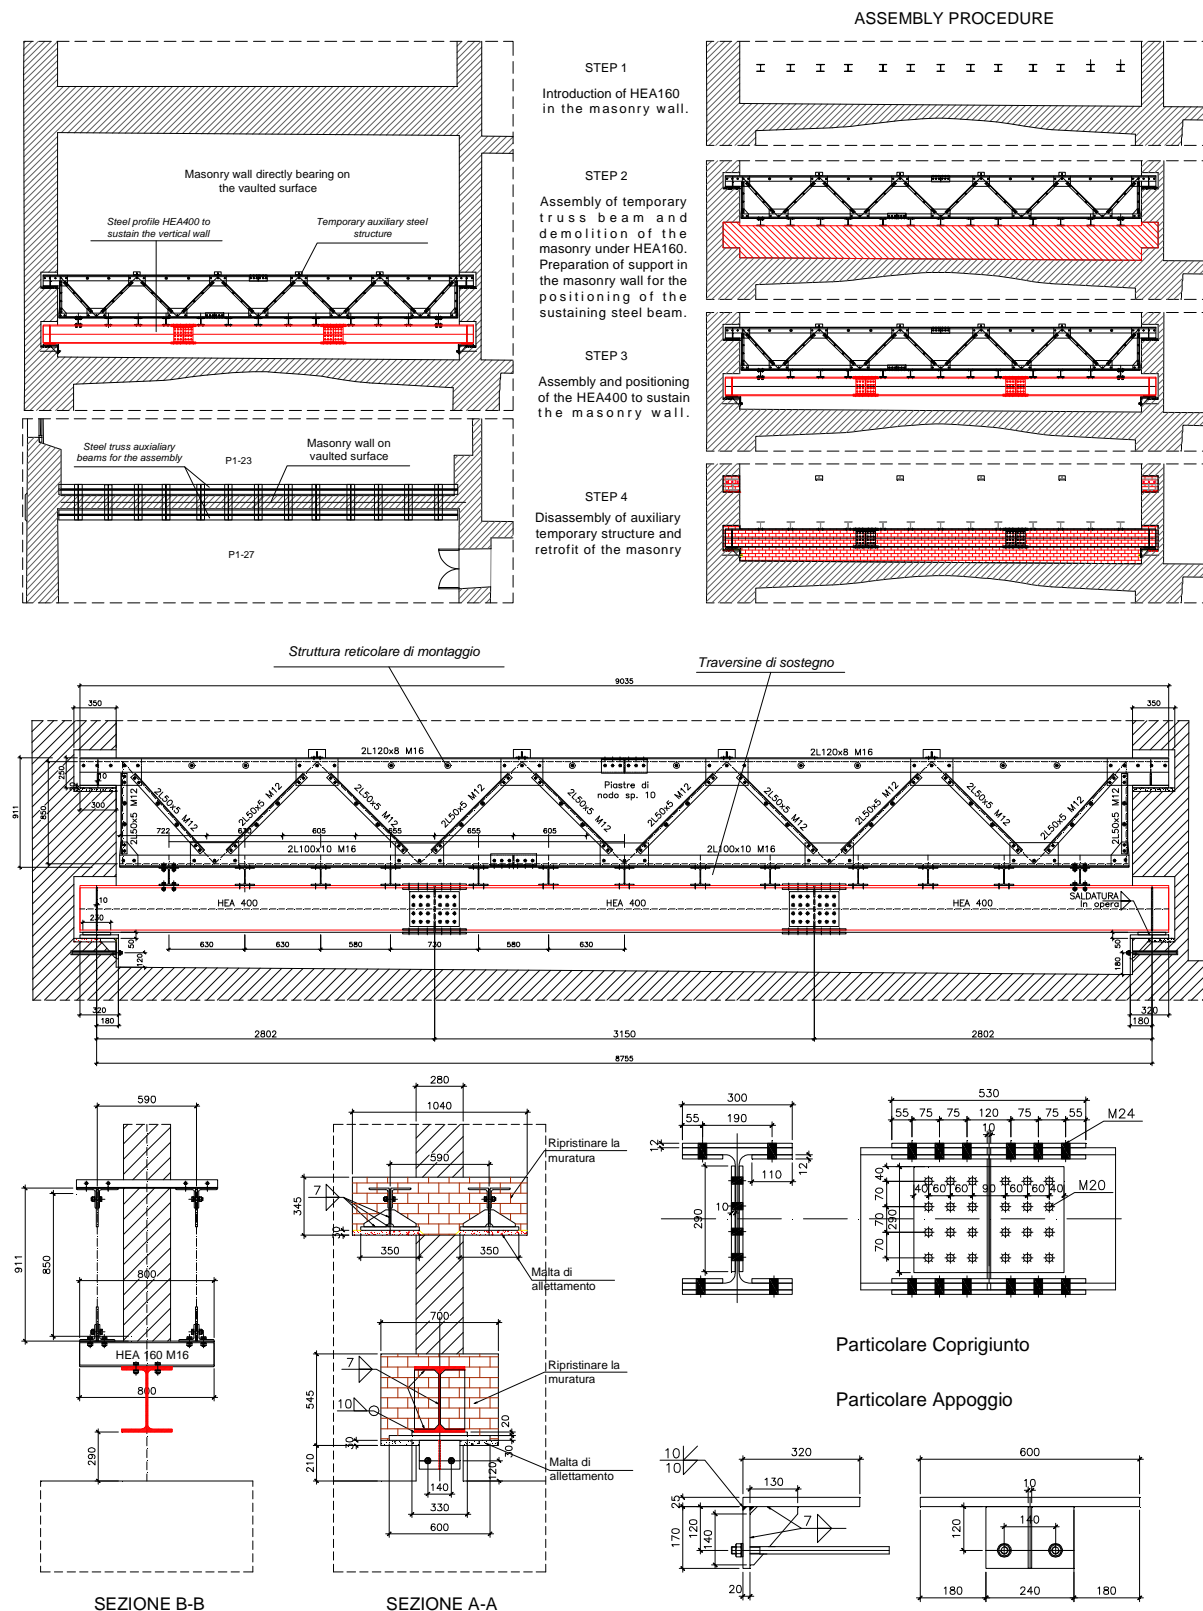
Figure 8: Introduction of stele profile and assembly procedure to avoid the load directly upon the vaulted surface near the Aula Magna.

To solve the problem of the masonry infill wall directly bearing on the vaulted surface close to the Aula Magna at the ground floor, the introduction of a steel HEA profile able to directly sustain the masonry wall and the rest of the superstructure - including the vault at 1st floor and the corresponding masonry wall at the 2nd floor - was accurately designed. The design of the bearing profile took into account both strength and stiffness aspects – this last to avoid the vertical deflection of the masonry wall – and, moreover, the analysis of the assembly procedure (Figure 8). A temporary bearing structure made up of two twin truss beams with transversal support steel beams with spacing equal to 50-70 cm was adopted, allowing safety conditions during the phases of cutting of the masonry wall and introduction of the HEA bearing beam.
