HUMAN-INDUCED VIBRATIONS ON MUSEUM ARTEFACTS: LITERATURE REVIEW AND CALCULATION EXAMPLE

The purpose of this article is to propose a short literature review on these topics and to provide an example of calculation for a selected case study: the Croce of San Teodoro, located at Gallerie dell'Accademia in Venice, Italy.

3 CASE STUDY: THE CROSS OF SAN TEODORO

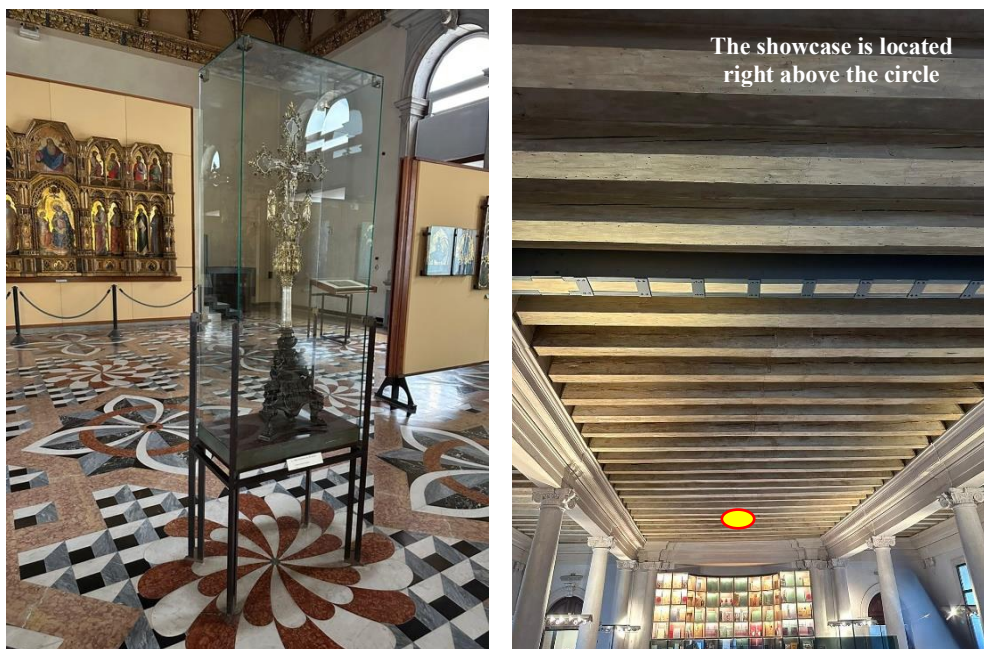
Figure 2 – Cross of San Teodoro (left) and supporting floor (right) at the Gallerie dell'Accademia, Venice.

The room where the Cross of San Teodoro is located has dimensions of 32 m by 12.5 m, placed right above the main entrance of the building. As already reported, the floor was re-built during the eighteenth-century refurbishing. It is made of primary wooden beams (supposed to be fir, $E \approx 10000$ MPa), with a cross-section of 550 mm by 850 mm supported by columns every 4 m, and secondary beams, measuring 180 mm by 300 mm with a span of 6.4 m (Fig. 2). The primary beams direction follows the lengthwise of the building, while the secondary beams are perpendicular to them. The exact composition of the topping slab of the floor is unknown, but it is believed to consist of a 10-mm-thick layer of wattled material, topped by a 100-mm-thick mixture of cement and sand, a 100-mm-thick screed layer and a 10-mm-thick layer of marble cladding (all the measures are approximated). The Cross of San Teodoro is positioned at the center of the shorter side of the building, 20 meters away from the perimeter wall of the entrance, in fact in the middle of the secondary beams system (see yellow circle in Fig. 2).

The Cross of San Teodoro, housed among many other works at the Gallerie dell'Accademia, drew attention due to the constant swinging of a decorative element (i.e. censer) resembling a pendulum on one of its arms. Although this does not pose a threat to the stability or preservation of the artwork, the continuous oscillation with an approximate period of 0.4 s does affect the enjoyment of the piece. Another factor that may disturb the enjoyment of the artwork is the visible trembling effect on the transparent materials of the cross (i.e. rock crystals) as a single visitor approaches. In fact, the human eye perceives more easily the vibration of reflective surfaces caused by the fluttering of light. Even the glass of the display case in which the object is located experiences visible oscillations as soon as a group of visitors walks nearby the object. The interest in this case study is not only limited to this particular manufacture but it can be extended to all other very flexible or reflective installations or artworks (e.g. slender reading desks, suspended items, crystal, glass, silver).

Due to these limiting factors, isolating the display case seems to be the best option: it is a cost-effective, feasible and non-intrusive solution to protect the Cross of San Teodoro from vibrations.

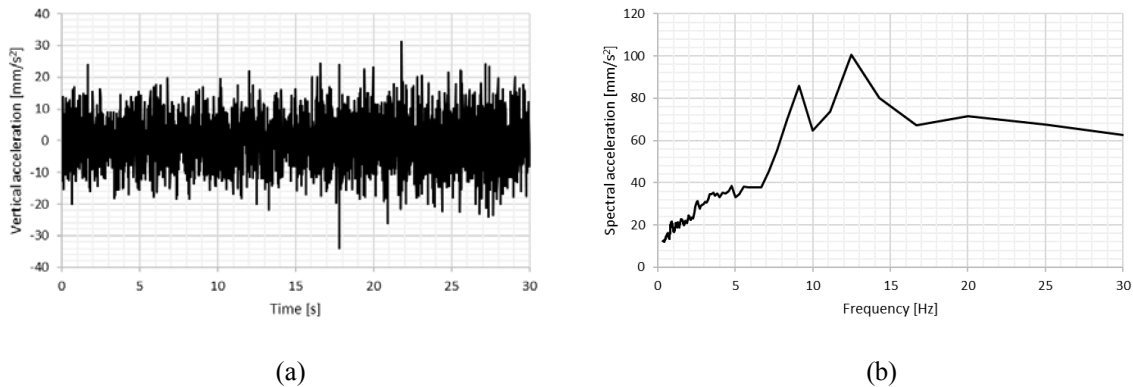
Figure 3 – Time-history of vertical acceleration (Fig. 3a) and correspondent elastic response spectrum (Fig. 3b).

Fig. 3 displays the time-history recording with a sampling frequency of 100 Hz as well as the elastic acceleration response spectrum (5% damping) of the vertical motion. From Fig. 3a is possible to observe a maximum vertical acceleration of approximately 35 mm/s^2 , and a maximum spectral acceleration between 90 mm/s^2 and 100 mm/s^2 (i.e. 0.1 m/s^2) in correspondence with the fundamental frequencies (first and second mode) of the floor (respectively 8 Hz and 12.5 Hz).

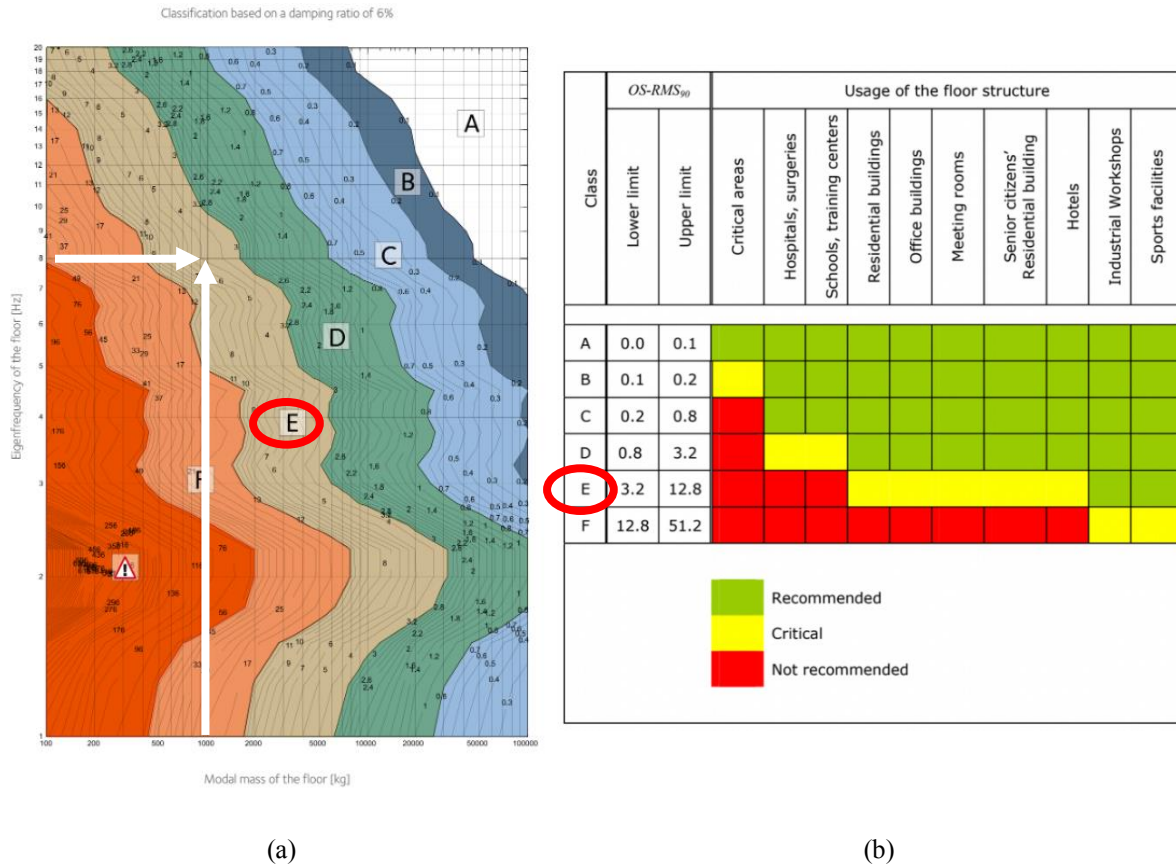
Knowing these two values allows the use of the abacus with a 6% damping ratio (a value commonly used for wooden floors) to determine the floor's classification according to Feldmann et al. [16]. The analysis revealed that the floor where the Cross of San Teodoro is located belongs to category “E”, as reported in Fig. 4a. Fig. 4b also reports a table that establishes the acceptability of a particular floor classification for different usage of the building. Although the table does not indicate a specific category for museums, it is evident that, at least for objects particularly sensitive to vibration as the one herein present, a category “E” floor should be considered “not recommended” (as for example as per hospitals and schools). The table reports also the interval in terms of OS-RMS, value of the velocity (mm/s) for a significant step covering the intensity of 90% people's step walking normally [38].

Further studies should be conducted on the ultimate and serviceability limit states for artefacts in terms of maximum vibrations; the limit threshold for artworks should be likely set not greater than the level of vibration corresponding to human perceptibility, even though smaller values could be appropriate in specific cases. In the scenario of this study, for example, a reduction of almost 8 times (to 4.5 mm/s^2) as depicted in Fig. 5 (green dot) would be required to reach this level. By following this approach, the values would also meet the acceptable criteria for class “C” in the graph presented in Fig. 4.

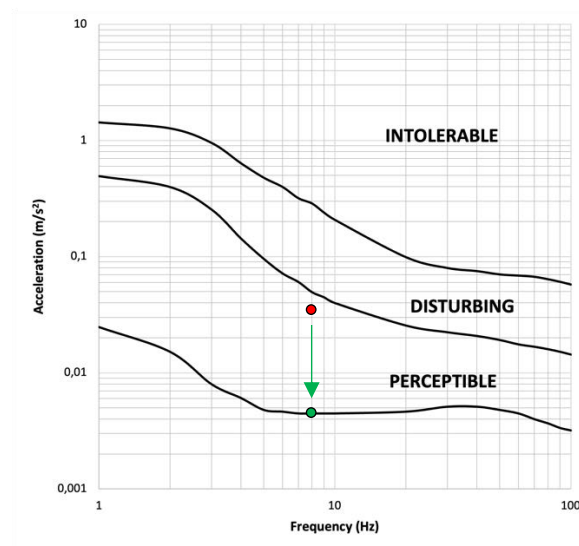
Figure 5 – Human perceptibility of vibrations and *in-situ* measurements (red dot), adapted from [13].

was plotted in terms of maximum accelerations vs. frequencies from [13]. It shows that the maximum recorded acceleration (approx. 35 mm/s^2) corresponds to a level of vibration “very perceptible”, “almost disturbing” for human perceptibility for the fundamental frequency of the floor of 8 Hz (see red dot of Fig. 5).
