DYNAMIC BEHAVIOUR OF GREEK POST-BYZANTINE CHURCHES WITH FOUNDATION DEFORMABILITY AND EVALUATION OF THEIR EARTHQUAKE PERFORMANCE – EXPERIMENTAL INVESTIGATION OF STONE MASONRY MATERIAL PROPERTIES

G.C. Manos¹, L. Kotoulas^{1*}, V. Matsou¹, O. Felekidou¹

¹Laboratory of Strength of Materials and Structures
Dept. Civil Engineering, Aristotle University of Thessaloniki
University Campus, Egnatia street, Thessaloniki, 54006
gcmanos@civil.auth.gr

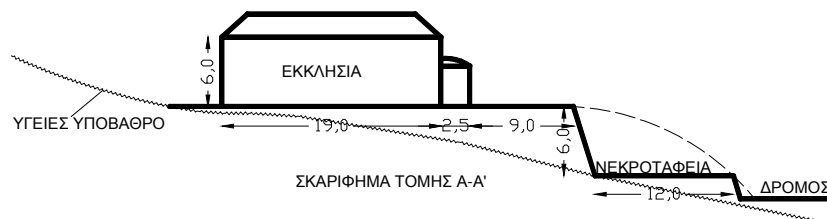
Figure 1. The layout of the church of the Assumption of Virgin Mary

The outlay of this church is shown in figure 1 by a cross-section in the longitudinal direction. Its basic dimensions are 21.5m long (together with the apse of the East wall) 11m wide and a maximum height to the top of the wooden roof 10m. With the dashed line the hard-soil is indicated. As can be seen, the West part of this church is founded on hard soil (weathered flysch layers) whereas the East part is founded on relatively soft soil that was deposited on top of the layers to compensate for the natural slope at this location. Apart from the relatively soft soil deposits at the East part of this church the malfunction of the drainage system at this point initiated considerable settlement of these soft soil deposits.

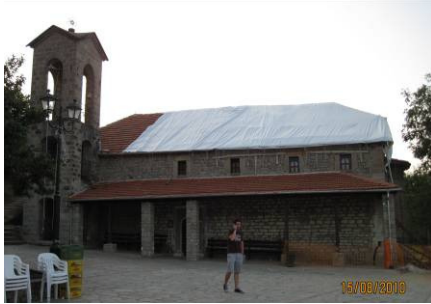
Figure 2a. Side view from the South

The unequal settlement of the foundation of the stone masonry walls as well as of the internal columns that supported the vaulting system, which covered this church, caused considerable damage. An external view of this church from the South is shown in figure 2a whereas figure 2b depicts the extensive damage that developed at the South-East corner. A very wide crack initiates at the top of the East peripheral wall near the apse and propagates towards the bottom of this wall being inclined to the South-East corner. Furthermore, a similarly wide crack propagates through the North peripheral wall from top to bottom as is shown in figure 2c. It must be noted that the thickness of these masonry walls varies from 750mm to 800mm.

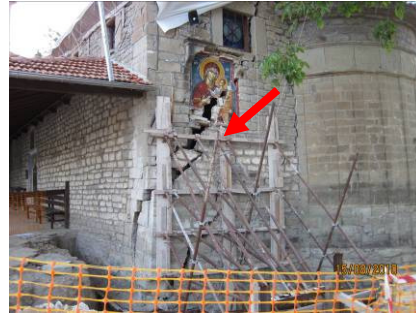
Figure 2b. Damage to the South-East corner

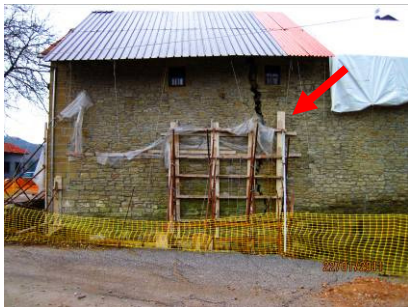
Figure 2c. Damage to the North wall

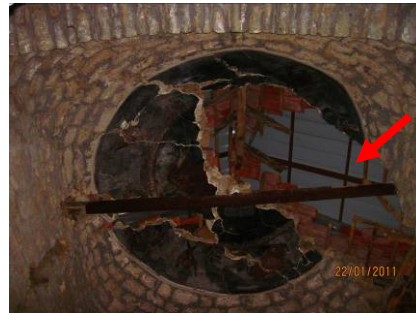
Figure 2d. Partial collapse of the central dome

From this extensive peripheral wall damage, the vaulting system that is supported by these peripheral walls also suffered extensive cracking that eventually caused the partial collapse of a part of the central dome, as shown in figure 2d.

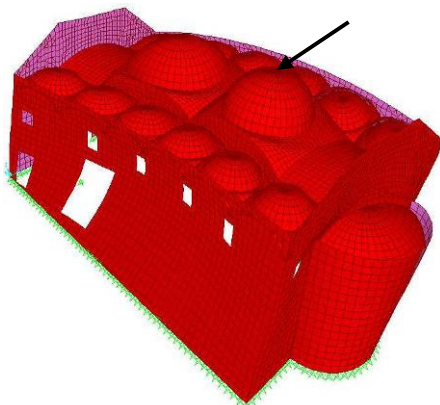
Figure 3a. Displacement Response. $0.9G+1.4(+E_x)$
 $U_x = 6.81 \text{ mm}$ $U_z = -1.51 \text{ mm}$

spond to tensile stresses which cannot be sustained by the weak stone masonry used to construct these churches. For the load combination $0.9G+1.4(+Ex)$ the maximum deformations at the top of the central dome were found equal to $U_x = 6.81$ mm $U_z = -1.51$ mm (figure 3a). For this load combination the maximum tensile stresses parallel to the bed joint σ_{11} were found equal to 0.51 MPa, at the bottom face of the masonry walls (figure 4a). As can be seen in this figure, high tensile stresses parallel to the bed joint develop both at the top of the North wall as well at the South-East corner of the East wall.

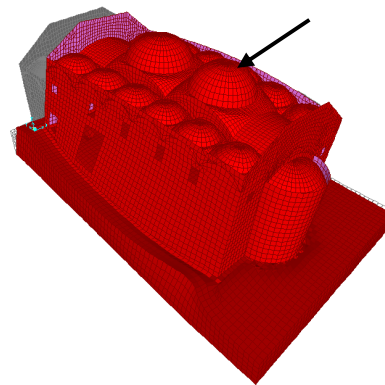
Figure 3b. Displacement Response. $0.9G+1.4(+E_x)$ $U_x = 21.33 \text{ mm}$ $U_z = -14.80 \text{ mm}$

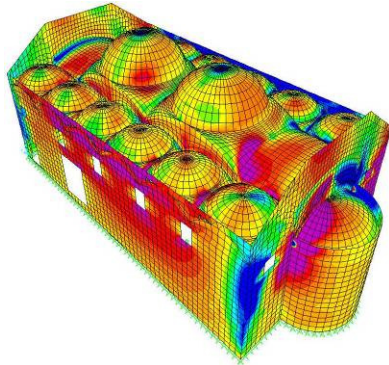
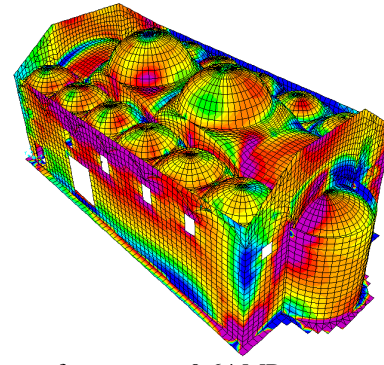
a) σ_{11} bottom face, $\max\sigma = 0.51$ MPa.

b) σ_{11} bottom face $\max\sigma = 0.64$ MPa

Figure 4. Out-of-plane behavior, Load Combination $0.9G+1.4(+Ex)$

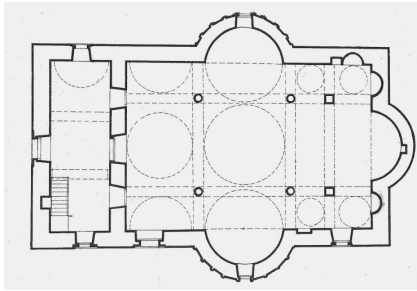
Figure 5a. Plan

the church in the longitudinal East-West direction is 17.60m and its width in the North-South direction is 9.85m. The construction of this stone-masonry church was completed in 1797 A.D. using the local natural stone. The plan and the East-West cross-section are shown in figures 5a and 5b.

The vaulting system that supports the three domes is depicted in figures 5a to 5f, as can be seen from the top by removing the wooden roof. The numerical simulation considered two distinct models. The first model assumed non-deformable foundation where the translations along the three axes (x , y , z) were restrained to zero.

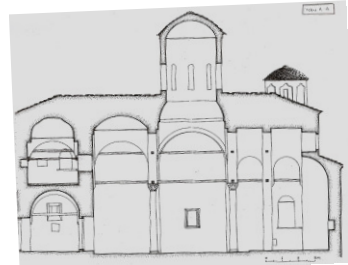
Figure 5b. East-West section, View from the South

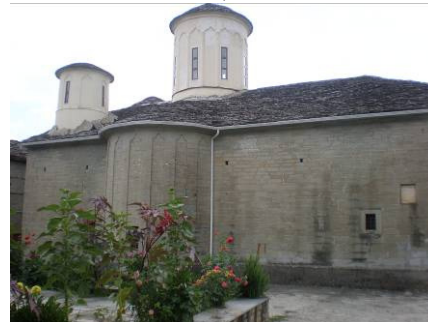
Figure 5d. View from the North

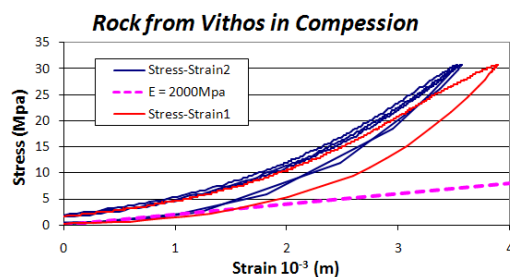
Figure 6. Compressive stress-strain behaviour of a slate sample taken from the vicinity of the church

The second model tries to account for the deformability of the foundation by using as supports linear springs with stiffness properties that were estimated taking into consideration the quality of the underlying media (figure 6) as well as the thickness of the foundation and the discretization employed.

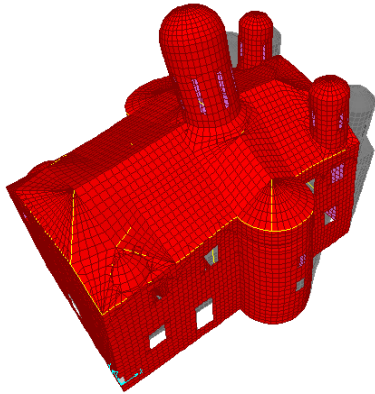
Figure 7a. 1st Translational eigen-mode y-y, $T_y = 0.154$ sec modal mass ratio $U_y = 44.67\%$

The modal analysis results, depicted in figures 7a and 7b, demonstrate the first effect of the deformable foundation which is the lengthening of the eigen-periods of the most significant translational modes as well as the mobilization of larger modal mass ratios for these eigen-modes when the deformable foundation was considered as compared to the corresponding values of the non-deformable foundation.

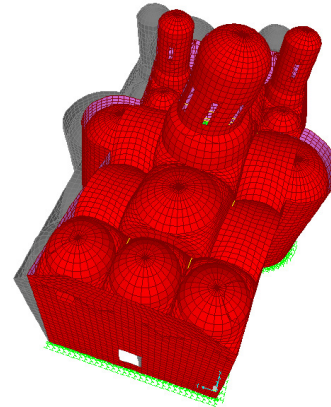
Figure 7b. 1st Translational eigen-mode y-y, $T_y = 0.197$ sec modal mass ratio $U_y = 60.26\%$

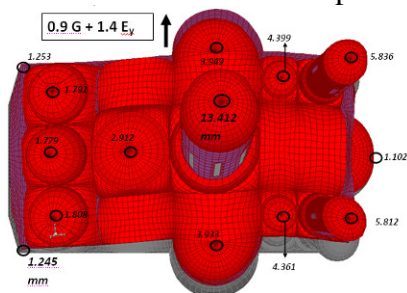
Figure 8a. $0.9G + 1.4E_y$, Non-Deformable Foundation Max. Disp. Top central dome 13.442mm

Next, the deformations of the structural system were obtained for both the non-deformable and the deformable foundation model. These were obtained for two sets of load combination. The first is designated as $0.9G + 1.4E_x$ and signifies the combination of the gravitational forces (G) with the seismic actions in the East-West (x-x) longitudinal direction. The seismic action was enforced by applying the dynamic spectral method with a design spectrum specified by the current Greek Seismic Code and for seismic Zone I and soil category A [10]. The second load combination is designated as $0.9G + 1.4E_y$ and signifies the combination of the gravitational forces (G) with the seismic actions in the North-South (y-y) transverse direction. The results are depicted in figures 8a to 8d.

Due to the foundation deformability the earthquake actions combined with the gravitational forces result in a considerable increase in the horizontal displacement response. This is more pronounced at the top of the peripheral wall where the vaults of the superstructure and roof are supported than at the top of the central dome level. At that level, the maximum displacement is equal to 14.710mm for the deformable foundation and 13.779mm for the non-deformable foundation for the load combination $0.9G+1.4E_x$. For the load combination $0.9G+1.4E_y$ the maximum displacement at the top of the central dome level is 13.442mm for the non-deformable foundation as compared with 14.640mm for the deformable foundation. Similar influence of the foundation deformability can also be observed in the maximum stress values that develop at either the peripheral walls, the internal transverse wall or at parts of the vaulting system of the superstructure.

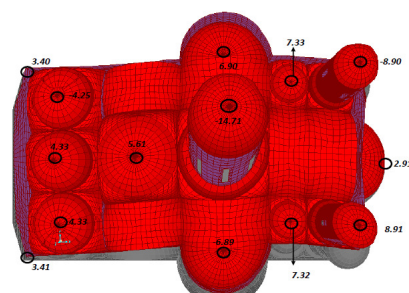
Figure 8b. $0.9G + 1.4E_y$, Deformable Foundation Max. Disp. Top central dome 14.640mm

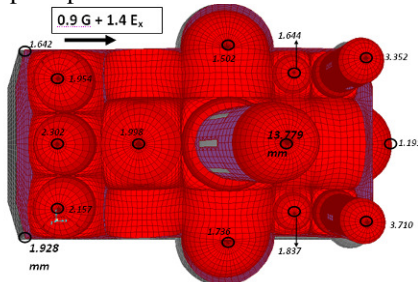
Figure 8c. $0.9G + 1.4E_x$ Non-Deformable Foundation Max. Disp. Top central dome 13.779mm

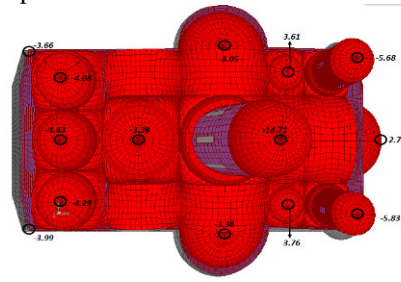
Figure 8d. $0.9G + 1.4E_x$ Deformable Foundation Max. Disp. Top central dome 14.710mm

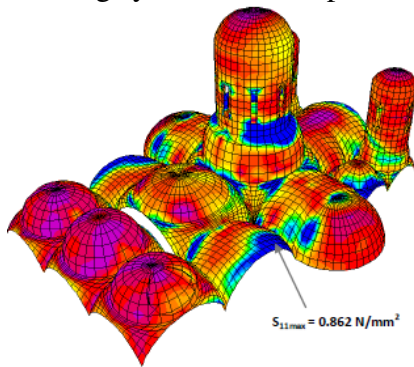
Figure 9a. $0.9G+1.4E_x$ Non-Deformable Foundation top face Max. Tensile σ_{11} 0.862Mpa

Figures 9a and 9b depict the tensile stress concentration at the outer (top) face of the vaulting system, as it results from either load combination $0.9G+1.4E_x$ or $0.9G+1.4E_y$. As can be seen, the foundation deformability increases the tensile stress demand at critical locations for the vaulting of the superstructure. This observation, which is based on the numerical results, is also supported by in-situ evidence of damage to the masonry parts of the vaulting system, as shown in figures 9c.

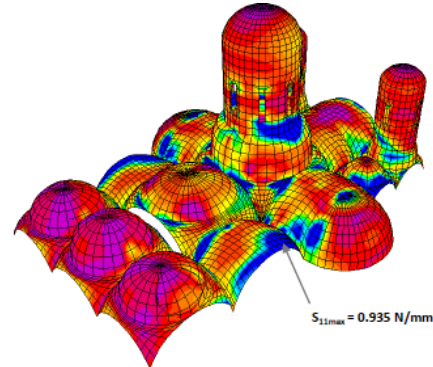
Figure 9b. $0.9G+1.4E_x$ Deformable Foundation top face Max. Tensile σ_{11} 0.935Mpa

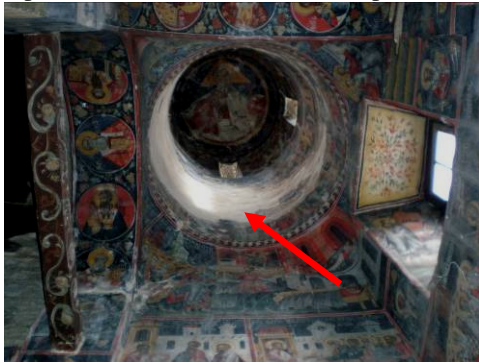
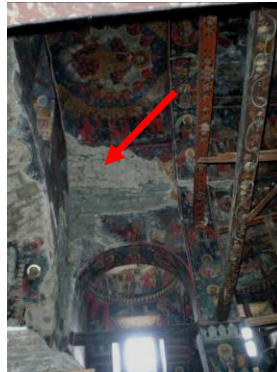
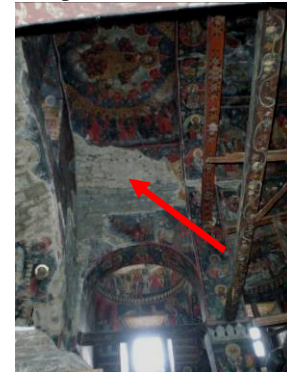
Figure 9c. Damage of the vaulting system

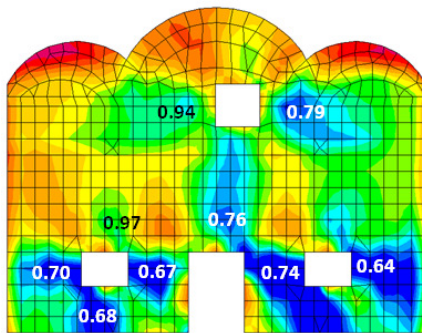
Figure 10a. Internal Transverse Wall, 0.9G+1.4Ey , Non-Deformable Foundation, Max in-plane shear stress strength / demand ratio R_τ

Figures 10a and 10b depict the R_τ ratio values of the in-plane shear strength / shear demand for the load combination 0.9G+1.4Ey. The structural element that these ratio values belonged to is the internal transverse wall which separates the main church from the women's quarters situated at the west portion of the church (see figures 5a). This wall as well as internal faces of all the peripheral walls, vaults and domes are decorated with very valuable frescos that bear signs of extensive damage (see figures 9 and 11).

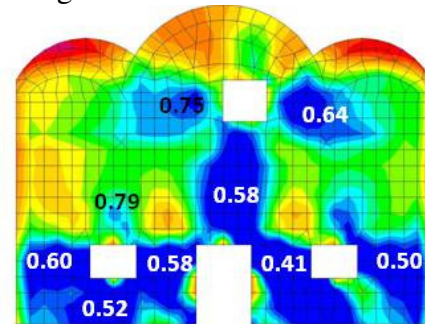
Figure 10b. Internal Transverse Wall, 0.9G+1.4Ey , Deformable Foundation, Max in-plane shear stress strength / demand ratio R_τ

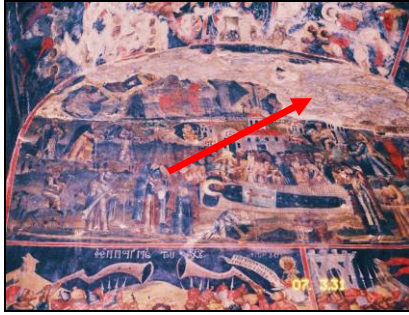
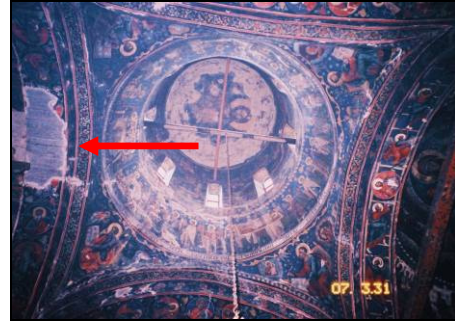
Figure 11. Damage of the Internal Transverse Wall and the adjacent arch

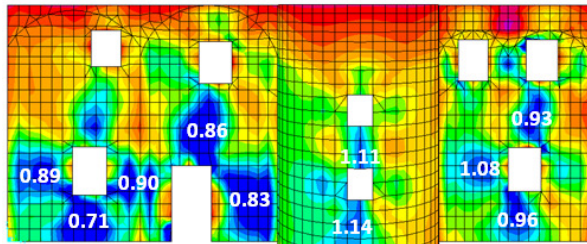
Figure 12a. Non-Deformable Foundation South Peripheral Longitudinal Wall, 0.9G+1.4Ex, Ratio values of R_{τ} in-plane shear strength / shear demand

This damage is also predicted by the numerical analysis results as can be seen from the strength / demand R_{τ} ratio values that are well below one ($R_{\tau} < 1$) in many locations (Figures 12a and 12b). Moreover, the deformability of the foundation leads this ratio to obtain even smaller values than for the case of the non-deformable foundation, which demonstrates the detrimental effect of the flexibility of the foundation for this church. The deformability of the foundation has such an effect in almost all peripheral walls; this can be established by either comparing the values of the in-plane shear strength / demand ratio R_{τ} (figures 12a and 12b) or the out-of-plane tensile strength / demand ratio R_M (see figures 13a and 13b), that is also visible at the outer face (figures 14).

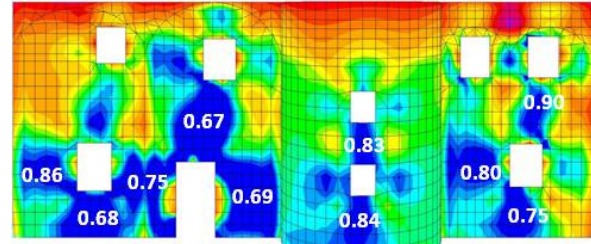
Figure 12b. Deformable Foundation South Peripheral Longitudinal Wall, 0.9G+1.4Ex, Ratio values of R_{τ} in-plane shear strength / shear demand

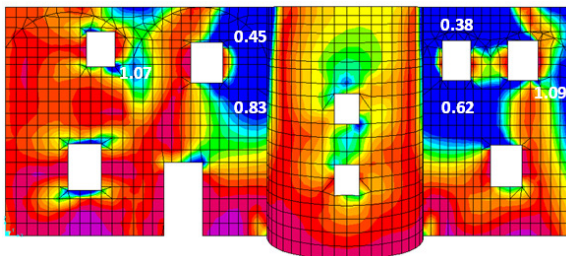
Figure 13a. Non-Deformable Foundation South Peripheral Wall, 0.9G+1.4Ey, Ratio values of R_M out-of-plane σ_{11} normal strength / demand (Top face)

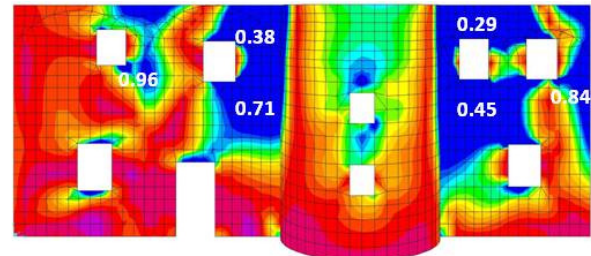
Figure 13b. Deformable Foundation South Peripheral Wall, 0.9G+1.4Ey, Ratio values of R_M out-of-plane σ_{11} normal strength / demand (Top face)

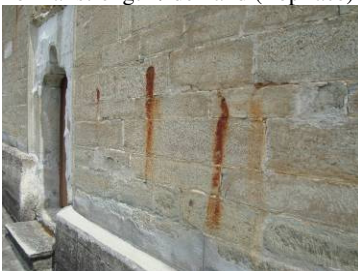
Figure 14. Damage of the peripheral masonry walls.

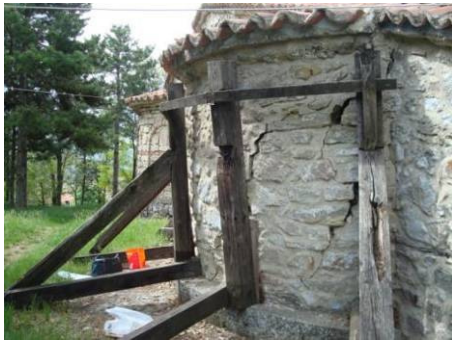
Figure 16a. Extensive cracking of the apse at the East wall

The horizontal dimensions of this church are 23.25m in length and 16.60m in width. The top of the roof lies at 7.1m from the floor level of the interior of this church. The naves are formed by 4-column colonnades (figures 15a and 15b) built with stone masonry. The lower part of the key of each arch of these colonnades lies at 5.25m from the floor level of the interior of this church. All the exterior walls are made of stone masonry. Apart from the main church a narthex was built at the North side at a later stage; this narthex is of a lower height than the main church. The West part of the church is allocated to the women quarters that is separated from the rest of the interior by a mid- transverse wall (figure 15d). The South longitudinal wall is supported by a system of wooden beams as is shown in figure 15c. These were installed after the Kozani-1995 earthquake sequence. Additional wooden supports are also placed at the mid-transverse wall (figure 15d) as well as at the mid-span of a longitudinal beam that spans the women quarters from East-West. According to past records, the structural system of this church showed signs of distress from soil-settlement sometime before the occurrence of this particular earthquake sequence. The records do not give information of any countermeasures being taken in the past up to the point of the earthquake occurrence. The main structural damage, as recorded after this earthquake sequence, is described below. Inclination of the South longitudinal wall outwards that is accompanied with extensive cracking at its joints with the East and West exterior masonry walls as well as with the mid-transverse wall. Extensive cracking is also evident at the East wall with the apses (figure 16a) and at the arches of the colonnades (figure 16b). Despite the fact that 18 years have passed since this earthquake damage, the counter measures so far are in the form of the temporary wooden shoring as well as the renovation of the wooden roof.

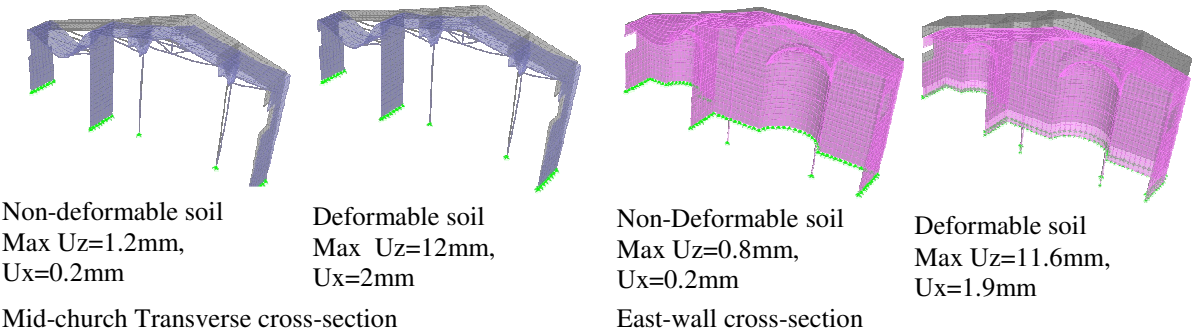
Figure 18. Deformations for gravitational forces (Non-deformable / Deformable foundation)

All the numerical simulations assumed elastic behaviour with relatively low-values of the modulus of elasticity for the stone masonry equal to $E=1660\text{MPa}$. The thickness of the masonry walls varied from 0.75m to 1.0m. The system of the wooden roof was modeled as well as all the wooden elements that connect the longitudinal and transverse walls with the interior colonnades and the mid-transverse wall. Figure 18 depicts the numerical predictions of the displacement response of this church when it is subjected to only gravitational loads

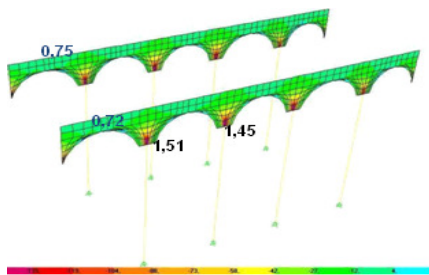
Figure 19a. G+0.3Q. Non-Deformable soil \mathbf{R}_σ Ratio of in-plane strength / demand $\mathbf{F22}$ (KN/m) normal to bed joint

These R_{σ} ratio values of in-plane strength / demand applying the limit tensile strength scenario, either normal to bed-joint (F_{22}) or parallel to bed-joint (F_{11}) are depicted in figures 19a to 19d for the masonry arches above the internal colonnades. The demands in these figures were obtained for the load combination G+0.3Q. As can be seen from these figures the R_{σ} ratio values are smaller for the deformable than the non-deformable foundation, which demonstrates the detrimental effect of the foundation deformability for this church even only for the gravitational forces.

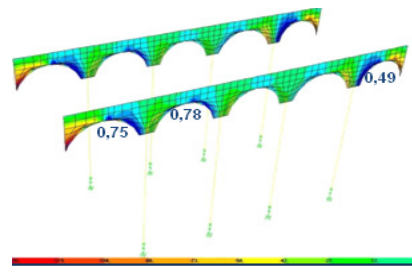
Figure 19b. G+0.3Q. Deformable soil Ratio \mathbf{R}_σ of in-plane strength / demand $\mathbf{F22}$ (KN/m) normal to bed joint

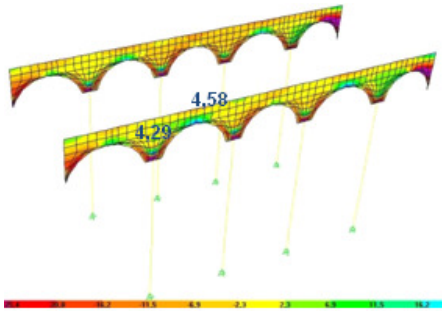
Figure 19c. G+0.3Q. Non-Deformable soil R_{σ} Ratio of in-plane strength / demand F_{11} (KN/m) parallel to bed joint

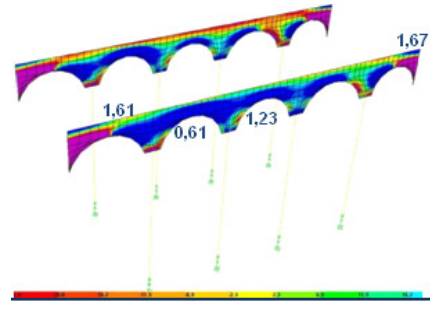
Figure 19d. G+0.3Q. Deformable soil R_{σ} Ratio of in-plane strength / demand F_{11} (KN/m) parallel to bed joint

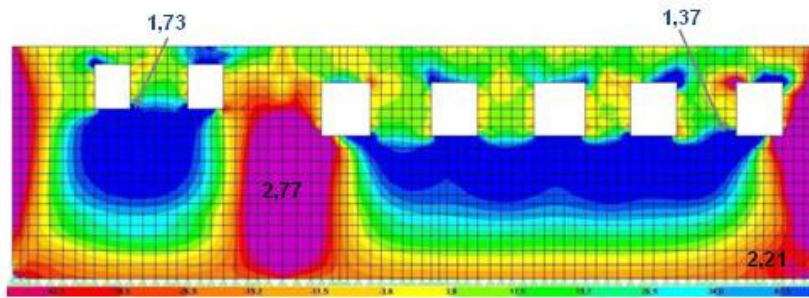
Figure 20a. Non-Deformable soil 0.9G+1.4E_y. R_M Ratio out-of-plane strength / demand σ_{11} (KN/m²) Outer-face.

dynamic spectral analysis as will be explained below. In figures 20a and 20b the R_M ratio out-of-plane strength / demand (σ_{11}) (KN/m^2) are depicted. The numerical simulation was repeated to include the seismic actions in the form of dynamic spectral analysis utilising the design spectrum derived by applying the provisions of the current Greek Seismic code for seismic zone I, soil category B and importance factor 1.3 [10] .

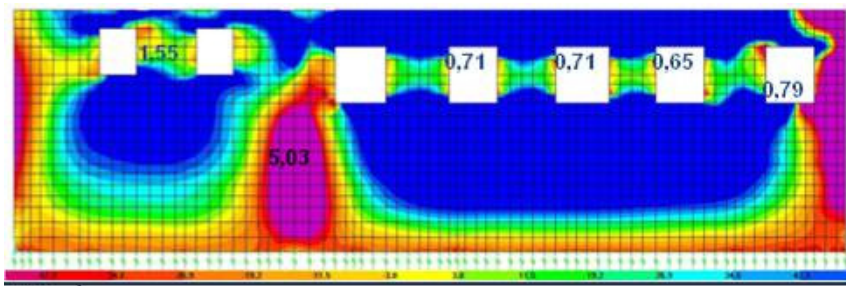
Figure 20b. Deformable soil 0.9G+1.4E_y. R_M Ratio out-of-plane strength / demand σ_{11} (KN/m²) Outer-face.

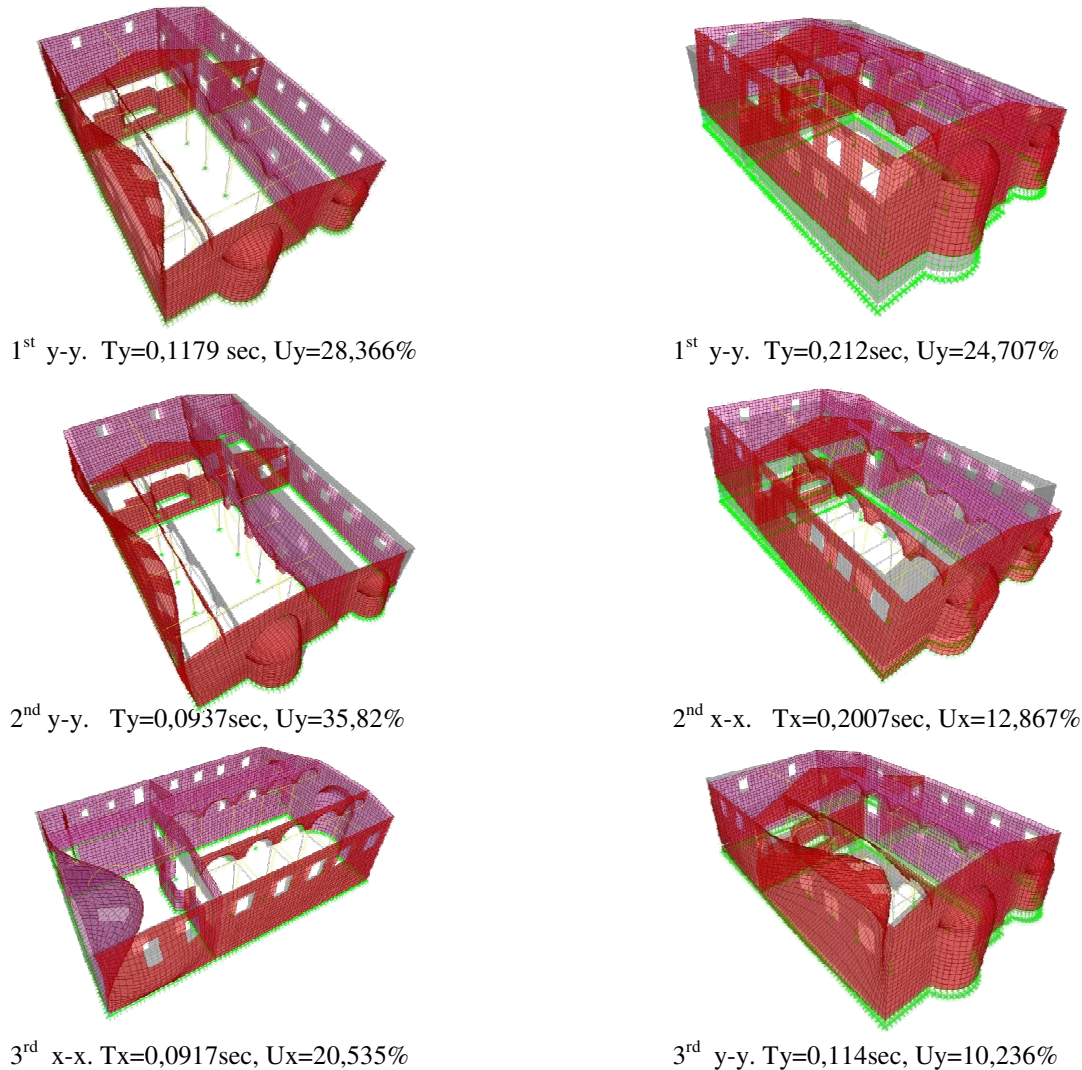
Figure 21. The most significant eigen-modes for the non-deformable and the deformable foundation together with the values of the corresponding eigen-frequencies and modal mass participation ratios.

This dynamic spectral analysis was based on a sufficient number of eigen-modes capable of mobilising sums of modal mass larger than 65% of the total mass of the structure. Figures 21 depict the most significant translational x-x and y-y eigen-modes together with their corresponding eigen-period and modal mass ratio values. This is done for both the non-deformable as well as the deformable foundation numerical models. As was also observed previously, the modal analysis results demonstrate the first effect of the deformable foundation which is the lengthening of the eigen-periods of the most significant translational modes.

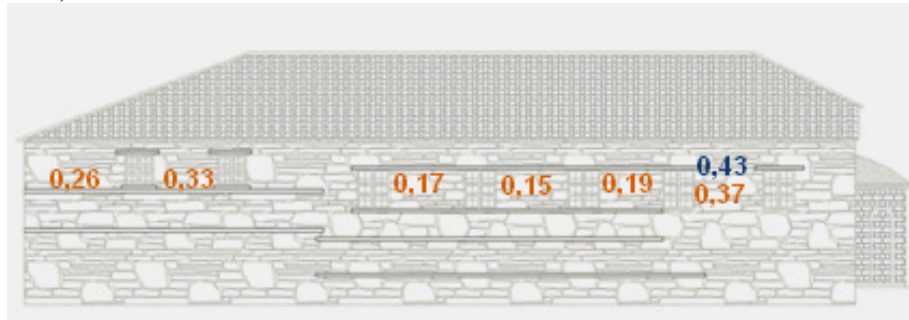
Figure 22. South Peripheral Wall. Regions with small values of the strength / demand R_M out-of-plane tensile behaviour (orange), R_σ in-plane tensile behaviour (blue)

Such an evaluation has been performed for the most vulnerable structural elements of this church; that is the internal colonnades, the South and North peripheral walls and the East peripheral wall with the apses. The predictions by the numerical analysis of potential damage regions is indicated with the strength / demand ratio values well below one ($R_\tau, R_\sigma, R_M < 1$). These predictions are depicted in figure 22 through the values of ratio R_σ (in-plane tensile behaviour, blue), ratio R_M (out-of-plane tensile behaviour, orange). In almost all structural elements the out-of-plane tensile behaviour results in strength / demand ratios with values well below one ($R_M < 1$). The smallest R_M ratio value appears at the South longitudinal peripheral wall and is approximately equal to $R_M = 0.15$. The average value of this R_M ratio obtained by averaging the corresponding values at six (6) different locations well spread over the entire length of this wall is equal to 0.245. This strongly indicates that the existing capacity of this wall in out-of-plane bending is exceeded fourfold by the corresponding demands. It is not surprising that this wall has visible signs of out-of-plane displacements that are in agreement with such a state of distress, as predicted by the followed methodology.

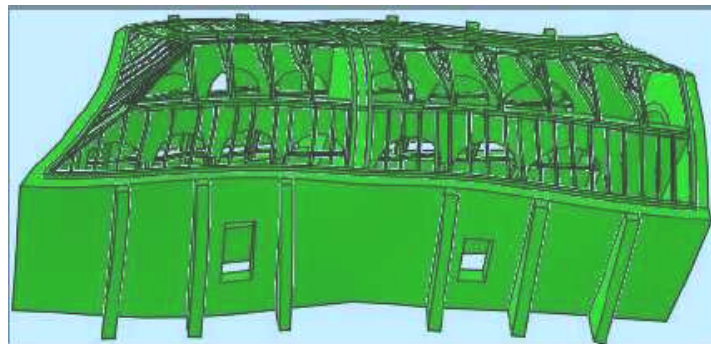
Figure 24a. 2nd x-x Translational eigen-mode. $T_x=0,2013\text{sec}$, $U_x=38,5\%$

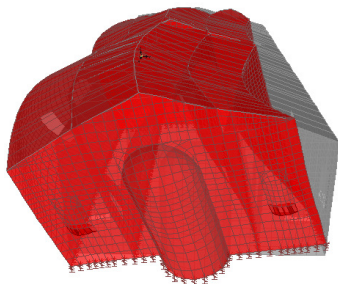
Figure 24b. Present condition, deformable foundation, Main Transversal y-y eigen-mode, $T_y = 0,326\text{sec}$ $U_y=61,62\%$

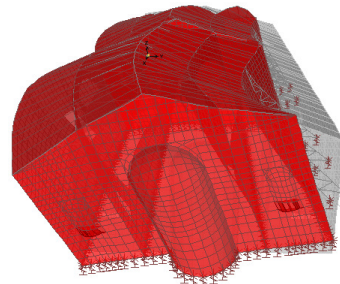
Figure 24c. Retrofitted with seimi-permanent shoring. Deformable foundation, Main Transversal y-y eigen-mode, $T_y = 0,263\text{sec}$ $U_y=68.17\%$

Semi-permanent shoring must be designed and constructed respecting the principle of reversibility. Moreover, it can be combined with the rest of the reversible techniques mentioned above, taking into consideration environmental influences. Such a retrofitting scheme is currently being investigated to be applied at Agios Dimitrios at Palatitsia Imathias, a 16th century three-nave Basilica. This church is 27.10m long on its South side and 22.15m long on its North side with an average width 12.625m. The height from the ground level to the top of the roof is 6.75m (figure 23). The studied retrofitting scheme consists of a system of semi-temporary external shoring of the longitudinal peripheral walls together with the upgrading of the wooden roof, the replacement of the internal wooden ties and the addition of new metal ties as well as mortar injections for all stone masonry. The performance of such a retrofitting scheme was investigated numerically by a full dynamic analysis (figures 24) employing the methodology described in sections 2, 3 and 4.

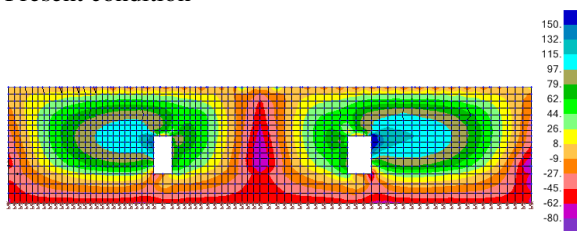
Figure 25a. South Longitudinal Wall, G+0.30Q+Ey Present condition, deformable foundation, σ_{22} (kN/m², Kpa)- normal stress - Bottom face.

This retrofitting scheme in the current investigation takes a variety of alternative forms. The numerical results so far provide sufficient evidence that such a retrofitting scheme can be quite effective in upgrading the performance of the various stone masonry elements in such a way that the strength / demands ratio values R_r in-plane shear, R_σ in-plane tension, and R_M out-of-plane tensile flexure, described in sections 2, 3 and 4 before, obtain values larger than the corresponding values for the current state of stress before any intervention. The objective of the current study is for these strength / demands ratio values to reach the threshold value of 1, ideally at all critical locations, thus signifying acceptable performance. Typical results are shown in figures 25 for the out-of-plane σ_{22} demands. This is done for both the existing condition (figure 25a) as well as for the condition after the previously described retrofitting scheme is applied (figure 25b). The existing state of stress includes large areas in the vicinity of the window openings with considerable tensile stress concentration exceeding the strength values, thus indicating potential structural damage regions. The introduction of the proposed retrofitting resulted in a considerable decrease of these out-of-plane σ_{22} demands. This decrease in the demands when combined with an increase in the strength values, achieved from injecting the stone masonry with compatible mortar, results in values of the strength / demands ratios (R_r in-plane shear, R_σ in-plane tension, and R_M out-of-plane tensile flexure) nearing the threshold value of one, thus satisfying the objective of the retrofitting scheme.

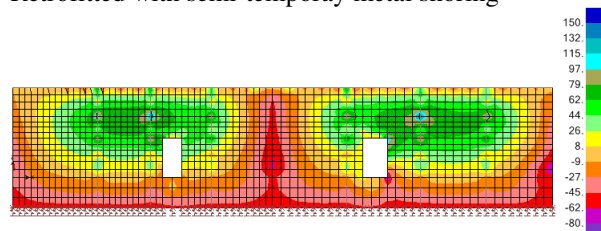
Figure 25b. South Longitudinal Wall, G+0.30Q+Ey Retrofitted with semi-temporay metal shoring, deformable foundation, σ_{22} (kN/m², Kpa)- normal stress - Bottom face.

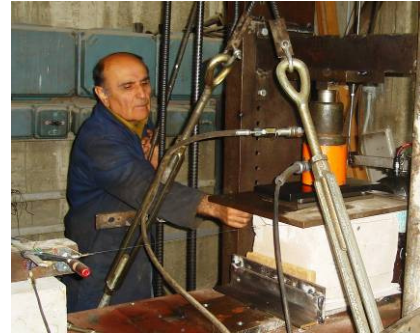
Figure 26b. Experimental set-up

A number of stone masonry specimens were built at the laboratory using lime mortar and natural stones. The lime mortar had such a composition as to be representative of old relatively weak mortars commonly used in the past. A series of such samples were tested accompanied by constant compression with variable shear as shown in figure 26b. This set-up was designed in an effort to record the shear force at a limit state which represented the failure of the mortar bed-joint as depicted in figures 26c,d. Based on these experimental results, the

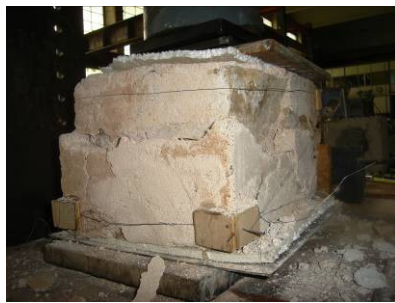
Figure 26c. Sliding mode of failure

the mortar bed-joint as depicted in figures 26c,d. Based on these experimental results, the Mohr-Coulomb limit state criterion (figure 26a, equation 1) can be approximately quantified.

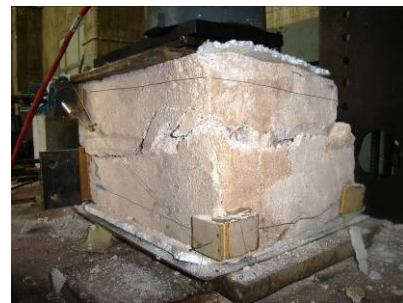
Figure 26d. Sliding mode of failure
