DYNAMIC IDENTIFICATION AND EVALUATION OF THE SEISMIC SAFETY OF A MASONRY BELL TOWER IN THE SOUTH OF ITALY

**Domenico Colapietro¹, Alessandra Fiore², Adriana Netti², Fabio Fatiguso¹,
Giuseppe C. Marano², Mariella De Fino⁴, Davide Cascella³, Antonio Ancona¹**

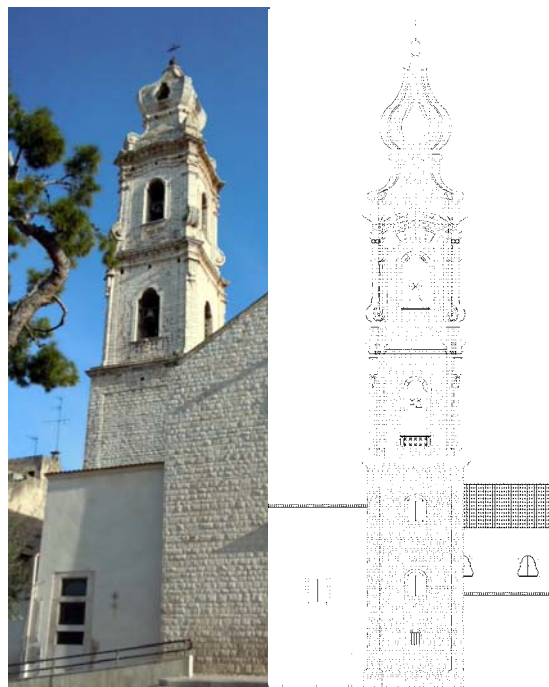
Figure 1: Bell Tower of “Santa Maria di San Luca”

It has a square cross-section with a side of 6.25 m and rises up with a simple and massive tower structure characterized by a rusticated stone exterior just sketched. Its height is 46 m. Internally, in the bottom portion, it was divided into three parts (respectively to the shares of 0, 4.74 and 9.55 m), characterized by barrel vaults in hewn stone limestone. The top portion is divided into three compartments by floors with steel beams and brick tiles covered by concrete. The first block is a simple polyhedral volume with a few decorative episodes, which tend to be enriched with friezes; among them, the most significant one goes from the bottom to the top; the corners bend, digging; they extend out in a continuous movement. The simplicity of the initial part gives way to sophistication. The Romanesque style is overwhelmed by the baroque style. The second block is surmounted by a sandwiched crown by a frame bluish of majolica, windows appears the ogival arch. The third bin is composed of a cockpit to cusp, surmounted by a sphere with metal cross.

The tower is constituted by two different kinds of masonry typology: basement is in hewn stone with good weaving while an upper block is in square stone. It shows a fair state of conservation, even if some superficial cracks and damage patterns occur, due to exposure to at-

The bell tower of “Santa Maria di San Luca” (Figure 1), in the city center of Valenzano in southern Italy, was built in 1774 beside of the seventeenth century church in the Franciscan convent.

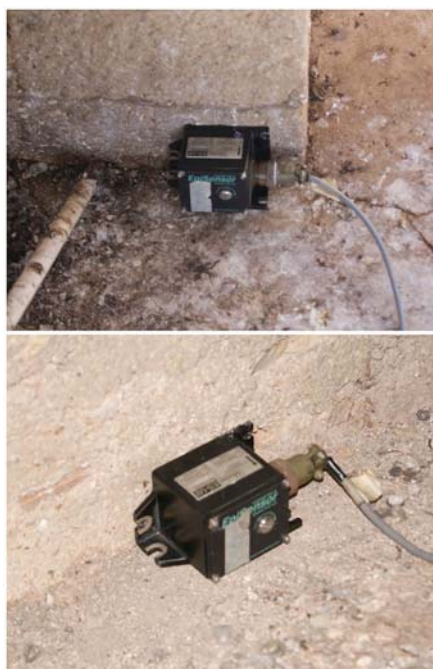
Figure 5: Location of the vibration sensors

The instrumentation used for dynamic monitoring included a data acquisition system (THOR, www.waveng.it) based on force-balance accelerometers (EpiSensor ES-U2 Kinematics) (Figure 5). It is able to manage more distributed sensor networks with real-time acquisition and data processing for structural analyses.
