## EARTHQUAKE BEHAVIOR OF HISTORICAL MINARETS IN ISTANBUL

**Keywords:** Minarets, Dynamic Analysis, Non-linear Modeling, Istanbul, Earthquake Response

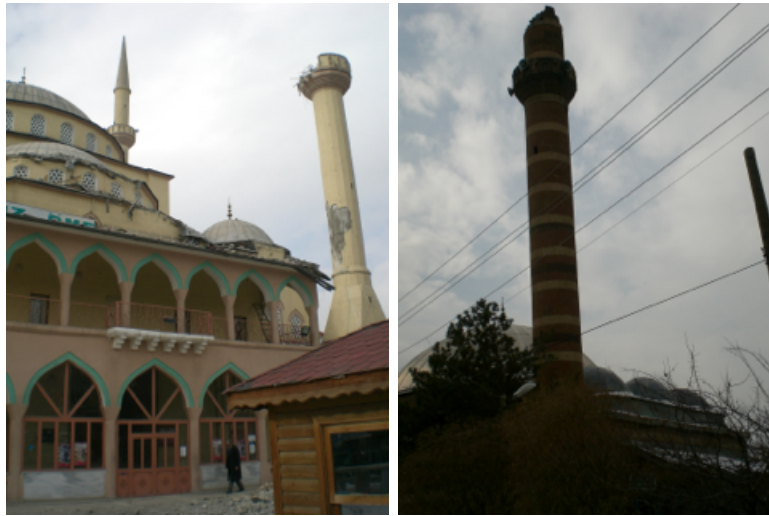
Figure 2: Minaret damage during the 23 October 2011 Van, Turkey earthquake

The most recent earthquake, in which minaret damage took place, is the 23 October 2011 Van earthquake. There was widespread damage to the mosques and their minarets. Both masonry and reinforced concrete minarets collapsed in the Van earthquake. Of 194 mosques surveyed in the Van province, 17% received heavy damage, 31% had medium damage and 30% light damage. The majority of them are not historical. Of 76 minarets, affected by the earthquake, 50 had to be demolished as they had either collapsed or had received damage beyond repair. 26 minarets were repaired. The location of the failure in the minarets that received heavy damage during the Van earthquake was mostly found to be at the region near the bottom of the cylinder, where a transition was made from a circular to a square section or where the minaret connects to the adjacent building or is part of it at the lower section. 360° planar cracks at this region were common. The majority of collapses occurred due to failure around

the balcony. Circular cracks along the body and cracks in the pulpit were also common. In Figure 2 images of damaged minarets are shown.

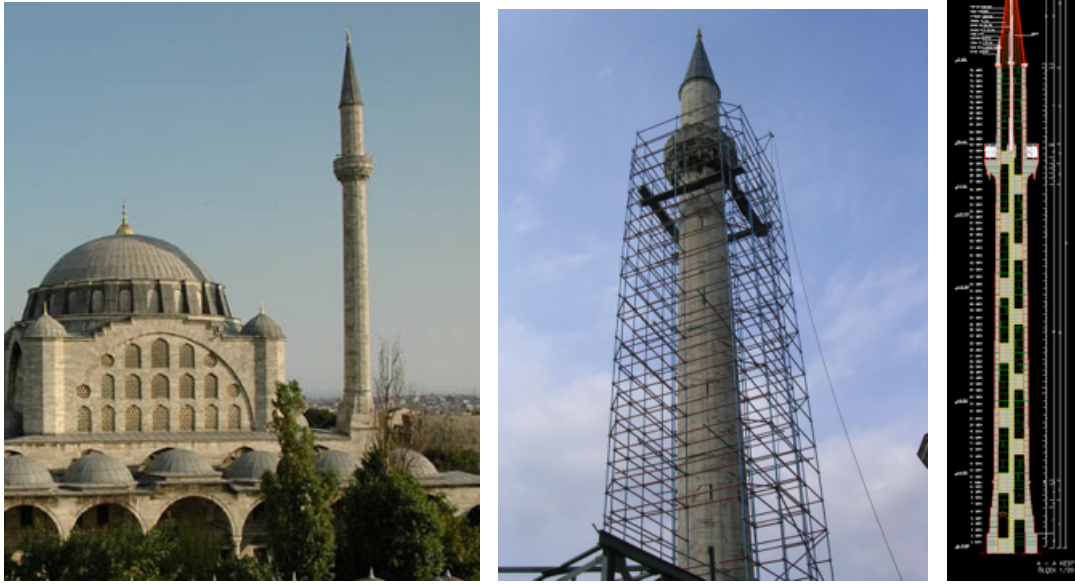
Figure 5: Mihrimah Sultan Mosque (left), its minaret before its disassemblage (center), cross-section of the minaret (right).

The 39.86m tall minaret of the Mihrimah Sultan Mosque is of cut-stone masonry. It received damage during the 1719 earthquake. Its upper 18-step section had to be repaired. It collapsed as a result of earthquakes of 1766 and 1894. An image of the minaret taken after the 1894 earthquake and before its repair in 1907 can be seen in Figure 6. During the recent restoration works, the section of the minaret above the transition segment (küp) was completely disassembled and was rebuilt following the original geometry with new stones [9].

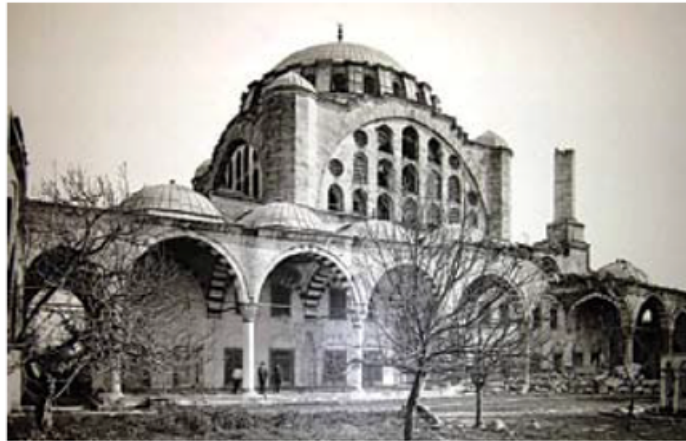
Figure 6: Image of Mihrimah Sultan Mosque with the minaret that collapsed in the 1894 earthquake, from the period between 1894 and 1907 [10].

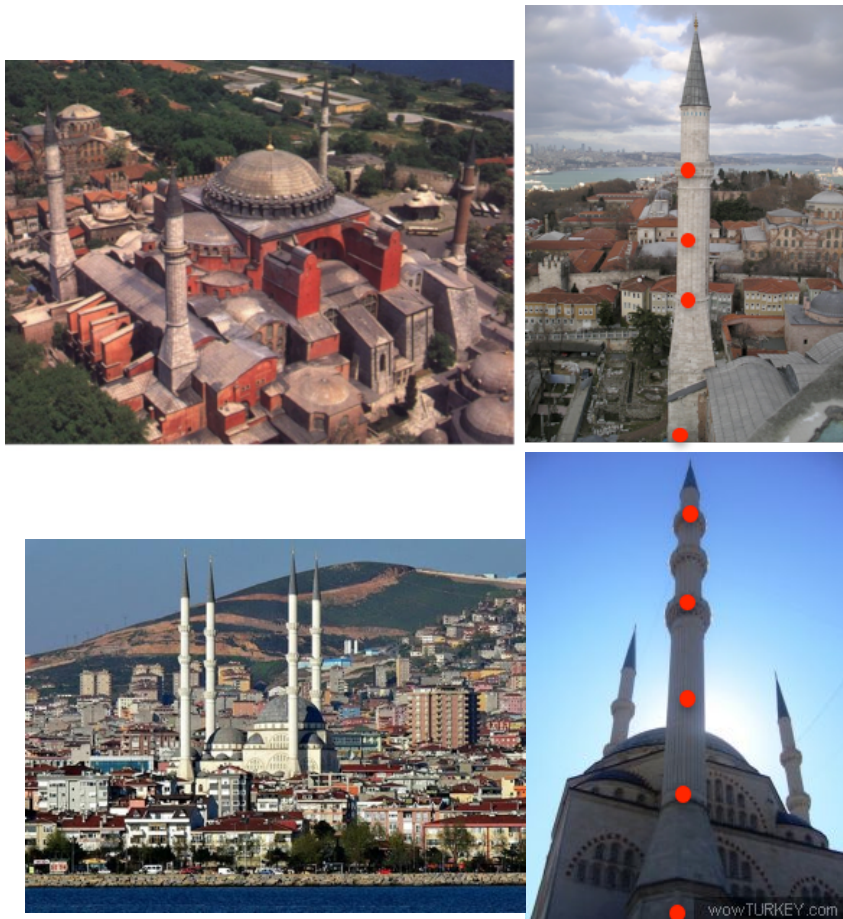
Figure 11: Strong motion instrumentation for the minarets of the Hagia Sophia Museum (top) and of the Maltepe Mosque (bottom).

We will install permanent structural earthquake monitoring networks in two minarets. One system will be installed in one of the Sinan minarets of the Hagia Sophia Museum. The other will be in one of the four minarets of the Maltepe Mosque. Maltepe Mosque has the tallest and most slender minarets among the ones that we have studied. Figure 11 illustrates foreseen systems.
