## SEISMIC EVALUATION OF THE HISTORIC CHURCH OF ST.NICHOLAS IN PIRAEUS BEFORE AND AFTER INTERVENTIONS

Constantine C. Spyrakos<sup>1</sup>, Alessio Francioso<sup>1</sup>, Panagiotis Kiriakopoulos<sup>1</sup>,  
and Stavros Papoutsellis<sup>1</sup>

<sup>1</sup>Laboratory for Earthquake Engineering, School of Civil Engineering  
National Technical University of Athens  
Zografos 15700, Athens, Greece  
e-mail: [cspyrakos@central.ntua.gr](mailto:cspyrakos@central.ntua.gr)

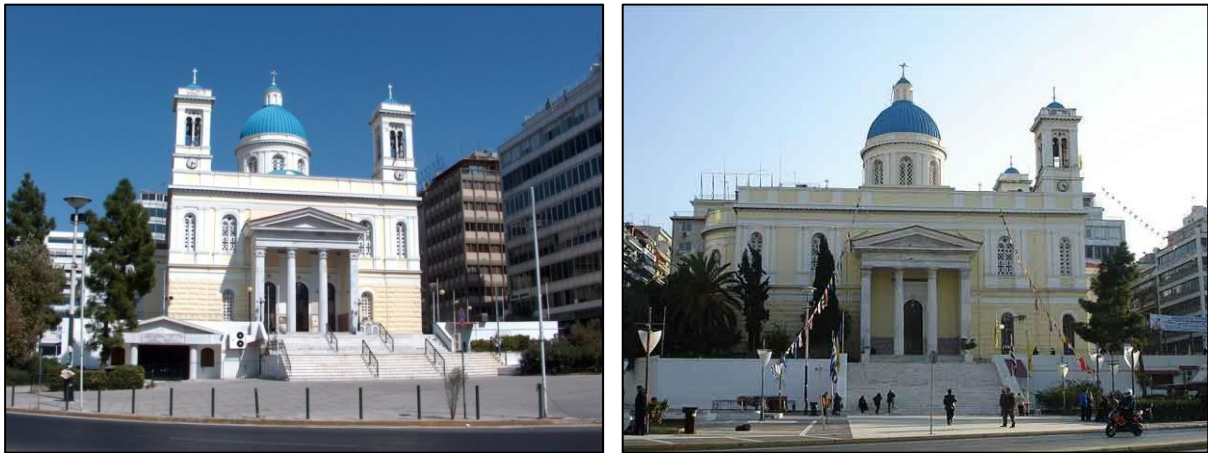
Figure 1. a) West façade and b) North façade of the church

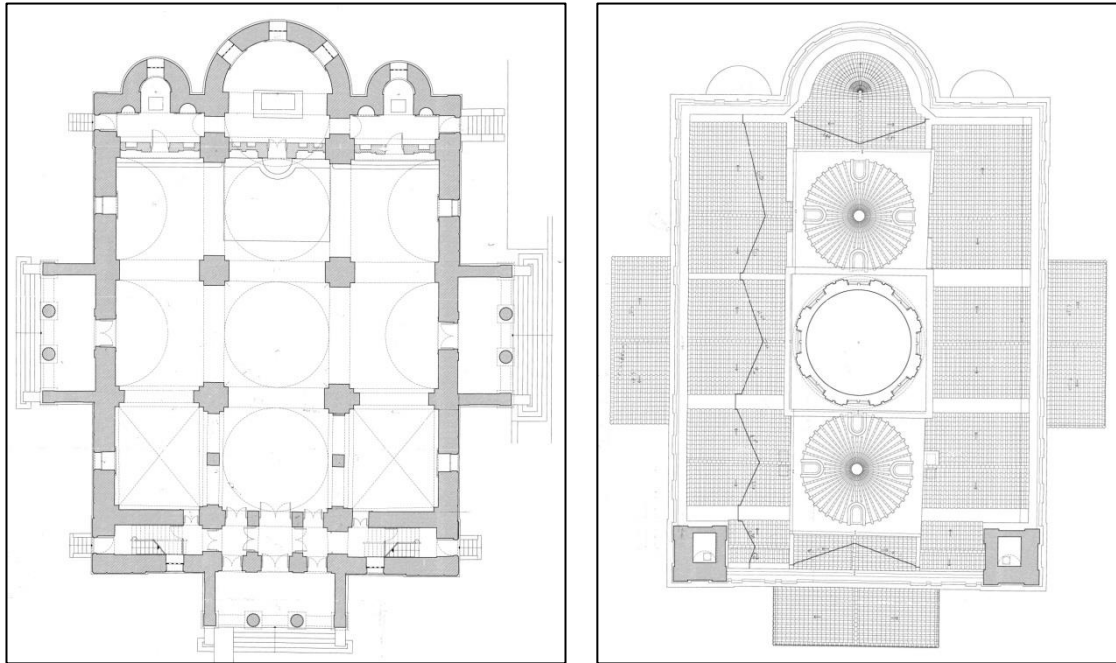
Figure 3. a) Ground floor plan. b) Roof plan

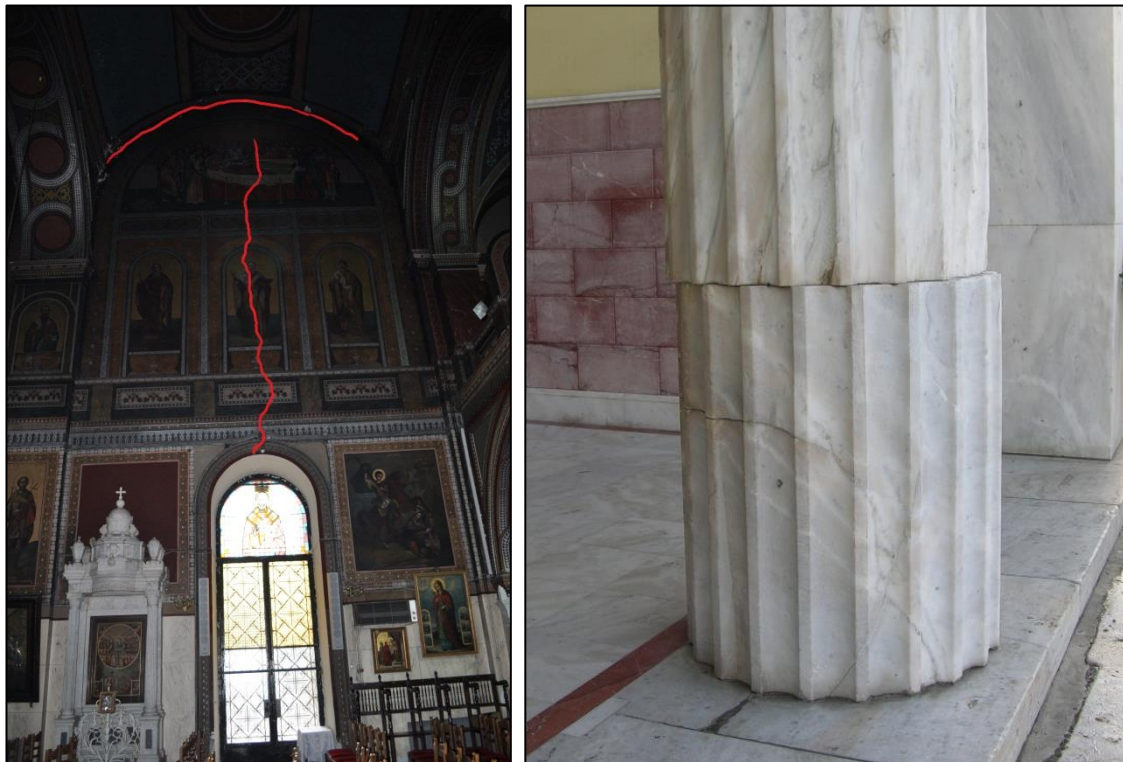
Figure 4. a) Through crack and detachment of lower drum at the southern part of the structure. b) Sliding of drum of a marble pillar caused by bombardment

Over the years the building has undergone several modifications until recent earthquakes (the Alkyonides 1981 and the Athens 1999) caused serious damages to the structure. The damages are mainly attributed to the fact that no special consideration was given in the initial design for seismic loads. Cracks appear in many parts of the masonry structure and mainly at the intrados of arches and vaults in the longitudinal and transverse directions.

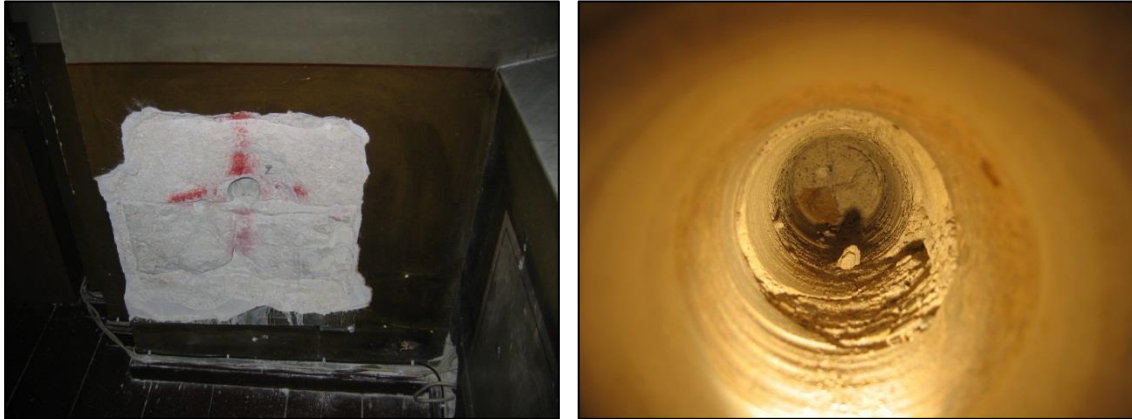
Drilled holes were opened in order to investigate by means of an endoscope the composition of the masonry walls along their thickness (Figure 5). The inspections revealed that the masonry walls were made of three-leaf masonry.

Figure 5. a) Area without plaster for inspection with endoscope. b) View inside the drilled hole

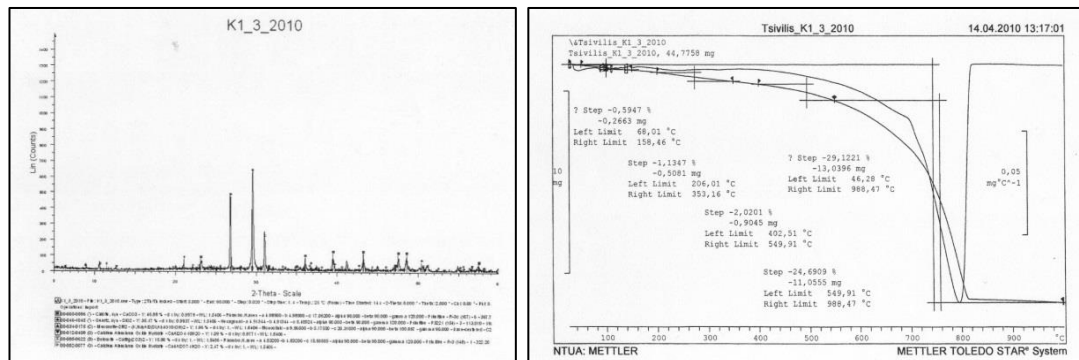
Mortar samples were analyzed following a three-step procedure: natural separation of mortar-stone, X-Ray diffraction and thermal analysis TG-DTG (Figure 6).

Figure 6. a) X-Ray analysis results. b) Thermal analysis results

The measurements and their analysis showed that: (i) the mortar contains natural hydraulic lime; (ii) the aggregate is a mixture of limestone, dolomitic and silica sands; (iii) the mortar contains muscovite.

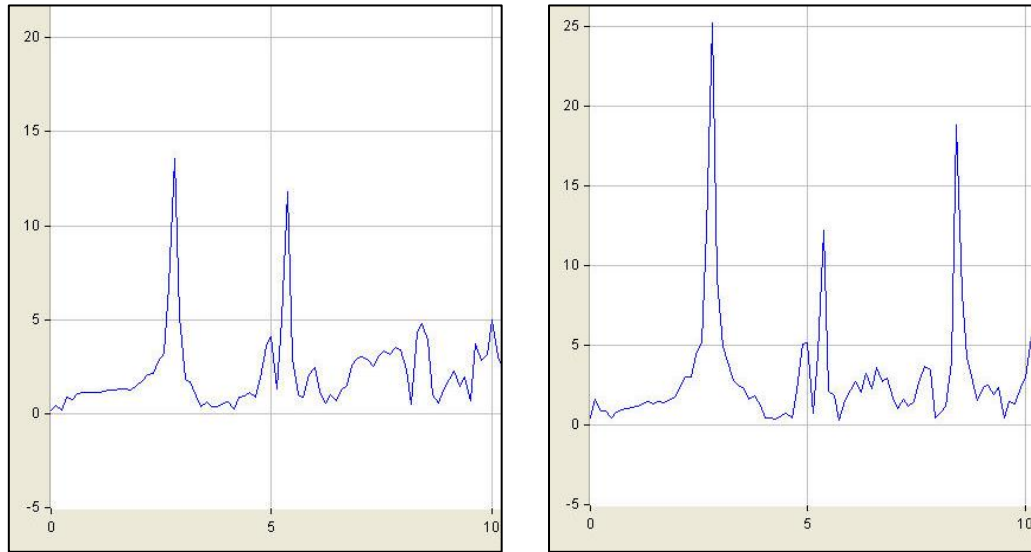
Table 1 presents the peaks of the Fourier spectra (see Figure 7) obtained from the ambient testing measurements.

Figure 7. Transverse direction X (N-S): a) at mezzanine; b) at dome level

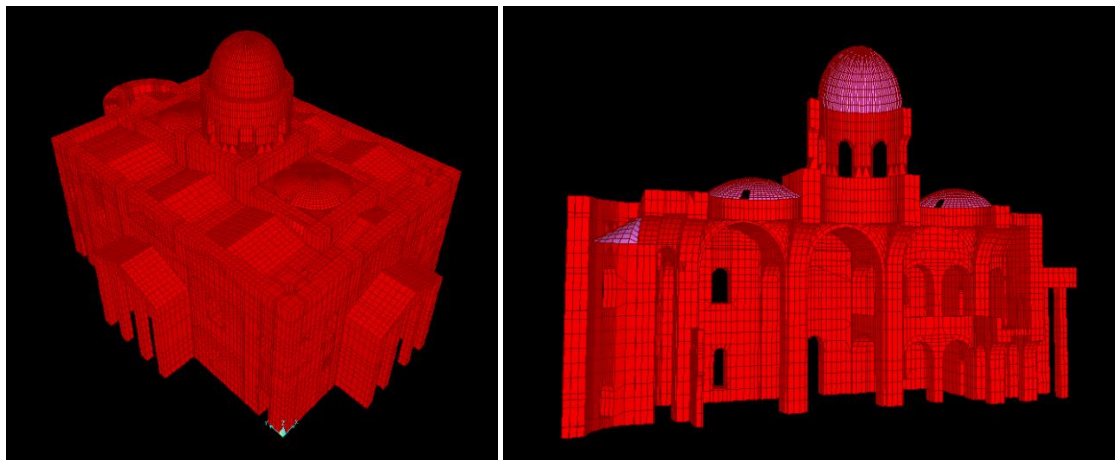
The structural model and the global analysis of the structure were performed with the finite element software SAP2000 v.15 [3]. The stone masonry and marble elements were modeled with eight node solid elements with three degrees-of-freedom per node, while four-node shell elements were used to model the central dome. Frame elements were used for the proper connection and collaboration of solid and shell elements [4]. The final model consists of 42180 solids, 3350 shells, 96 frame elements and 63580 nodes, see Figure 8.

Figure 8. Three dimensional model: a) N-W view b) E-W section

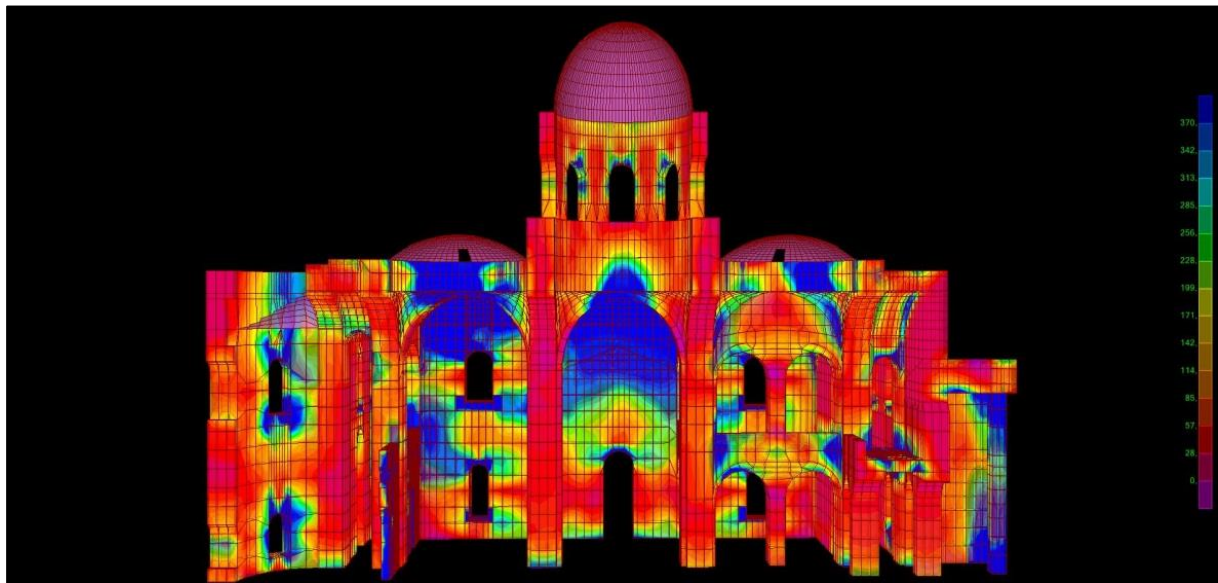
The representative Figure 9 shows the stress distribution for a seismic combination. Deep blue (darkest color) indicates the areas where the developed stresses are greater than the tensile strength of masonry. A detailed presentation of the results and the corresponding figures are provided in [7]. It is worth noting that the analysis identified with good accuracy the areas where critical damages were identified from the visual inspection.

Figure 9. Stress distribution S22 for the  $E_x+0.3E_y+0.3E_z$  combination

Comparison between Table 3 and Table 5 clearly indicates the decrease of the modal periods after the interventions. According to the results of response spectrum analysis applied to the strengthened structure, it was observed that excess of the tensile strength (10% of the compressive strength of masonry) is limited at "secondary" places of the masonry walls for the seismic load combinations. Figure 16 showing the stresses after interventions corresponds to Figure 9.

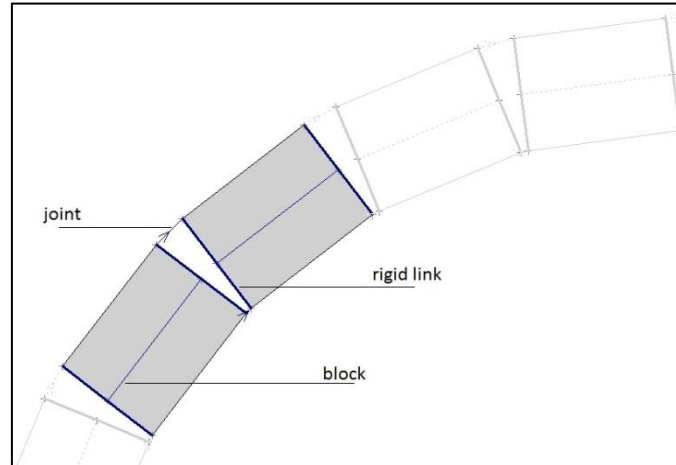
A realistic approach to analyze these systems is to model the arches as a set of blocks and joints. The approach is known as the “blocks and joints” method [9]. As shown in Figure 10, both blocks and joints are frame elements: the blocks have the mechanical properties of the stone and their cross section is the effective cross section of the arch, the joints represent the mortar between the blocks. Four joints for each block are used; therefore, the joint cross section is  $\frac{1}{4}$  of the arch cross section. The joints have a pin-end and a fixed-end, the fixed-end provides continuity with the previous block, the pin-end transfers shear and axial force to the next block, while the joints are connected to the block ends through rigid links; in this manner the system transfers moment, shear and axial force from one block to another.

Figure 10. Structural model of an arch

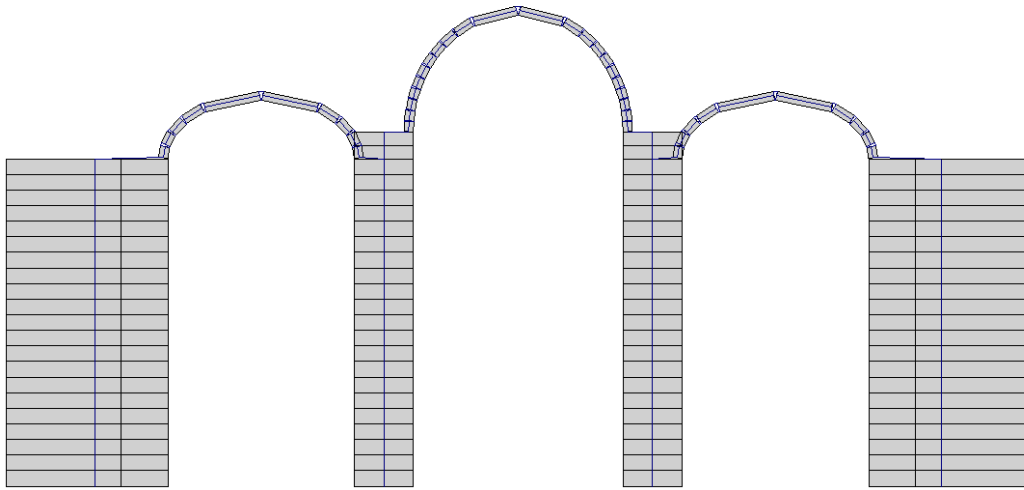
The analyzed macroelement consists of three arches and four piers arranged along an alignment in the transverse direction of the church. The model and the analysis were performed with the aid of the software Aedes PC.E [9]. The model shown in Figure 11 consists of 604 frame elements and 488 nodes. For each node the rotation around the vertical Z axis is restrained, while the nodes at the base of the piers are fully fixed.

Figure 11. Structural model of the analyzed macroelement

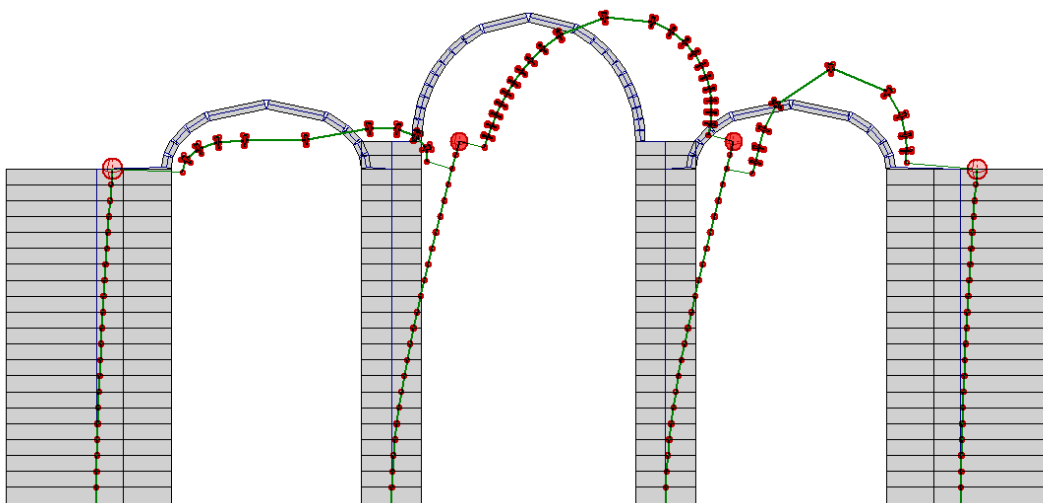
Figure 12 shows the deformed shape of the first mode of vibration, with the red spheres representing the mass associated to each node. The fundamental period of the structure is  $0.544 \text{ s}$  and the associated participating mass is  $58\%$  as obtained from modal analysis.

Figure 12. Deformed shape of the fundamental mode of vibration

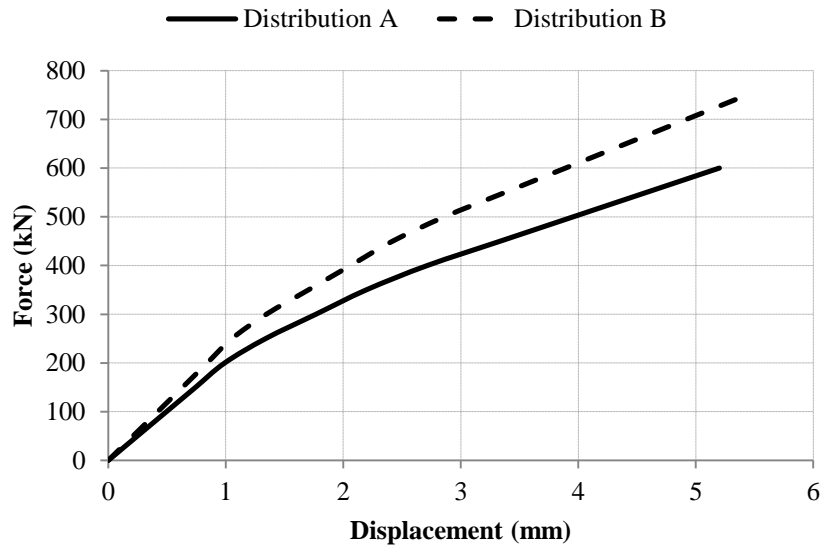
Figure 13 shows the capacity curves of the structure at the initial state, obtained for the load distributions A and B. In the first case the structure reaches an unstable configuration for a lateral force equal to 600 kN, while with the load distribution B the maximum lateral force the structure can sustain is 750 kN.

Figure 13. Capacity curves of the structure at initial state

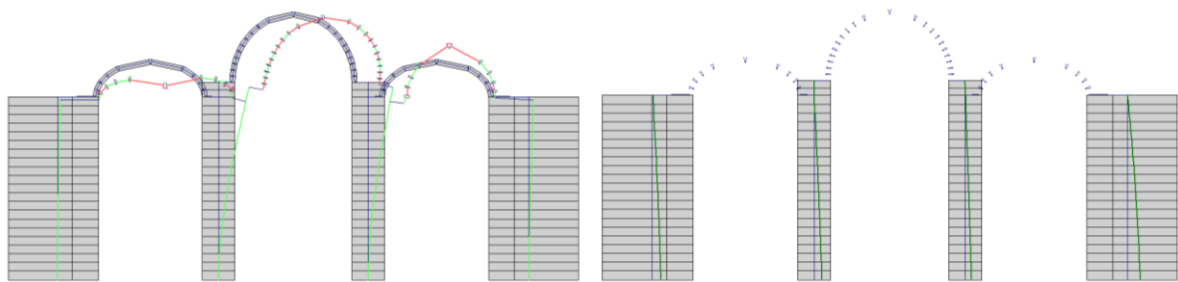
The results from the “triangular” distribution of the lateral forces, being more severe, will be used for safety evaluation of the structure. Figure 14 shows the deformed shape and the position of the pressure curve at the last step of the pushover analysis for the distribution A.

Figure 14. a) Deformed shape and b) pressure curve at last step of curve A

The deformed shape reveals the position of the plastic hinges that developed in the arches for joint degradation between the blocks. The pressure curve remains internal to the cross section of the piers; therefore, no plastic hinges develop in that area.

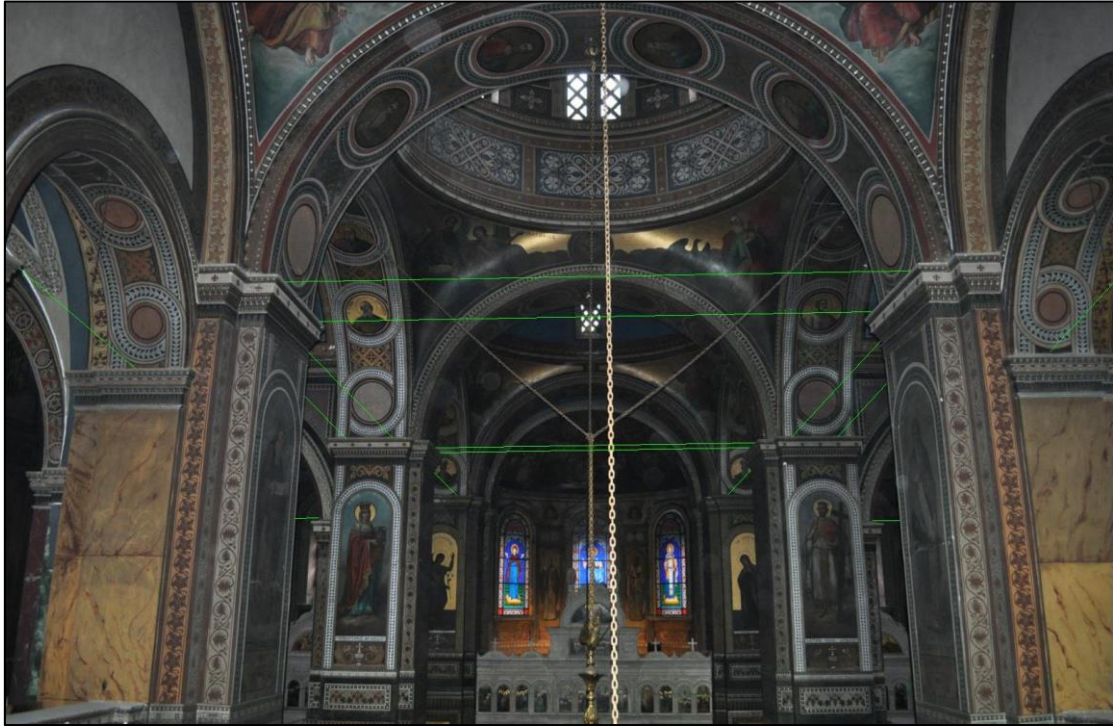
Also stainless steel tie-rods F430 with a diameter of 40mm were placed at the upper part of the arches in the interior of the church. The mechanical properties of the tie-rods are: modulus of elasticity  $E_c = 200 \text{ GPa}$ , yield strength  $f_y = 379 \text{ MPa}$  and ultimate strength  $f_u = 552 \text{ MPa}$ .

Figure 15. Position of the steel tie-rods

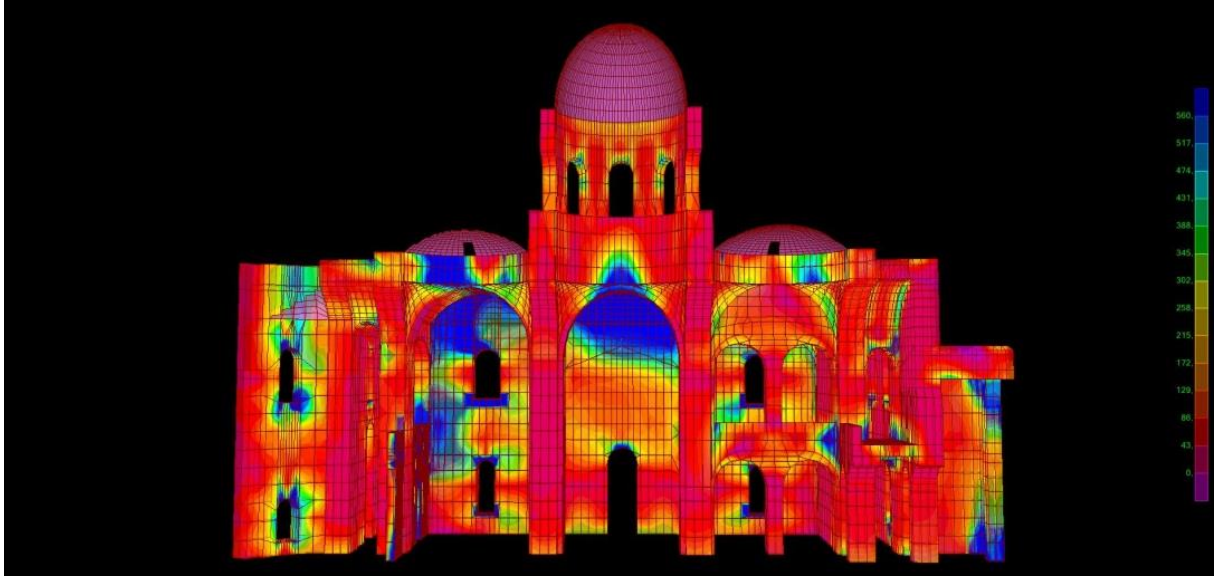
Figure 16. Stress distribution S22 for the  $E_x+0.3E_y+0.3E_z$  combination
