ANALYSIS AND DESIGN OF STAIRCASES AGAINST SEISMIC LOADINGS

Keywords: Staircases, Space Structure, Multistory Building, Earthquake, Vertical Component of Earthquake, Finite Element Analysis.

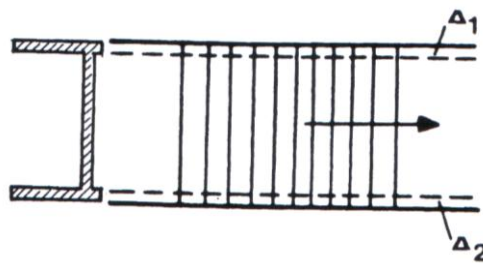
Figure 2: Stairs whose steps are supported on two girders.

Staircases constitute a very important part of a structure, both architecturally and aesthetically, as well as structurally. They appear in different shapes and forms, each requiring its own method of analysis [1-2]. Regarding their structural configuration stairs usually fall in one of the following categories: a) Stairs with cantilever steps that are supported on a shear wall along the stair. b) Stairs whose steps are supported on a slab (Figure 1). In this case, the slab with its two landings constitutes one structure with one or three branches. c) Stairs whose steps are supported on two girders, like simply supported beams (Figure 2). d) Stairs with free standing landings, with branches perpendicular or parallel to each other (in plan view) (Figure 3). e) Helical stairs (Figure 4) which are supported on the slabs of the upper and lower floors, without intermediate supports.

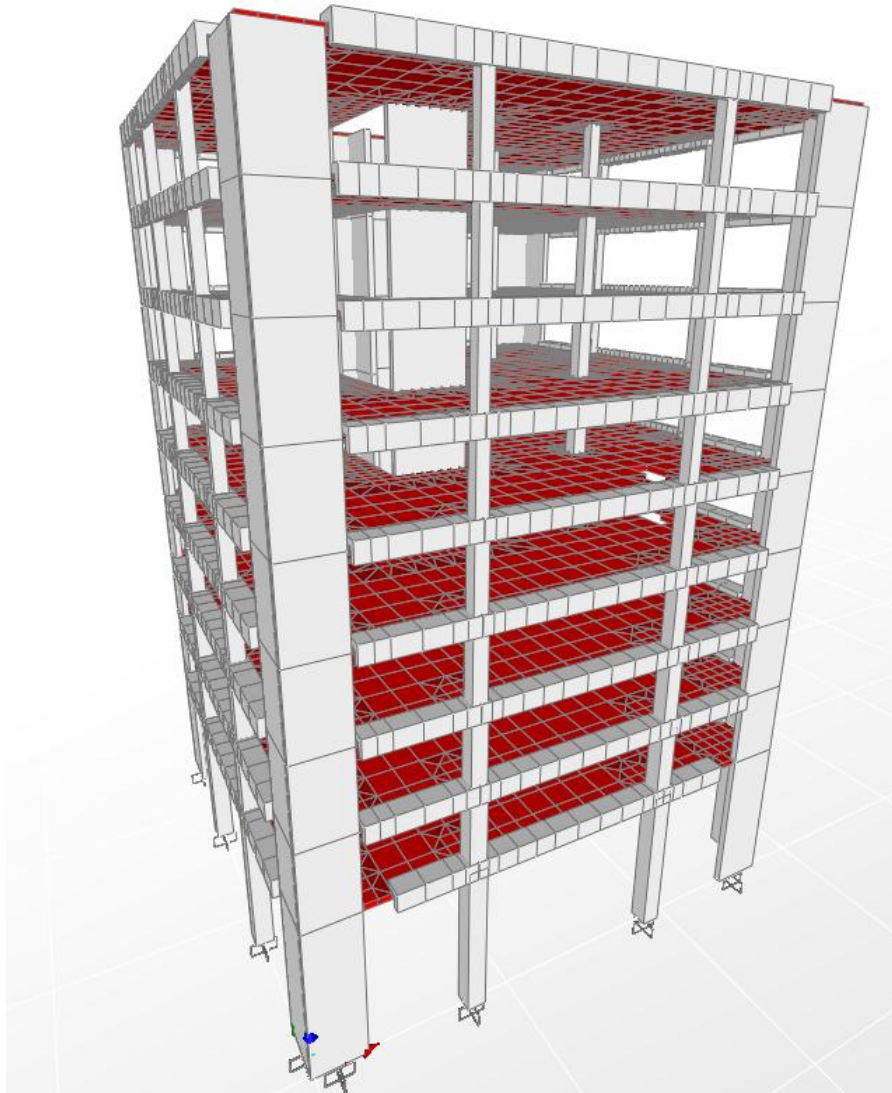
Figure 10: 3D model of the typical building studied in this investigation.

The modeling and the analysis of the structure was accomplished with the help of the finite element environment SAP2000 [6]. The three dimensional model of the structure that was formed is shown in Figure 10.

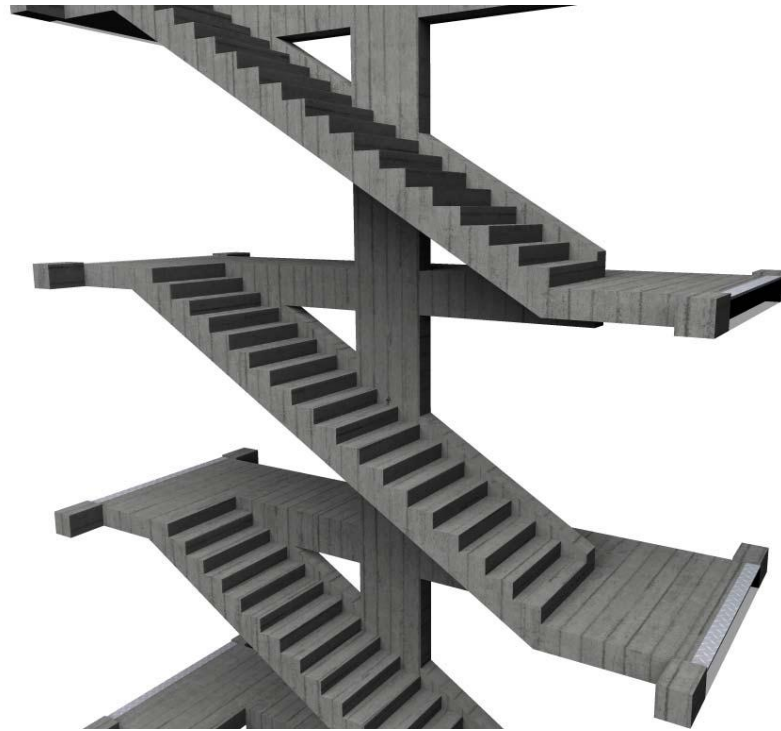
Figure 24: 3D view of the 2nd alternative proposal.

In this study, two alternative solutions, regarding the structural system of the staircase are proposed. In the first (Figures 21 and 22), two supporting columns (with a cross section of dimensions 90cm by 25cm) at the ends of the staircase are proposed. At the floor levels a beam (with a cross section of dimensions 120cm by 50cm) is constructed, on which the corridor-cantilever is supported. In addition, another beam is constructed (with a cross section of dimensions 220cm by 50cm), which has the same slope as the staircase, and on which the steps are fixed. With this solution enough stiffness is supplied by the columns in the direction x-x (i.e., the direction of the staircase). Therefore, and in order to prevent the transversal displacements it is proposed the introduction of seismic stoppers. These are four short cantilevers, of dimensions 30cm x 50cm with a height equal to 30cm, on both sides of the staircase, that are supported (with fixed supports) on the two buildings. With this scheme the central staircase becomes independent. Moreover, seismic joints between the staircase and the two buildings are added. The width of these joints is calculated from the seismic displacements of the two buildings and is equal to 15cm.
