NUMERICAL MODELLING, ANALYSIS AND RETROFIT OF THE HISTORICAL MASONRY BUILDING “LA SAPIENZA”

S. Caprili¹, F. Mangini¹ and W. Salvatore¹

¹ Department of Civil and Industrial Engineering, University of Pisa
Largo L. Lazzarino 1, 56122 Pisa, Italy

Keywords: Cultural heritage, masonry building, vulnerability assessment, structural safety

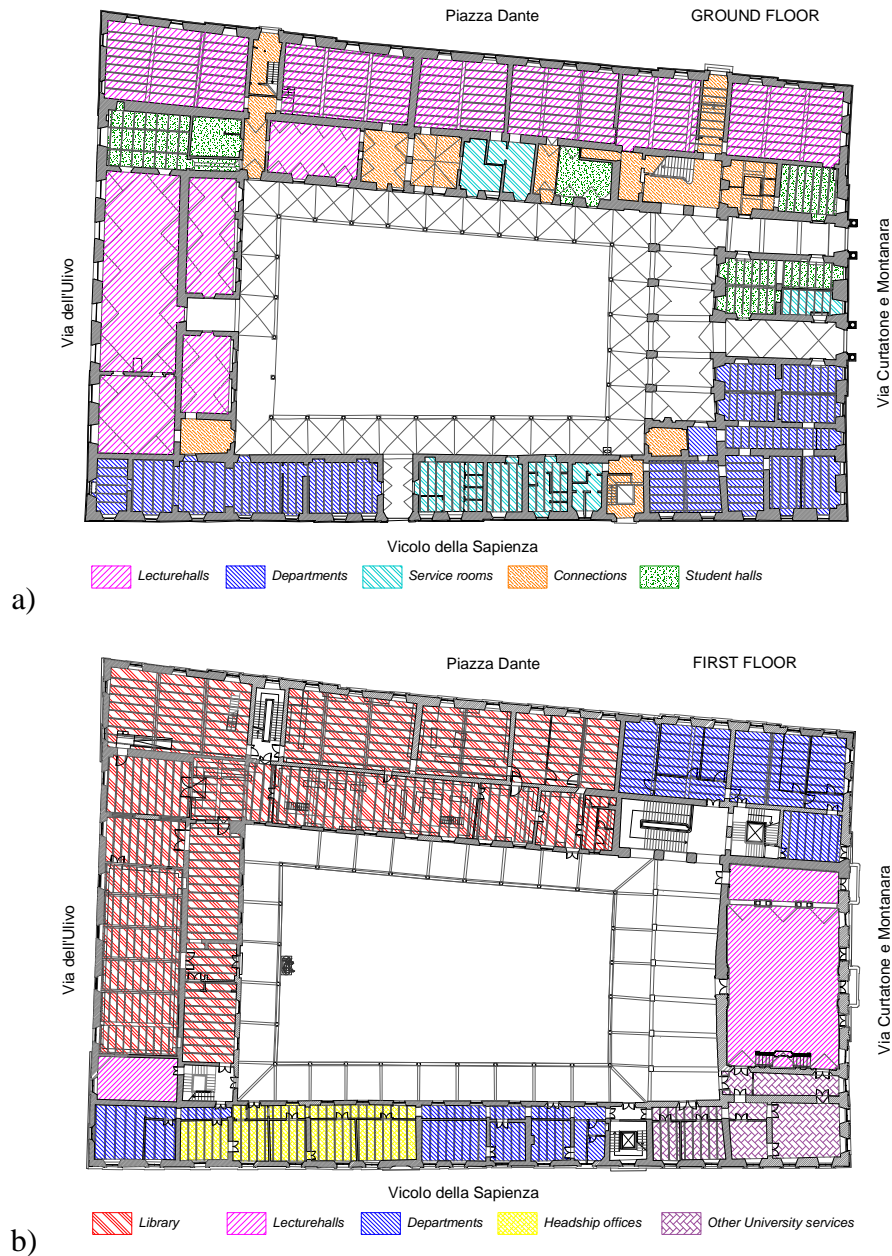
Figure 3: Plans of a) ground floor, b) first and c) second floor with indication of the activities housed.

ground floor), houses the University Library, which takes up the entire surface area of two sides of the building (along Piazza Dante square and Vicolo dell'Ulivo). The University Library also covers nearly the entire second floor, in part overlying the first floor sections, in part along the opposite side (along Via della Sapienza). Mezzanine floors and loft structures are, moreover, present in correspondence of the first and second floor of the library. The general plans of the building, with the indication of the different activities carried out, are presented in the Figure 3.

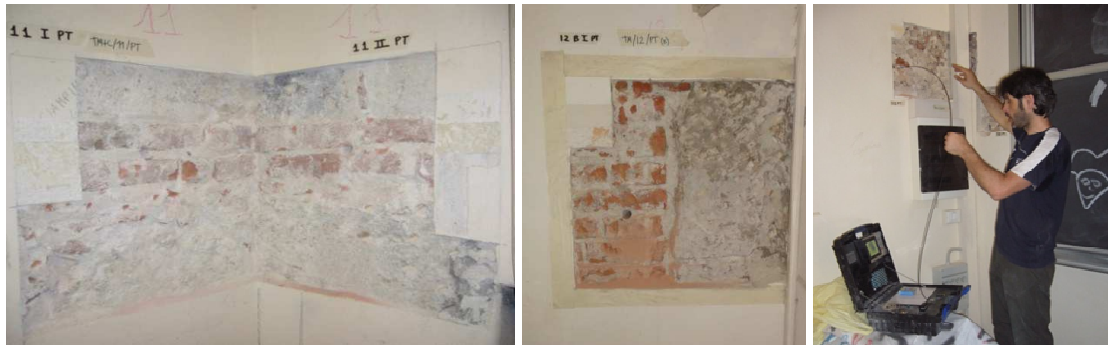
Figure 4: Execution of in situ investigations on masonry walls.

The masonry patterns were investigated by removing 50x50 cm plaster surface with following endoscopic examinations (Figure 4), necessary to determine the presence of air spaces or adjacent facings of different thickness and type. The studies revealed the presence of 5 different types of masonry patterns (i.e. full brick, full brick and split stone, stone with brick courses, etc.) and the absence of suitable connections between perpendicular walls. The distribution of the different masonry typologies present in the building's various floors was reconstructed bearing in mind the results of the historical analysis (Figure 5). In general, the different types of masonry corresponded to the different historical stages of the building's construction and modification; for example, the area at the corner between Via Curtatone e Montanara and Via della Sapienza, originated from the building's medieval walls and tower-houses, revealed greater complexity and heterogeneity, as well as already evidenced during the historical analysis. Three experimental flat jacks tests were then executed on three different masonry typologies to determine the compressive strength of the material and to estimate the effective actual stress state on vertical elements.

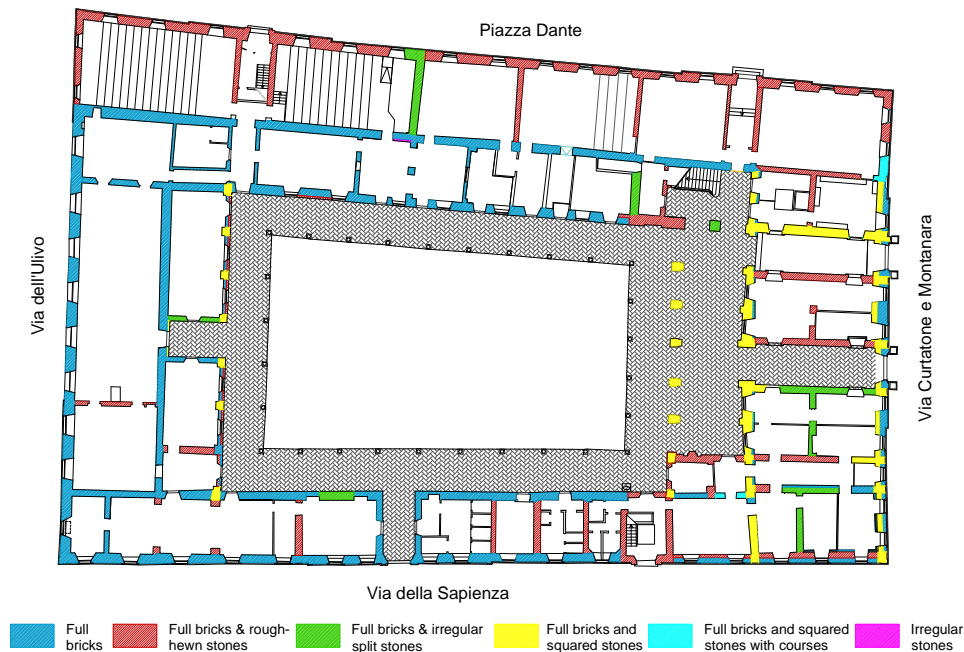
Figure 5: Plan of ground floor with indications of the various types of masonry

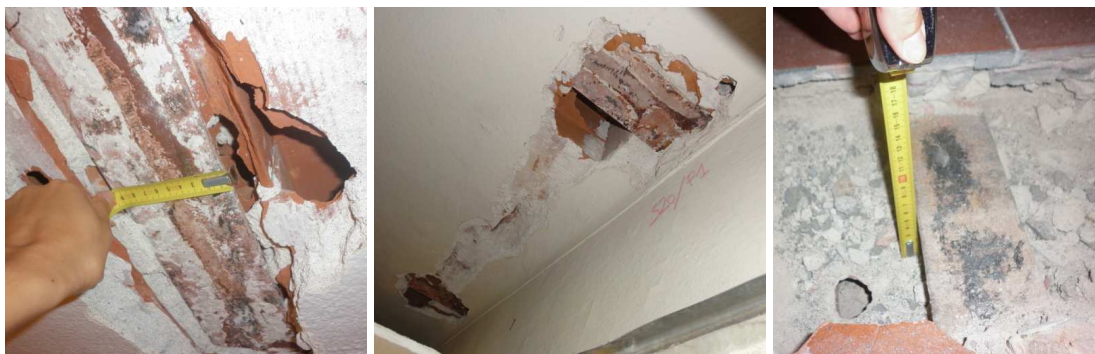
Figure 6: Execution of in situ investigations on horizontal floors with steel elements.

Similar investigations (removal of plaster and endoscopic analyses) were also executed on vaulted surfaces, in order to define the masonry typology, the disposition of blocks and the total thickness of the filling materials. The direct in situ survey of horizontal storeys allowed the determination of the steel profiles' dimensions and of the thickness of the slabs and flooring, necessary to estimate of the effective dead load (Figure 6).
