## LASER SCANNING, MODELING, AND ANALYSIS FOR DAMAGE ASSESSMENT AND RESTORATION OF HISTORICAL STRUCTURES

**Keywords:** Earthquakes, finite elements, historic buildings, laser scanning, structural assessment, seismic analysis and retrofit.

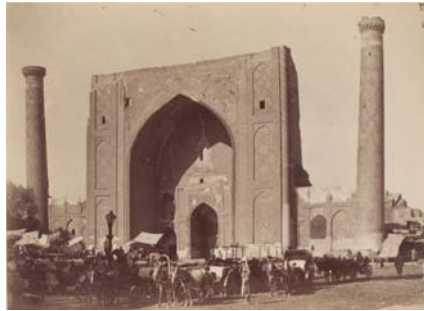
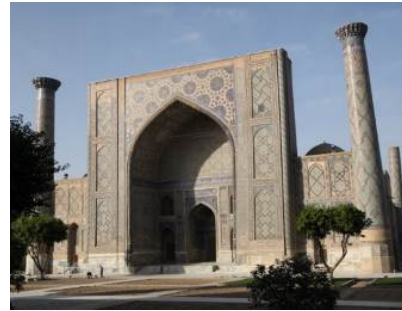
Fig. 2. Main entrance of the Ulugh Beg Madrasah

(a) View in 1890 (after [6])

(b) Current view

As a result of all restoration efforts (shown in Figs. 2(b), 3(b), and 4(b)), the current condition of the ensemble is significantly better than it used to be in the late 19th century. Nevertheless, there are evidences of structural anomalies in the ensemble's monuments. For example, a visual observation reveals the following: 1) A large crack in the dome of Tilya-Kori Mosque, 2) An inclined minaret on North-West side of the Ulugh Beg Madrasah, and 3) A visible misalignment in the Ulugh Beg Madrasah's portal. The current view of the whole ensemble is presented in Fig. 5. The Ulugh Beg Madrasah is on the left side, the Tilya-Kori Madrasah and Mosque are in the center, and the Sher-Dor Madrasah is on right side of the image.

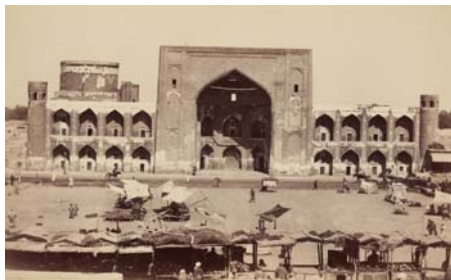
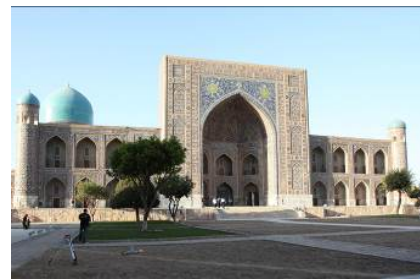
Fig. 3. Main entrance of the Tilya-Kori Madrasah and Mosque (Note that the mosque dome is not present in the old photo (a))

(a) View in 1890 (after [6])

(b) Current view

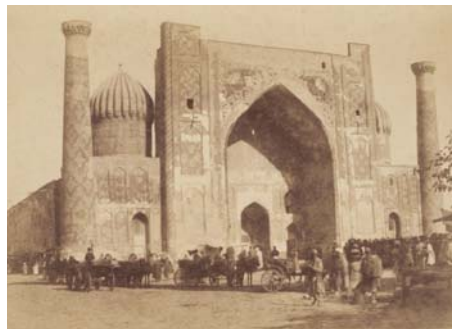
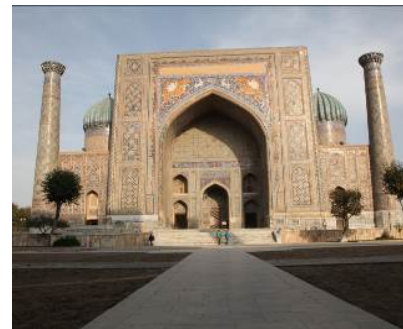
Fig. 4. Main entrance of the Sher-Dor Madrasah

(a) View in 1890 (after [6])

(b) Current view

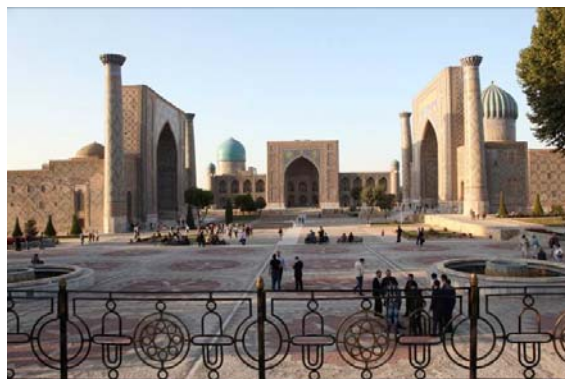
Fig. 5. Current view of the Registan Square ensemble.

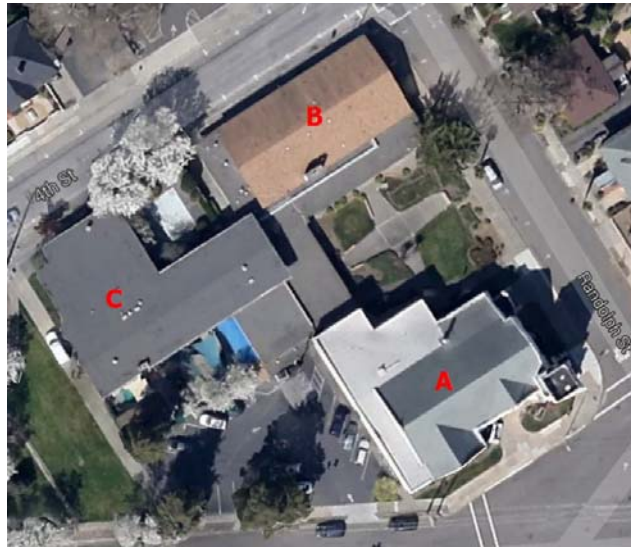
Fig. 30. Google Earth view of First United Methodist church ensemble, Napa.

A number of churches were damaged during the 2014 South Napa earthquake. Three churches were studied by means of laser scanning. As a representative example, an ensemble of First United Methodist Church in downtown Napa, California, USA, was studied and presented in this paper. The ensemble consists of three adjacent buildings: A) Church's main sanctuary building (1917), B) Centennial hall (1952), and C) Educational building (1955) as identified in Fig. 30.

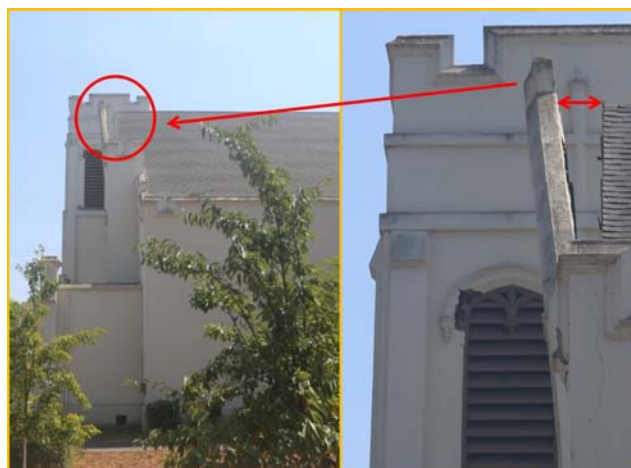
Fig. 31. Ground elevation views of the separation of the east wall of First United Methodist church ensemble, Napa.

The research team arrived at the site within several hours after the main shock and scanned the ensemble from 4 positions (stations). It was discovered that the east wall of the church's main sanctuary building (building A) separated from the roof on top and bowed out towards the nearby street as presented in Fig. 31. Since no damages were observed in other buildings of the ensemble, the research team focused their investigation on this unreinforced masonry building only. The views of the wall before and after the earthquake are presented in Fig. 32.

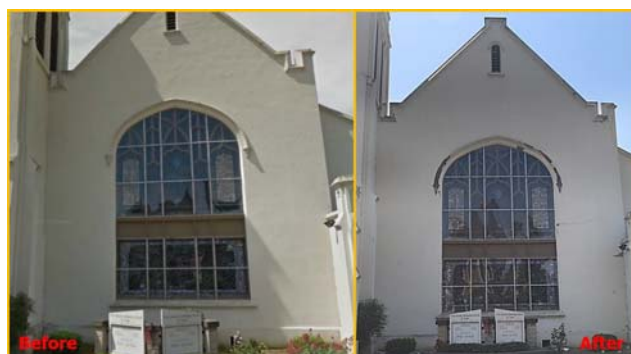
Fig. 32. East side wall before (left) and after (right) of First United Methodist church ensemble, Napa.
