STRUCTURAL MONITORING OF MONUMENTAL BUILDINGS: THE BASILICA OF SANTA MARIA DEGLI ANGELI IN ASSISI (ITALY)

Nicola Cavalagli, Massimiliano Gioffrè and Vittorio Gusella

Department of Civil and Environmental Engineering, University of Perugia
via G. Duranti 93, 06125, Perugia, Italy
e-mail: {nicola.cavalagli,massimiliano.gioffre,vittorio.gusella}@unipg.it

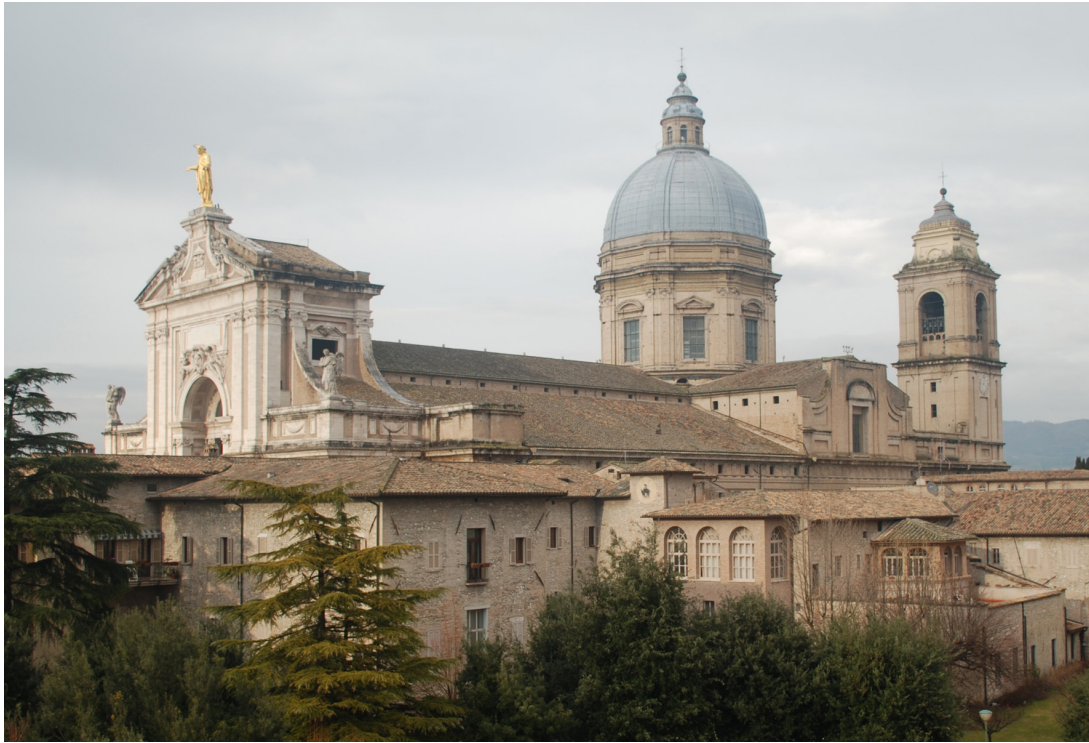
Figure 1: Basilica of Santa Maria degli Angeli in Assisi.

The Basilica of Santa Maria degli Angeli (Fig. 1) is located in the center of Italy. Over the years the structural system has been affected by significant seismic events, among which the earthquakes in 1832 and in 1997 were the most severe. In particular, the event in 1832 caused the collapse of the nave and the left aisle, together with a wide spread damage scenario, which also involved the drum-dome system.

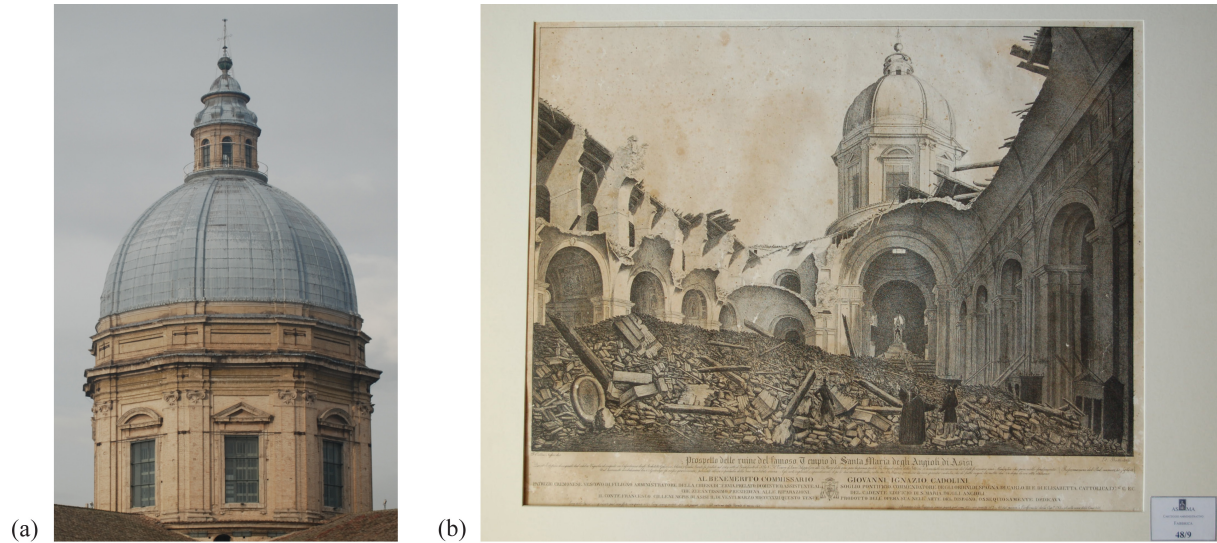
Figure 2: (a) Image of the drum-dome structural system. Three orders of steel rings can be easily seen. (b) Line-engraving of the damage conditions after the 1832 earthquake. *Prospetto delle ruine del famoso Tempio di Santa Maria degli Angeli di Assisi*, by Cilleni Nepis.

The dome of the Basilica is majestic and impressive, and is characterized by a singular slenderness due to the lightness of the drum (Fig. 2 (a)) [4]. The inner diameter is of about 20m and the variable thickness of the unique shell starts from 1.60m to 0.70m. The inner perimeter of the drum is circular, while the outer is octagonal; the coupled pilasters at the angles of the

Throughout its history the structure has been subjected to significant seismic events that have compromised also the structural integrity of the Porziuncola. Historical documents describe the damages due to the earthquake of 1832, that caused the collapse of the nave and of a portion of the left aisle (Fig. 2 (b)). The drum-dome system did not collapse, but was severely damaged. Date back to this event the strengthening measures of the drum with three orders of steel rings (Fig. 2 (a)). After the Umbria-Marche earthquake of 1997 the basilica has been subjected to several rehabilitation and strengthening measures [5]. The works have mainly concerned the façade stability, the strengthening of the transepts and aisle vaults and the reinforcement of the drum. The kinematic mechanisms related to these crucial aspects can be detected by the evident cracks, especially for the façade and the drum (Fig. 3).

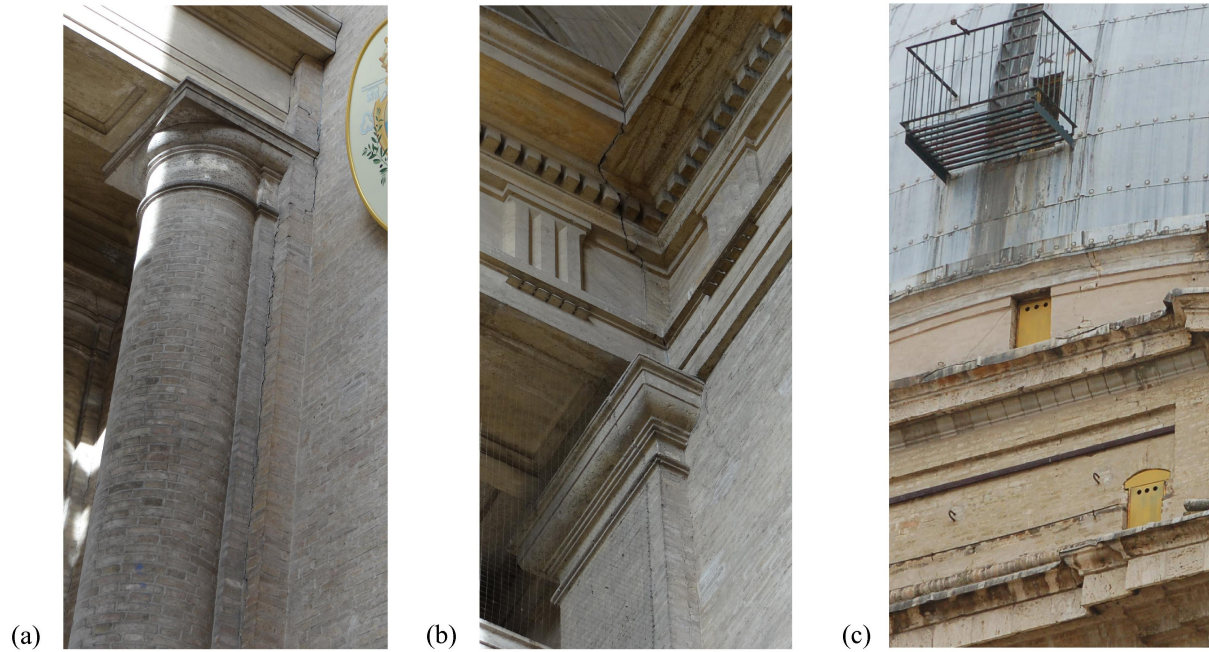
Figure 3: (a)-(b) Vertical cracks between the new and the old façades. (c) Major through crack of the drum-dome system.
