SHEAR STRENGTH AND DEFORMATION MECHANISMS OF COMBINED AND CONFINED MASONRY WALLS SUBJECTED TO CYCLIC LOADING

Arturo Tena-Colunga¹, Artemio Juárez-Ángeles², and Víctor Hugo Salinas-Vallejo³

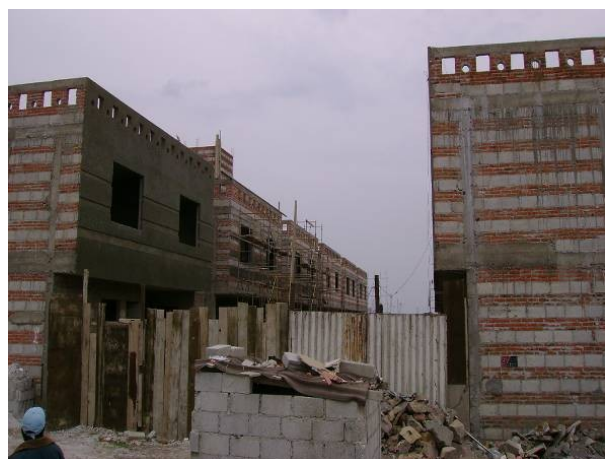
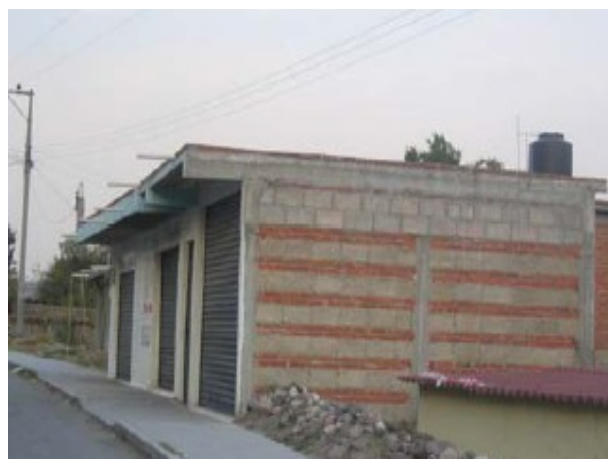
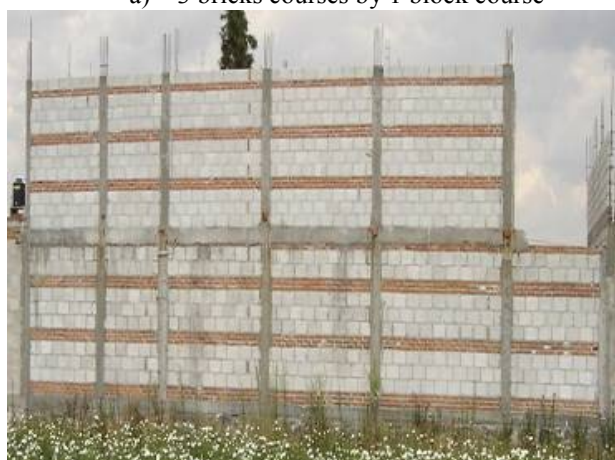
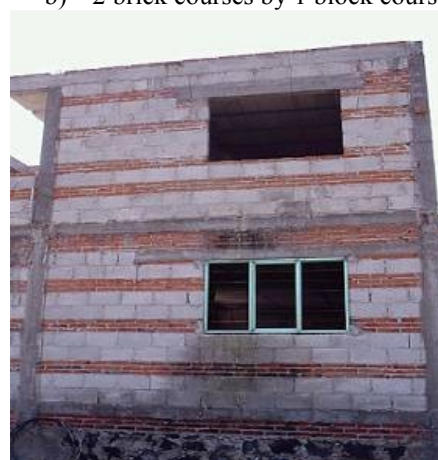
a) 3 bricks courses by 1 block course

b) 2 brick courses by 1 block courses

c) 3 brick courses by 3 block courses

d) 3 brick courses by 2 block courses

Figure 1. Combined and confined masonry construction

This modern version of combined and confined masonry has been being used since early 1990s. Different arrangements to combine and alternate brick courses with block courses have been used [1-4, Figure 1], but the one that it is more commonly used is the one depicted in Figure 1a, where three courses of clay bricks alternate with a course of concrete blocks.

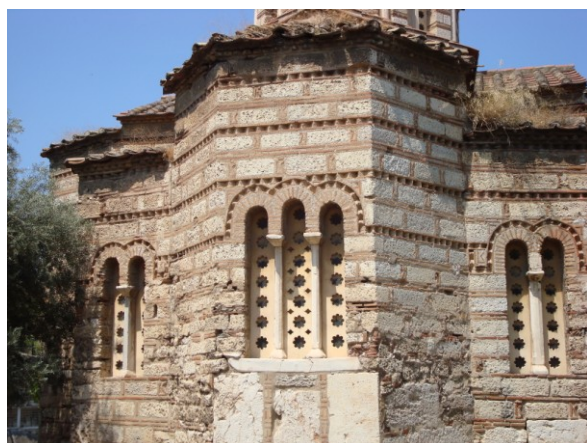
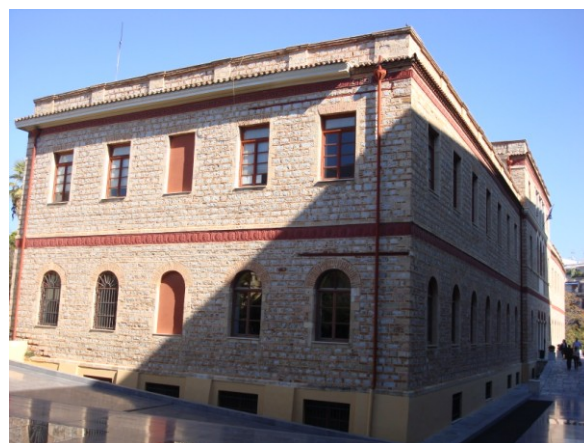
Figure 2. Existing old combined masonry buildings in Athens, Greece

This modality of construction has historical background in old construction in Europe in places like Istanbul, Turkey or Athens, Greece (Figure 2) and in few buildings of the XVII or XVIII century in Mexico (Figure 3), where natural stones were alternated with fired bricks. However, this newer version became popular in recent times by the initiative of the inhabitants of the Mexican states of Puebla, Tlaxcala and Oaxaca. They tried to solve with this modality the cracking problem observed in walls made with concrete blocks due to differential settlements. As a matter of fact, their idea of alternating courses of bricks with concrete blocks was successful to solve that problem.

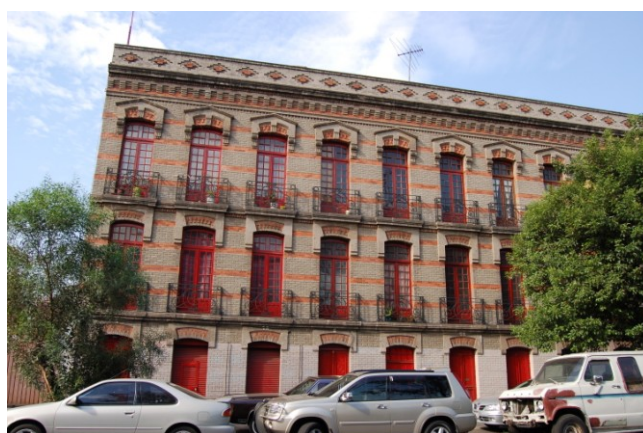
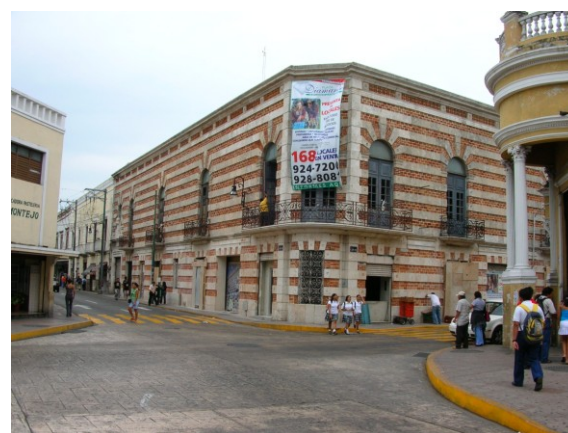
Figure 3. Existing old combined masonry buildings in México

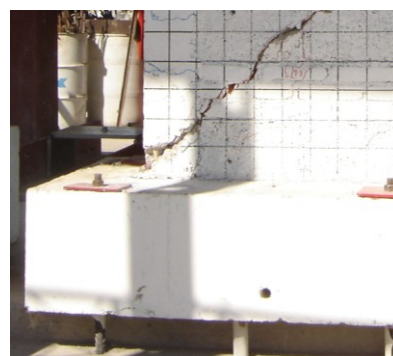
a) Top right corner

b) Bottom left corner

Figure 14. Shear crack penetration of confining RC columns of wall MCC-1 that lead to failure

Instability in the wall response triggered for a drift angle of 0.6% for wall MCC-1 after a major shear crack penetrated the confining column (Figure 14); this last half cycle is marked with a broken red line in Figure 13a.
