## **NUMERICAL STUDY ON SEISMIC RESPONSE ANALYSIS OF THE PLATE GIRDER BRIDGE DAMAGED BY THE 2016 KUMAMOTO EARTHQUAKE**

**Abstract.** *In 2016 Kumamoto Earthquake, many buildings, embankment structures and transportation infrastructures have been damaged. This paper presents damage survey of a plate girder bridge, namely Tawarayama Bridge which is situated on Kumamoto Prefectural road No 28, Tawarayama bypass, where the damage related to the bridge is enormous and elucidates the damage mechanism that can occur in that type of bridge due to earthquake with epicenter which is very close to bridge.*

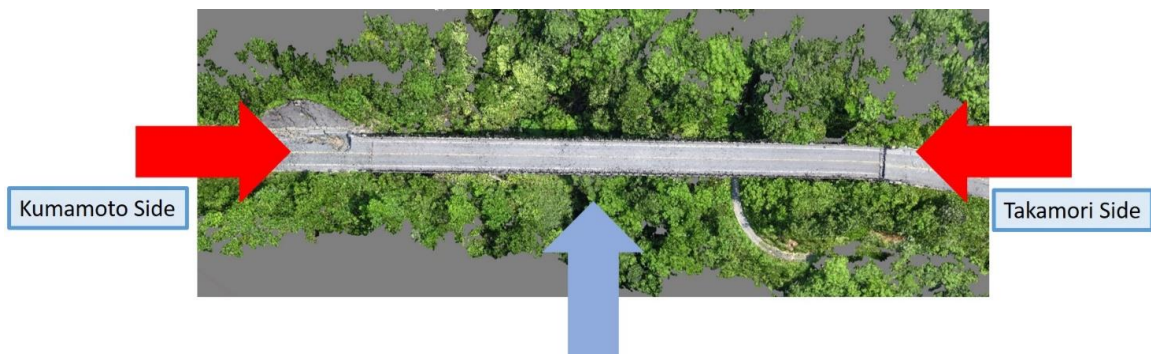
Figure 7. Deformation of Tawarayama Bridge

Tawarayama Bridge which situate on Tawarayama bypass is also damaged by the 2016 Kumamoto earthquake as it is very near to active fault line. The deformation of the whole bridge can be seen in Figure 7 which was produced by 3D scanner technique. The damages of the bridge is found as follows.

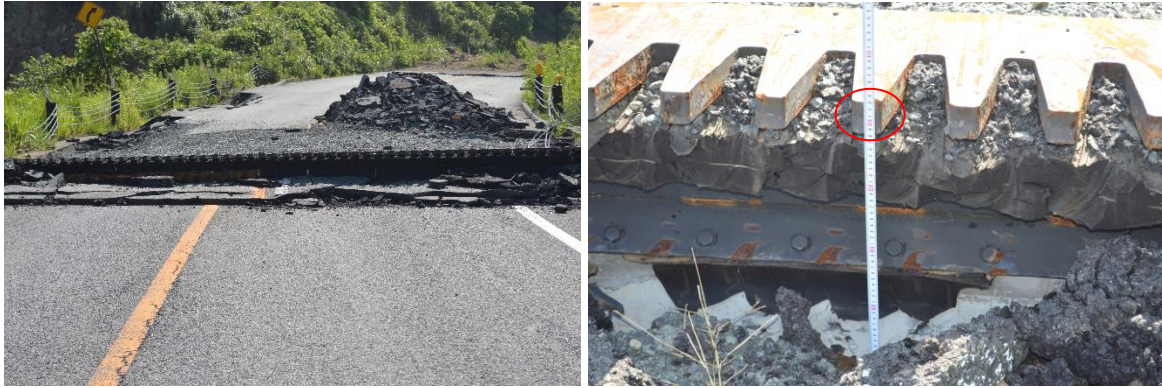
Figure 8. Damage of A2 abutment (East side)

The settlement of deck slab is occurred at the east side (A2 side) of the bridge due to the girders falling off from the rubber bearings and the abutment tilting. The deck slab settlement of 53cm was seen as shown in Figure 8.

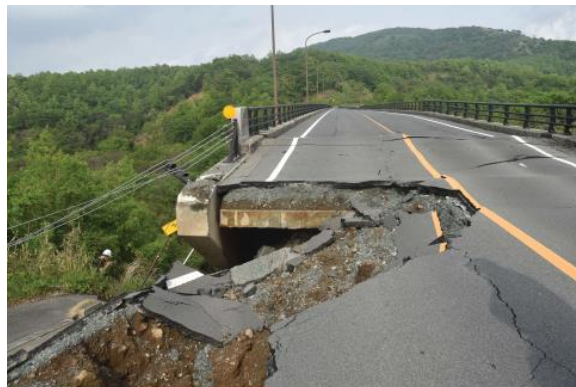
Figure 9. Damage of A1 abutment (West side)

At the west side (A1 side), it is seen that road embankment has collapsed due to the soil movement and caused exposing of the pile foundation under the abutment. It may be due to large compressive force and future consideration should be made for specific result.

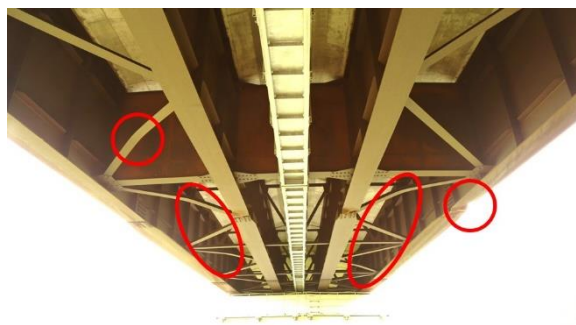
Figure 10. Deformation of main girder

Figure 10 shows the deformation of main girder and P1 pier seen from A1 side. The deformation can be found about 20 m from A1 side while moving towards P1. The deformation of G3 girder is shown in Figure 11. It has confirmed that the buckling in the vicinity of the lower lateral structure is occurred. The impinging of lower horizontal members buckling may be due to acting of compressive force on the bridge deck from both the A1 and A2 abutments, or, approaching of the abutments towards the bridge girder.

In this paper, this fact is raised as the most important destructive mechanism. The extent of compressive force which should be assumed for the seismic design of bridge girder, has not verified yet. In addition, the ground motion was larger than assumed so it is needed to identify the sites ground motion. According to this survey, it can be suggested that in future, seismic design of bridge girder should be considered based on the buckling phenomenon of bridge girder in response of seismic intensity 7 ground motion, especially at the vicinity of the girder ends.
