On the Assessment of the Plaka Bridge Collapse using Non-linear Analysis Preventable or Doomed?

Abstract

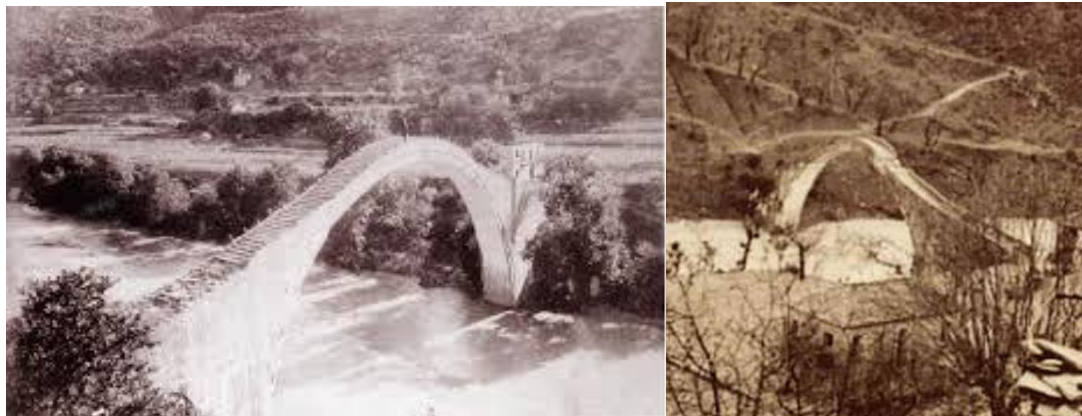
Figure 1: Original Plaka Bridge structure (left) at the beginning of the 20th century and the bridge condition following bombardment during World War II (right). Notice the updated parapet on the right.

What is important to note that updates of the original bridge shown in Figure 1 (left) introduced a more substantial parapet which add significant load to the structure which becomes top-heavy. It is a practice that has affected numerous such stone bridges without the consequences have been assessed properly.

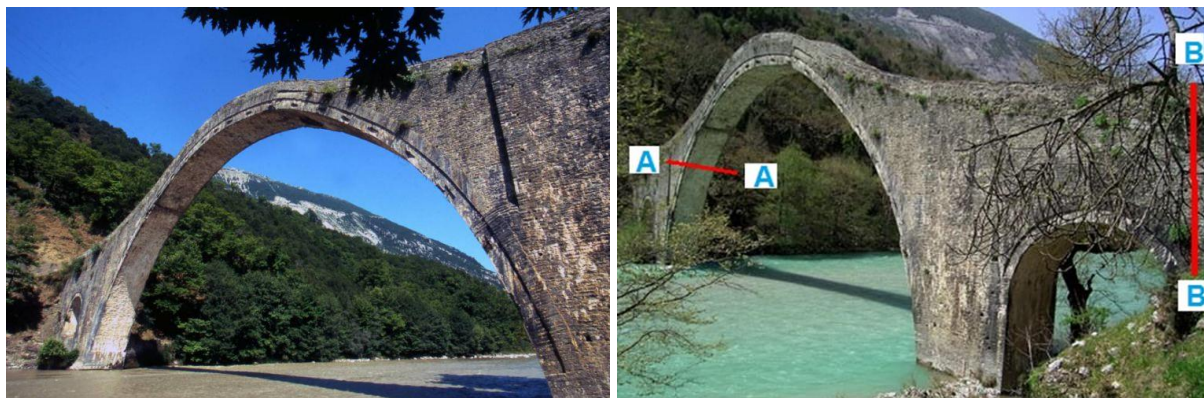
Figure 2: The Plaka Bridge prior to its collapse. Shown on the right is the location of the central pier (on the river bed) and its geometrical shape relative to the flow for assessing hydrodynamic forces. Designated as A-A and B-B are the failure surfaces/sections shown in Figure 3.

Also to be noted in Figure 2 are the ties (or keys) that have been introduced on the primary arch only with a specific pattern. Reference to this point will be made later in the analysis.

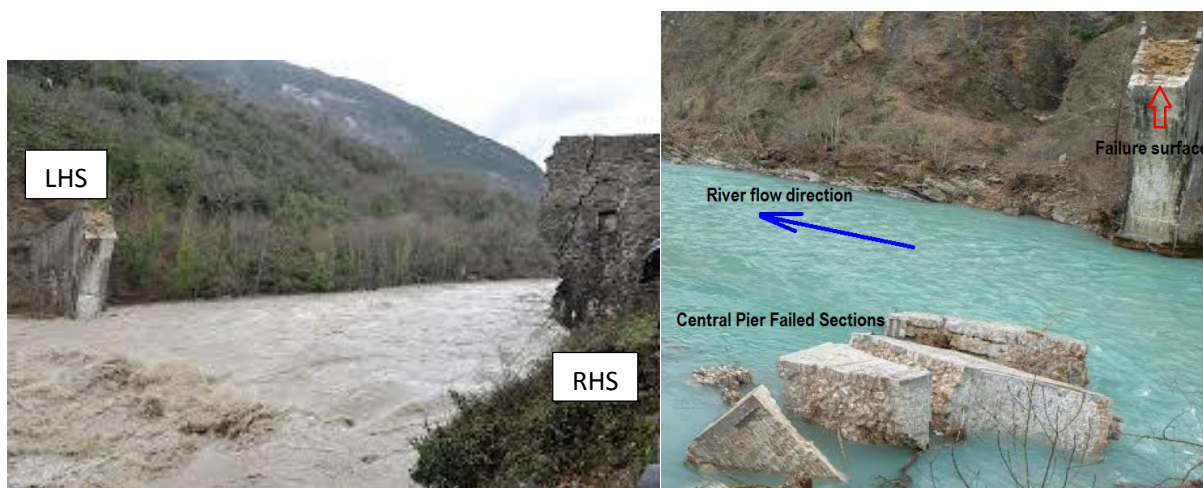
Figure 3: Post-collapse Plaka Bridge. Figure on the left provides some reference regarding the free stream velocity as well as the differential of water level between the upstream and downstream faces of the central pier. Shown on the right are the locations of the central pier segments/arch segments which

appear to have landed almost upstream and against the flow providing evidence that the bridge was not toppled over by the flow but rather collapsed in a more complicated manner.

As can be seen in Figure 3, a secondary arch is constructed at the right side of the main arch resulting in a mid-pier that is founded on the river bed. Moreover, a large arch shape opening is present at the left abutment with its foundation being also partly supported on the river bed. The presence of these two openings (right secondary arch and the left relief) was apparently insufficient to relieve the pressure load and protect the structure from the forces caused by this unprecedented flood.

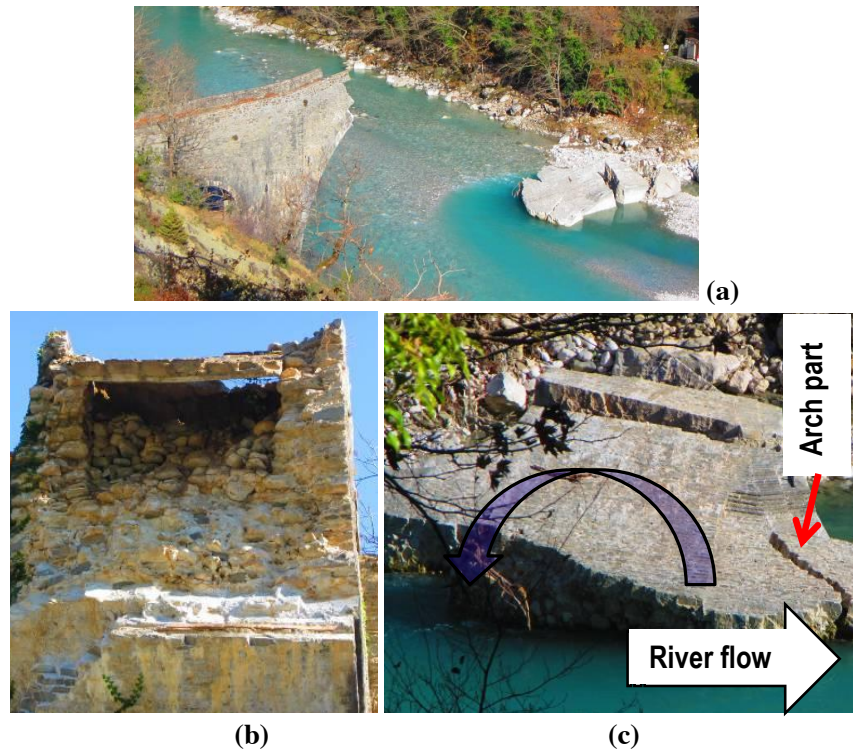
Figure 4: Overview and details of the collapsed Plaka Bridge.

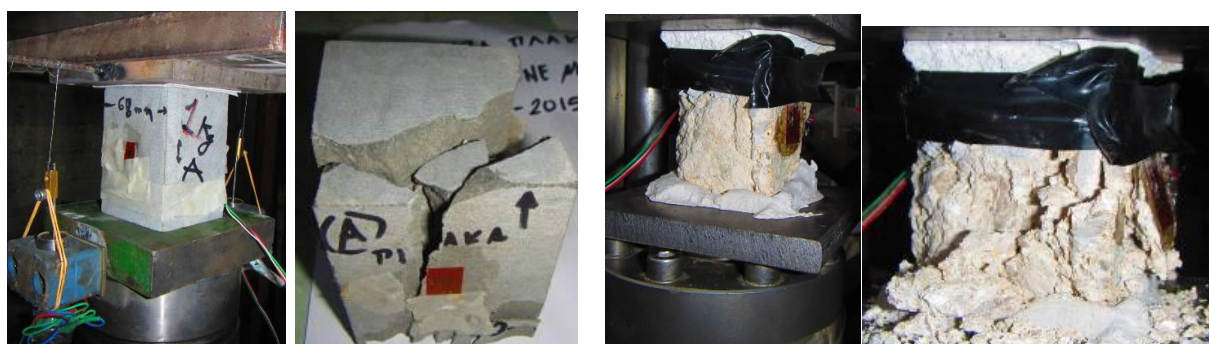
Figure 6: Testing in compression stone samples (left) and mortar samples (right) from Plaka Bridge

A laboratory testing sequence was performed with the objective to identify the mechanical characteristics of the basic materials representative of the materials employed to build stone masonry bridges in the general area. For this purpose, stone samples were selected from the vicinity of the collapsed Plaka Bridge and analyzed. Most importantly, it was facilitated that a mortar sample from the collapsed Plaka Bridge be taken to the laboratory for testing. From both the stone and mortar samples collected in-situ it was possible to form specimens of regular prismatic geometry. These specimens were subjected to either axial compression or four-point bending tests. For the compression tests the loaded surfaces of the prisms were properly cupped. Figure 6 depicts typical loading arrangements employed for the compression (stone and mortar specimens) tests employed for the Plaka Bridge samples. The applied load was measured through a load cell and the deformation of the tested specimens was measured employing a combination of displacement sensors as well as a number of strain gauges. These measurements were continuously recorded with a sampling frequency of 10Hz. Through these measurements, the mechanical characteristics of the tested specimens were obtained in terms of compressive strength, flexural tensile strength, Young's modulus of elasticity and Poisson's ratio. The obtained values of these mechanical parameters are listed in Tables 1-3.

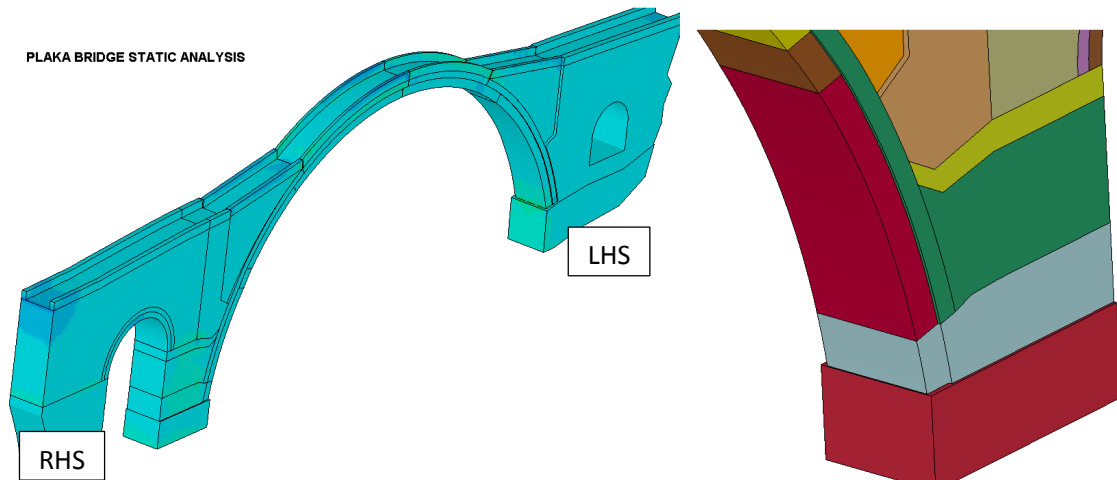
Figure 7: Global FEM representation of the Plaka Bridge (upstream side) at left and section details of the central pier.

Figure 7 depicts the modeled Plaka Bridge in 3-D along with details of the different sections that made up the structure. Interface (contact) conditions such as the one above control the structural continuity. These contact interfaces and their failure are controlled by the mortar between the distinct elements. Several failure conditions are available and have been explored in the study. The uncertainties surrounding the state of the mortar and its failure behavior can only be treated, however, with sensitivity studies that are computationally costly. While individual stones comprising the various parts of the bridge (arches, pier, walls, etc.) are not used but rather the combined behavior of the stone and mortar making the finite element mesh (tensile failure controlled by mortar), the distinct parts of the bridge were made out of different segments between which contact conditions (or mortar behavior) control the deformation or failure. Experience has shown (including the Plaka Bridge) that these structures fail in large sections rather individual stones and so the adopted assumption is realistic. For example, the primary arch was represented by twelve (12) different segments connected together with each connection or interface capable of failing or separating under shear or tension (assumed failure criteria for mortar).

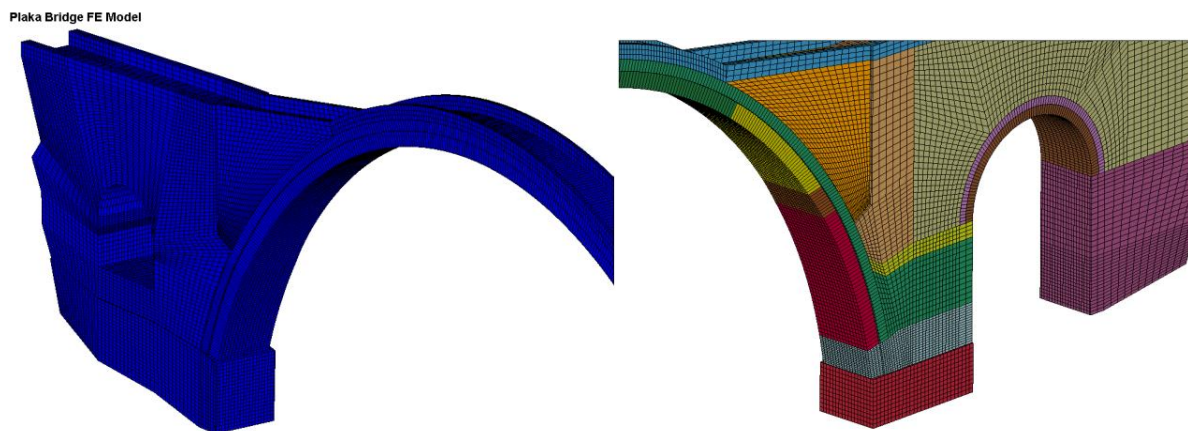
Figure 8: Numerical discretization of the Plaka Bridge into finite elements

Details of the refined FE mesh used to represent the Plaka Bridge are shown in Figure 8. The general finite element mesh-generation software True-Grid [17] and non-linear analysis software LS-DYNA [16] (capable of analyzing static, modal, and earthquake loadings) were employed.

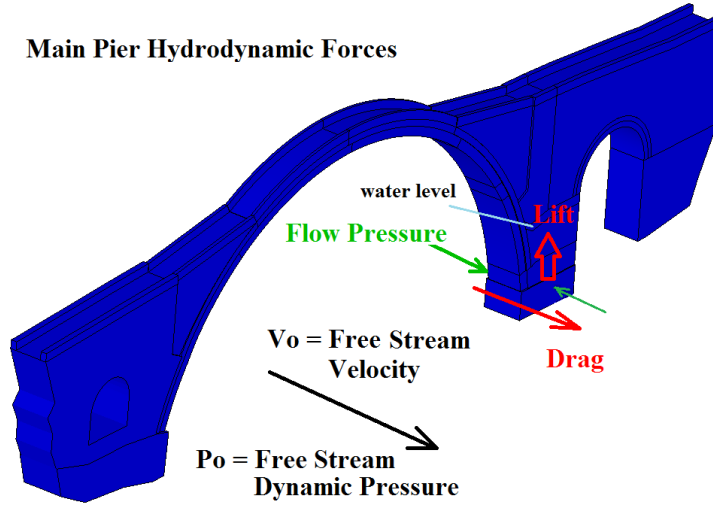
Figure 9: Plaka Bridge schematic and orientation of pier loads

Figure 9 shows characteristics of flow around a bluff body for a high Reynolds number. V_o is the free stream velocity, P_o is the free stream mean dynamic pressure, F_D the drag force on the body, and F_L the lift force on the body.

Hydrodynamic forces (drag and lift) were distributed on the surfaces up to the level shown in Figure 9. Negative pressure was also assumed (for conservatism) on the downstream face of the central pier. For the base of the pier, which was assumed to be founded on rock), during Phase II failure conditions were introduced that allowed the bottom of the pier to displace following when the failure conditions with the increasing hydrodynamic loads is met. The hydrodynamic loads built up to the maximum flow assumed and then remained steady. Fixed boundary conditions were assumed for the abutments during Phase II (gravity + flow loads). It was assumed that the river bed was scoured by the flow, exposing the central pier to water flow and pressure all the way to the assumed basement rock.

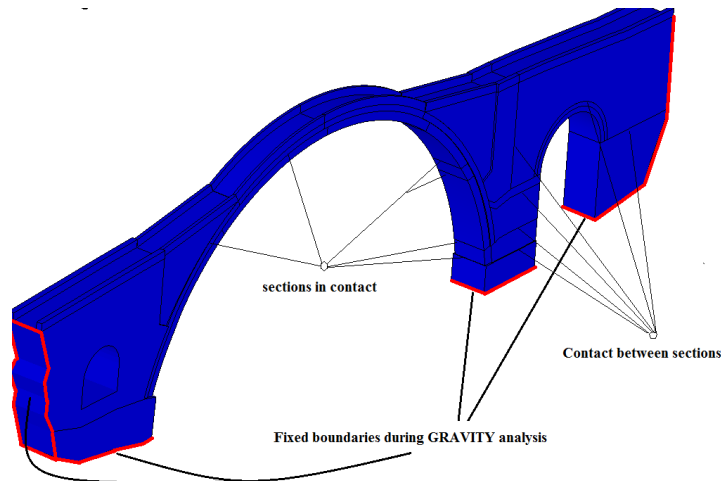
Figure 10: Plaka Bridge boundary conditions for GRAVITY analysis

Using only gravity loads the Plaka Bridge was analyzed during the first phase of the two-step process. The gravity analysis is a quasi-static one where the structure stabilizes with the help of artificially high global damping. Following the numerical stabilization the phase II was initiated with the application of the hydrodynamic loads using the restart capabilities of the adopted code (LS-DYNA). Figure 10 depicts the boundary conditions for the gravity analysis. Specifically, the bottoms of the central pier as well as the two abutments were assumed fixed on competent rock.

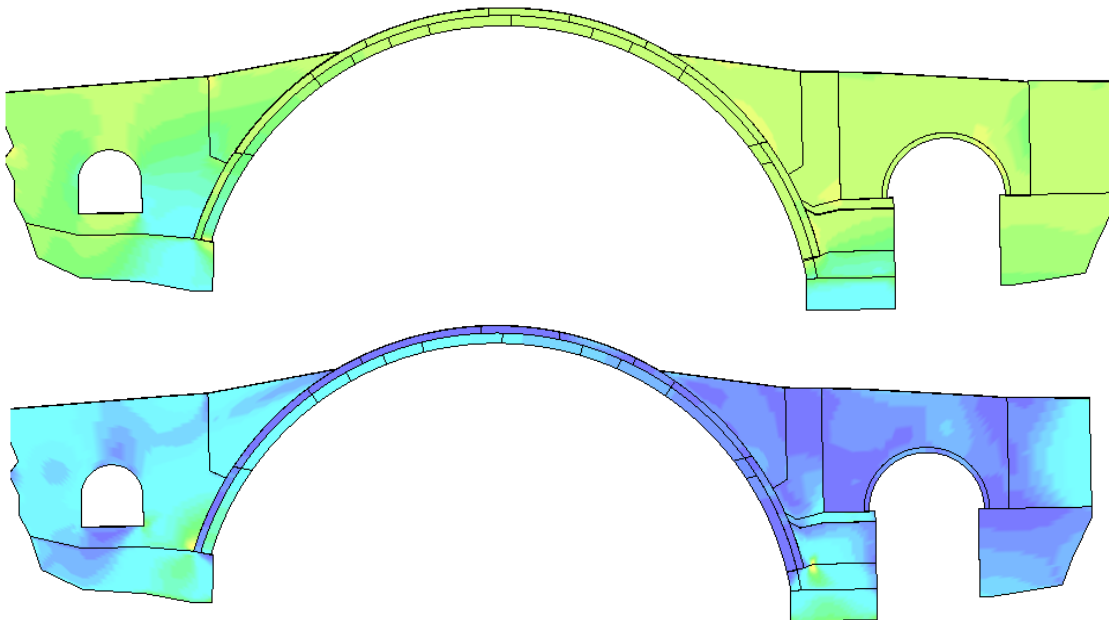
Figure 11: Stress distributions for the Plaka Bridge under gravity load. Vertical stress (top) and principal stress (bottom)

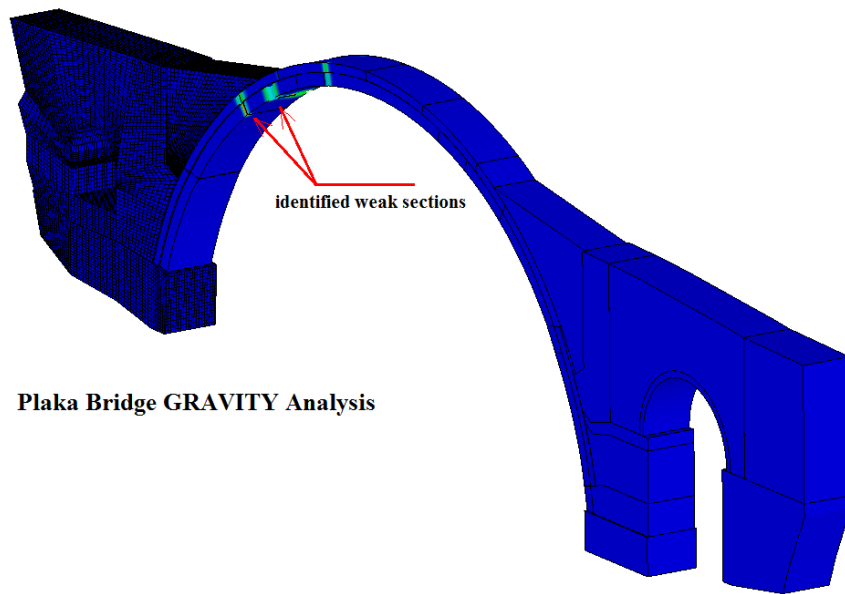
Figure 12: von Mises stresses in Plaka Bridge under gravity load. Important to note is the identification of locations exhibiting high von Mises stresses.

The gravity analysis revealed areas of distress as shown in Figure 12 as well as a confirmation of the need for special ties used in the primary arch.

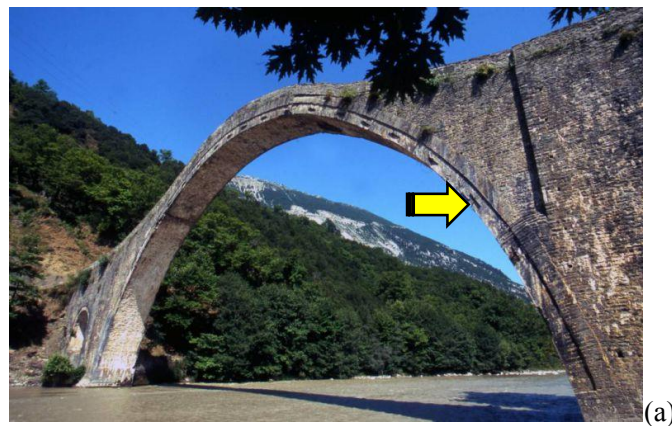
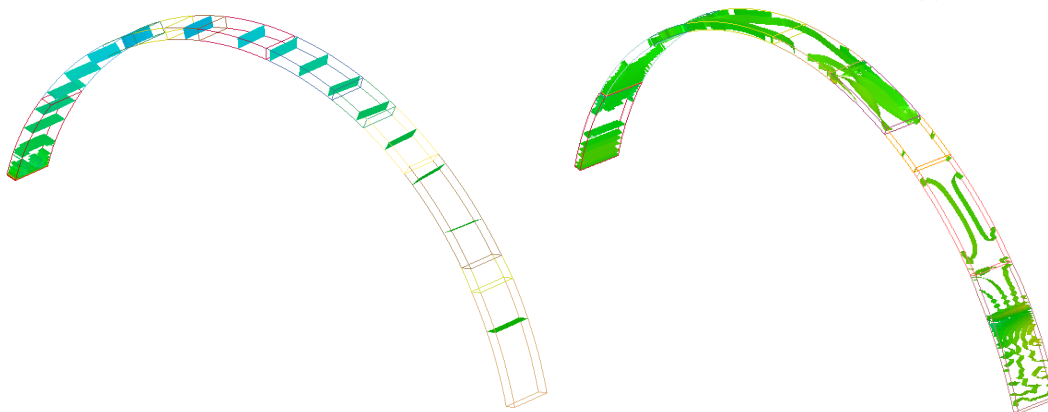
Figure 13: Horizontal stress distribution in the two arches (primary and secondary). The special ties (keys) shown in (a) tend to confirm the need to mitigate forces acting on the primary arch. No such keys are apparently necessary for the secondary arch (as also shown in (a)).

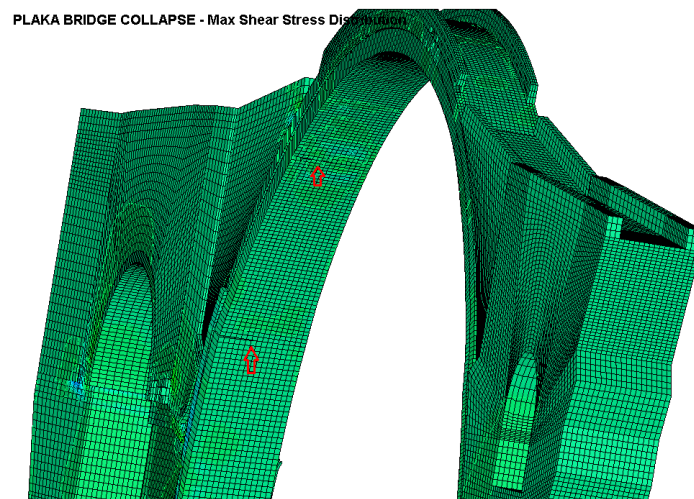
Figure 14: Initiation of collapse with section separation on the primary arch (RHS)

Shown in Figures 14 and 15 are the early stages of the large deformations exhibited by the Plaka Bridge due to the flood loads. In Figure 14, the separation of large segments of the RHS of the primary arch is observed as the upper structure begins to move in the direction of the flow. Figure 15 (left) a zone of high shear stresses are shown on the LHS of the primary arch and near where the arch structure actually separated from the left abutment (see Figure 3). Figure 15 (right) depicts the large deformation experienced by the lower part of the central pier. While in the postulated failure scenario the base of the pier was intentionally undermined, segments above the base block also begin to move downstream.

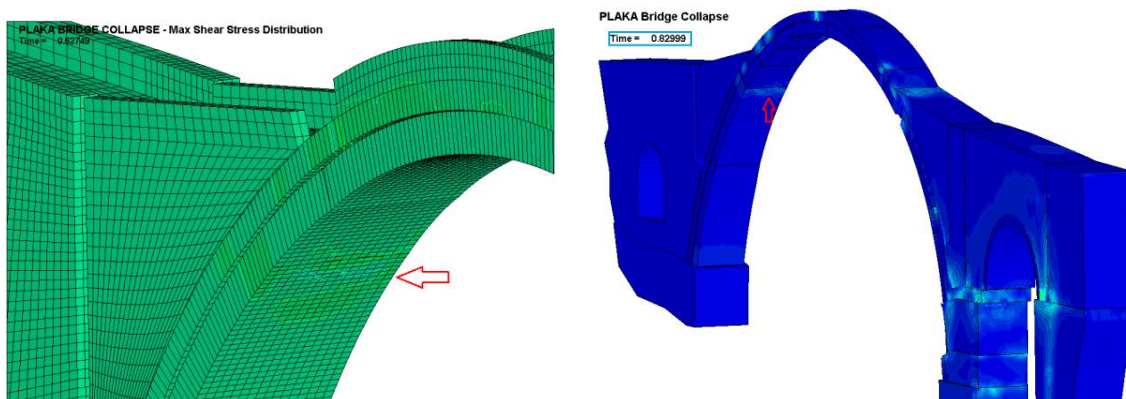
Figure 15: Maximum shear stress profile on the LHS section of the primary arch

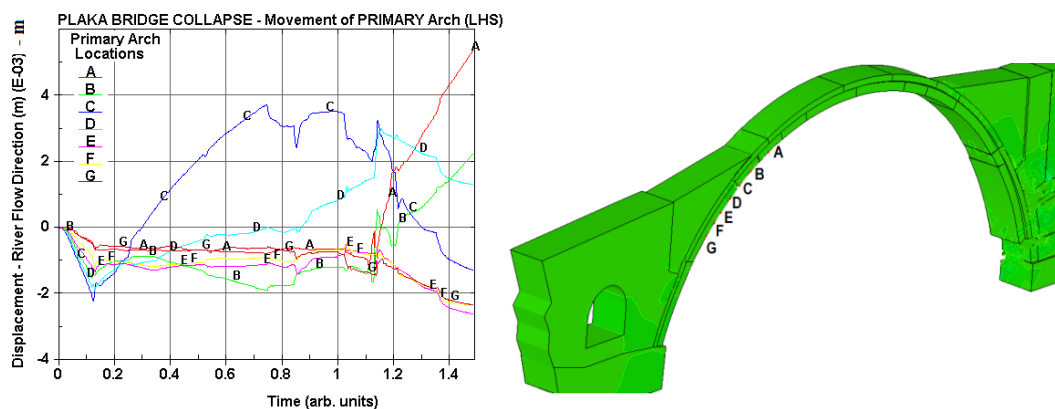
Figure 16: Deformation of the bridge in the early stages of failure

The deformation of the primary arch in the early stages of the postulated collapse scenario is shown in Figure 16. Specifically, the evolution of the displacements at locations on the LHS of the arch is shown in Fig. 16 (left). Important to note is the fluctuation of the direction of the arch movement between positive (direction of flow) and negative (upstream). The large displacements of the central pier blocks are also shown in Fig. 16 (right). The rapid fracture occurring in the LHS of the primary arch is depicted in Figures 17 (a-d). Figure 17a depicts the high shear stresses developed on the downstream side of the location and Figure 17b the opening of arch. Important to note is the failure at the location is initiated on the downstream side which indicates that the apex section of the arch exhibits the tendency to move against the flow.

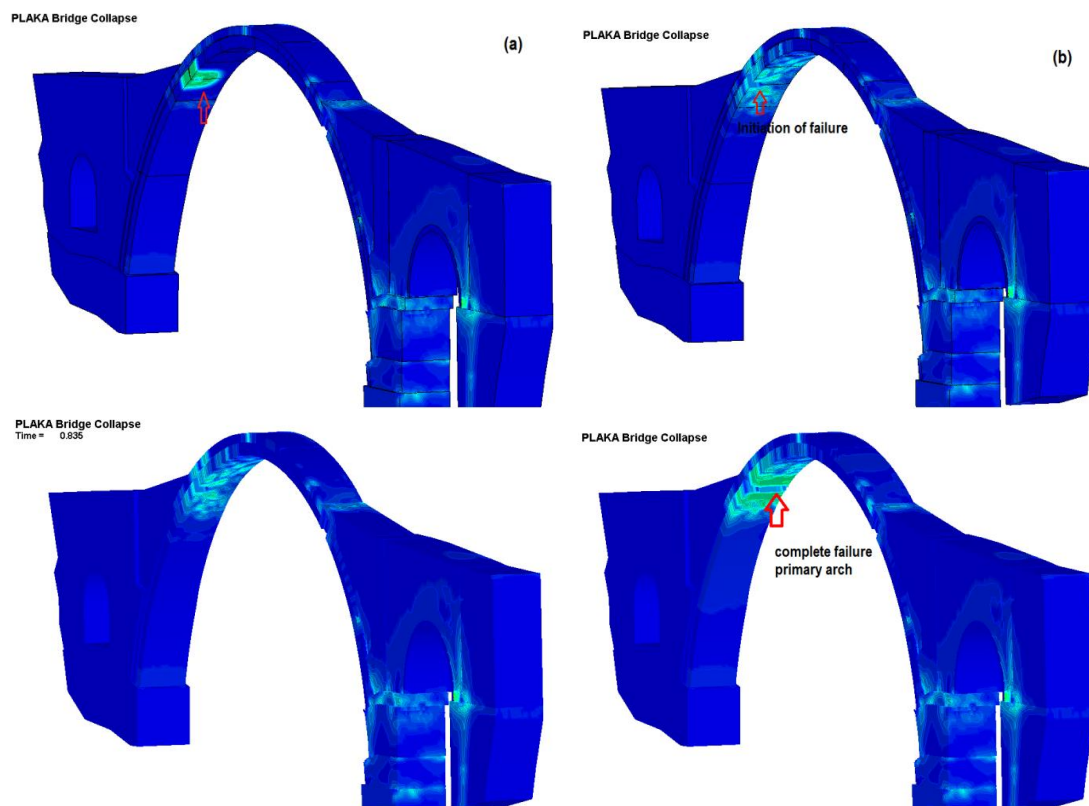
Figure 17: Snapshots of the sudden failure predicted on the LHS of the bridge arch

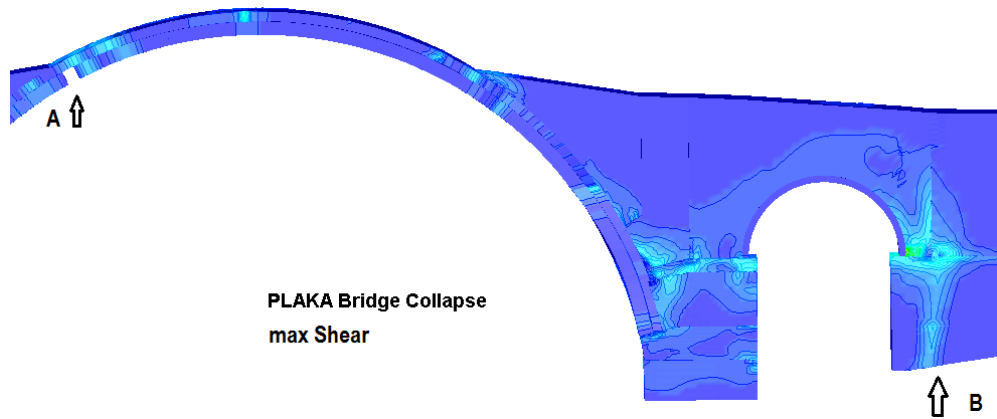
Figure 18: Maximum shear stress profile on the LHS section of the primary arch

Figure 18 depicts maximum shear stress distribution during the early stages of the predicted arch failure (location A). Shown is the section (location B) where high shear stresses also develop. Location B represents the RHS location where the right abutment separated from the failed part of the bridge (see Section B-B of Figure 2 and Figure 3).

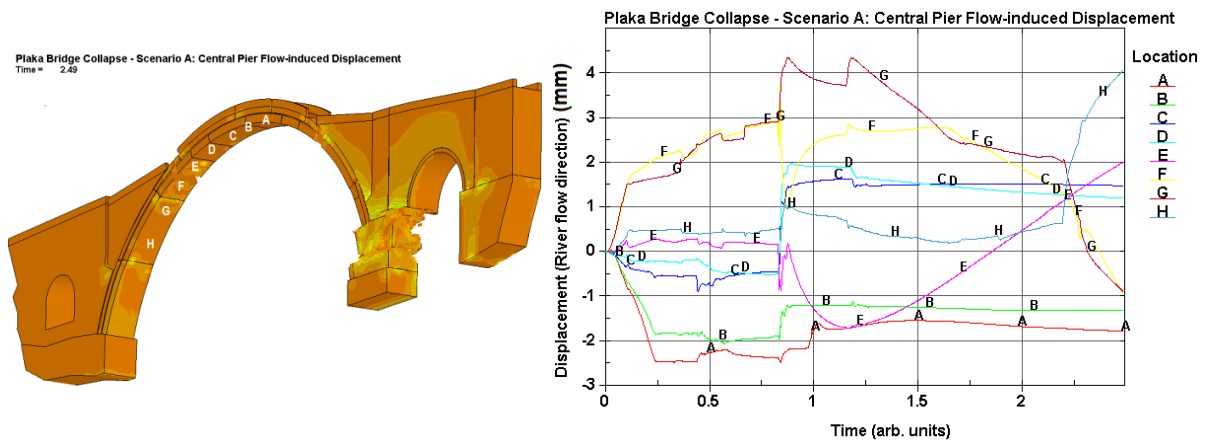
Figure 19: Locations (left) and predicted displacements of the main arch during collapse

The predicted swaying of the arch during the collapse process is clearly depicted in Figure 19 (right) with changes from positive to negative territories of the displacement in the direction of the flow.

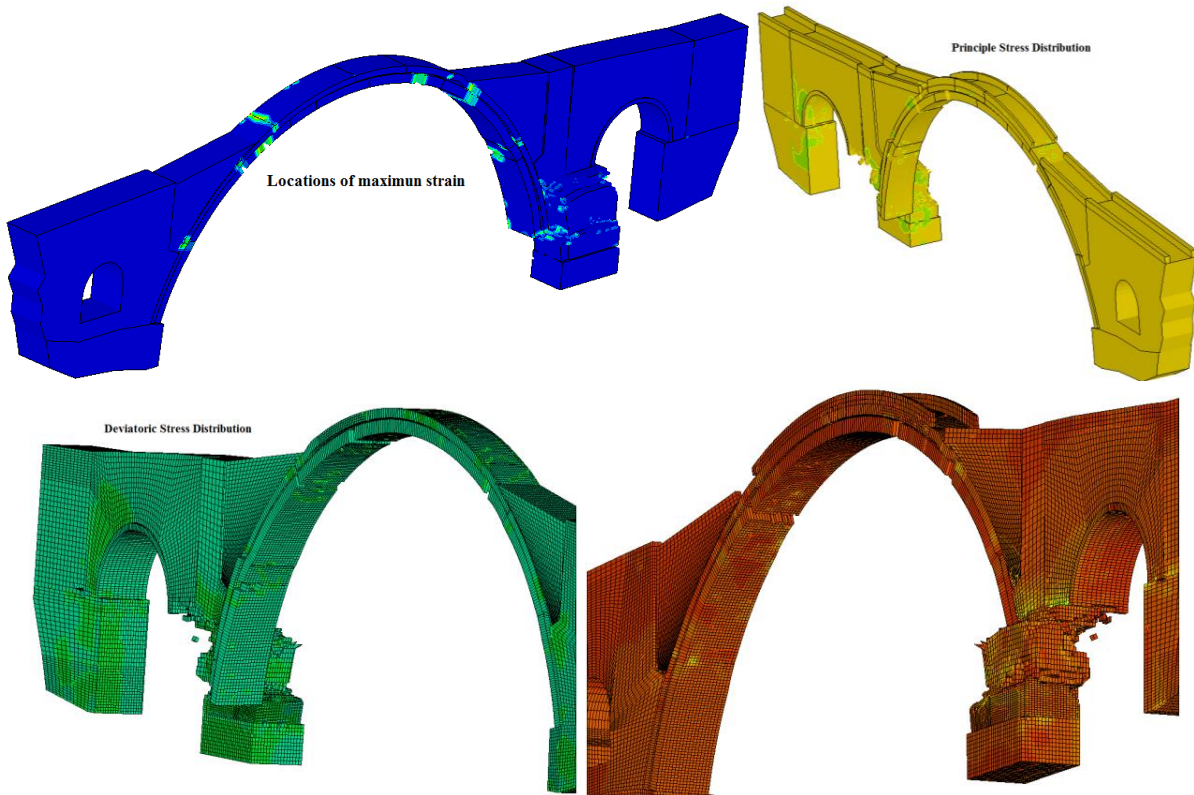
Figure 20: Evolution of collapse (pier) and identification of locations of arch separation.

Shown in Figures 20 and 21 are stages of the collapse of the Plaka Bridge and the mode of failure of different parts of the bridge that can be used to compare with actual bridge collapse. Two very important observations are made: First, is the predicted mode of failure of the blocks comprising the central pier (Figs. 20d and 21b). This tends to support the observations of the failure in large blocks shown in the photographs of Figures 3 and 4. Second important observation is the rupture surface on the LHS of the arch where it meets the left wall, a location which very close coincides with the actual failure surface (photos of Fig. 3 and 4).

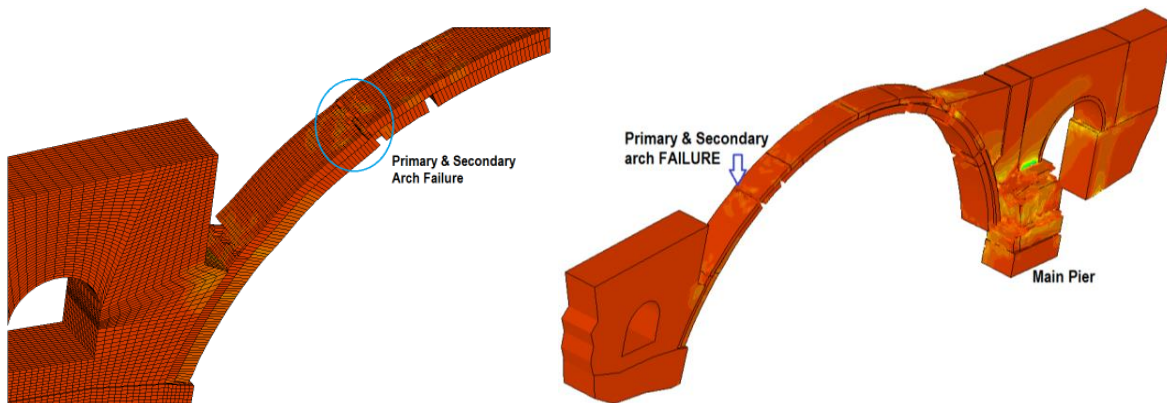
Figure 21: Identification of the location of complete section separation on the LHS of the arch structure (primary + secondary) during the later stages and start of complete collapse. The failure section predicted closely traces the location of the observed failure of the actual bridge (Figure 3).

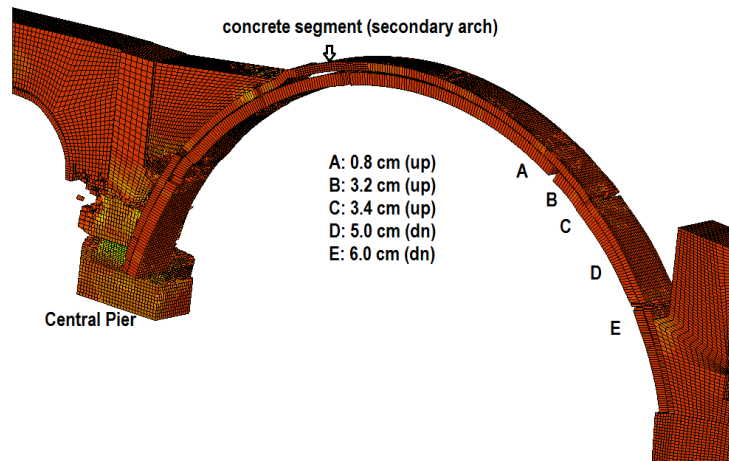
Figure 22: State of damaged Plaka Bridge prior to total collapse and arch deformation profile

The state of the structure just prior to the complete collapse and the displacement profile on the LHS of the arch structure where the failure surface has been observed is shown in Figure 22. The displacement indicator up/dn implies displacement in the direction of the flow (dn) and opposite to the flow (up). Delineated is the segment of the secondary arch repaired after the World War II bombing using concrete,

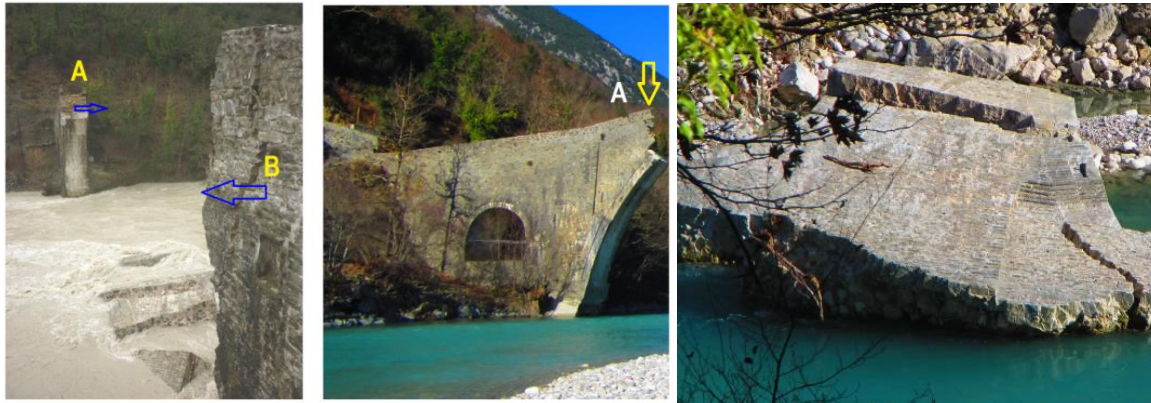
Figure 23: Photographic evidence of Plaka Bridge collapse

Several scenarios encompassing uncertainties that existed regarding (a) the structural health of bridge prior to the collapse (weakened sections of the arch structure), (b) the conditions at the base of the central pier (competent rock or gravel) and (c) the flow water level were postulated and analyzed. The scenario of the degraded central pier base support (equivalent to the scenario of a weakened pier section above the base) is presented in detail in this paper. This scenario was deemed to be the most likely that has triggered the failure based on the numerical analysis results that seem to corroborate the post failure available evidence. Key, post collapse evidence is summarized in the photographs of Figure 23. Specifically, the following important observations are made based on Figure 23:

- The failure at section A (LHS) appears to have occurred suddenly (as it is evident from the smooth failure surface of the primary and secondary arches).
- A second important point at A (shown in Fig. 23 middle) is the failure surface of the parapet and filling wall. This indicates that the arch section at the LHS location actually separated and fell upstream.
- Figure 23 (right) depicts the orientation of a large segment of the RHS arch structure and wall that was supported by the central pier. The toppling of this large block in the opposite direction than the flow indicates significant rotation resulted from the large displacement of the pier blocks below in the direction of the flood flow.
