ASSESSMENT AND STRENGTHENING MEASURES OF THE HISTORIC MASONRY COMPLEX: “PROSFYGIKA” IN CENTRAL ATHENS

Constantine C. Spyrakos¹, Eleni Panou-Papatheodorou², and Dimitrios Kokkinakos³

Abstract. *This paper presents the results of the analysis regarding the seismic risk assessment of a historic three-story masonry structure, part of a building complex in central Athens. The building complex has been declared as preserved because of its historic, architectural and structural characteristics.*

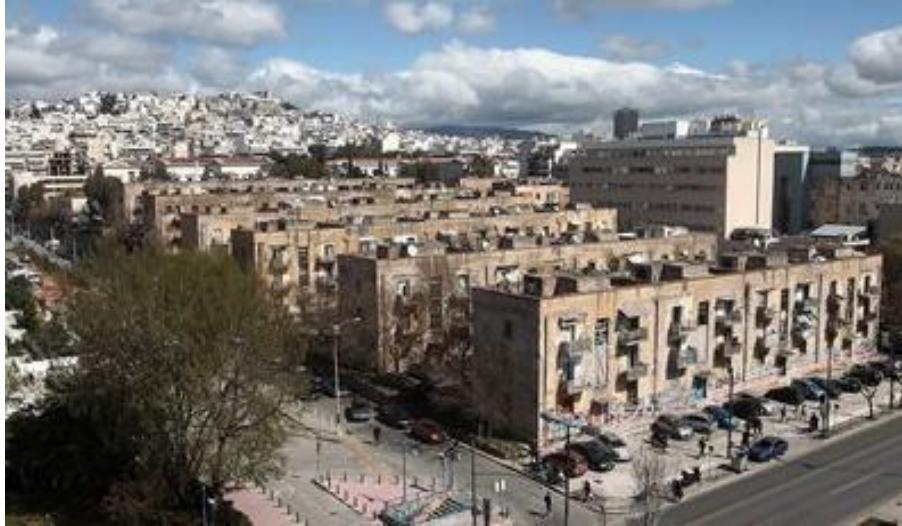
Figure 1: “Prosfygika” historic complex.

The dimensions of each building are 69.60m (length of the facade) by 8.90m (width) by 10.60m (height). The load bearing walls are constructed of stone masonry and the floors of reinforced concrete. The load bearing masonry walls are interrupted by reinforced concrete floors, a characteristic that attributes to them a historical character in the evolution of building construction and is the primary reason for their enhanced seismic behavior. They represent the predecessor of the modern reinforced concrete construction with infill walls.

The construction of the historic complex “Prosfygika” located in central Athens dates back to the 1930s. It consists of eight three-story blocks of flats, with a total number of 228 flats, constructed in an area of 14500m². The complex was constructed to house Greek refugees that arrived from the East Minor. Because of its historical, architectural and structural characteristics the complex has been declared a monument by the state.

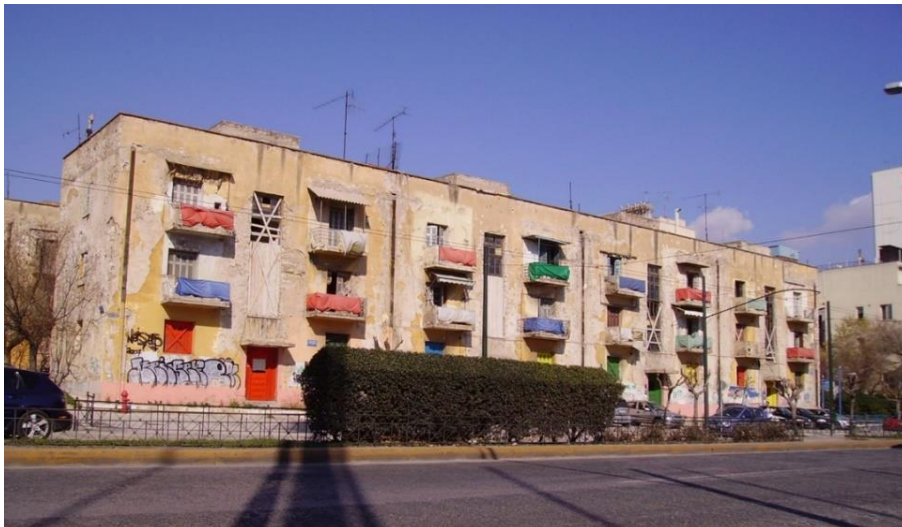
Figure 2: Façade of a typical building of the complex.

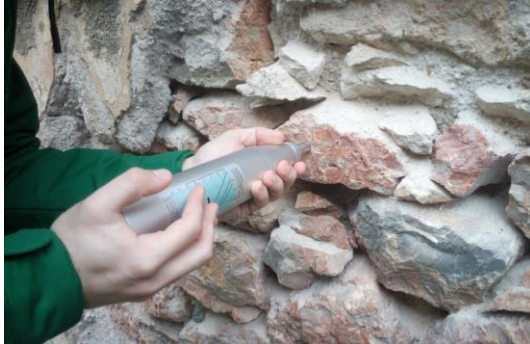
Figure 3: Rebound hammer test.

Several in-situ tests at different locations of a representative structure tests were carried out in order to assess the mechanical characteristics of the load bearing stone masonry. Based on measurements, e.g., tests shown in Figure 3, the compressive strength of the stones was measured to be: $f_{bc} = 50MPa$. Based on the characteristics and the composition of the poor quality mortar, its compressive strength was taken as: $f_{mc} = 1MPa$.

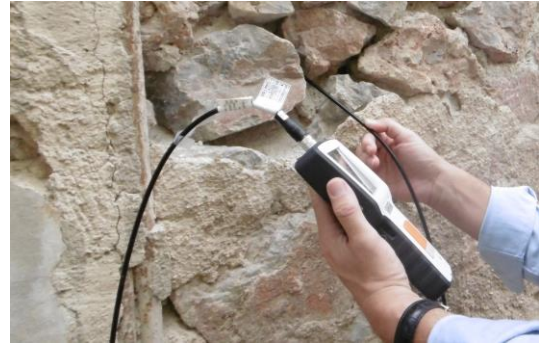
Figure 4: Endoscope test.

With the aid of an endoscope, the composition of the masonry walls along their thickness (Figure 4) was examined showing relatively large voids of a construction closely resembling to a three-leaf masonry.

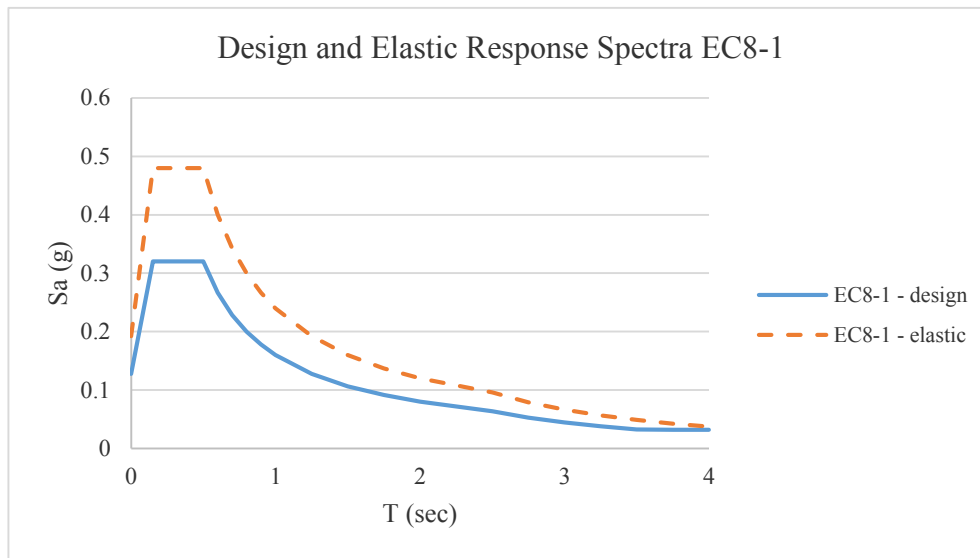
Figure 7: Design and elastic response spectra Eurocode 8-1 [5].

The response spectrum according to the provisions of Eurocode 8-1 [5] for $\gamma_I = 1.0$ is presented in Figure 7:

The elastic response spectrum according to the provisions of Eurocode 8-1 [5] is presented in Figure 7.

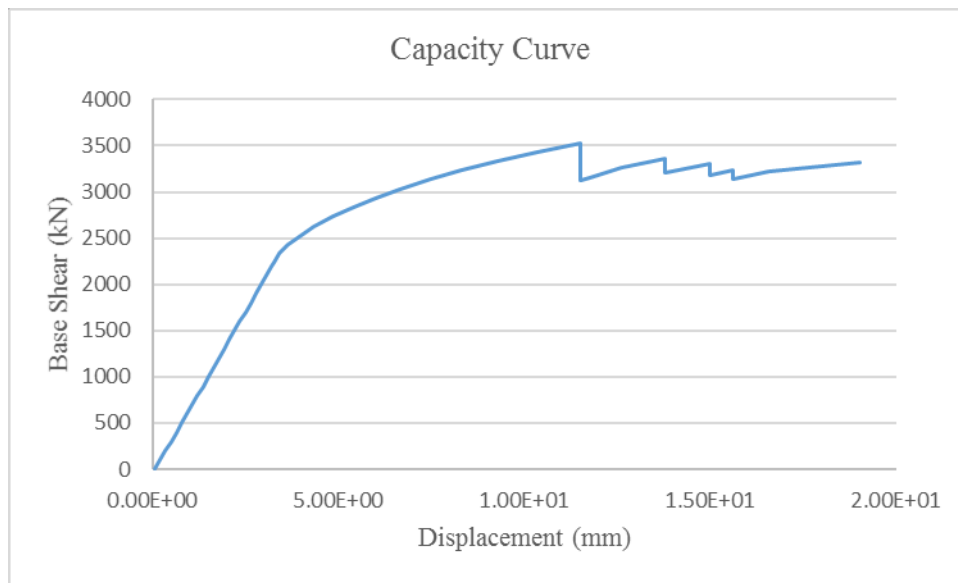
Figure 9: Indicative capacity curve for the seismic load of the combination $Y+0.3X$ for the unimodal lateral load distribution.

From the assessment of the structure for the seismic loading according to the seismic code 1985 [7] and for limit state of significant damage (SD), the capacity curve of the structure has been calculated. An indicative capacity curve for the multi degree-of-freedom system is presented in Figure 9:

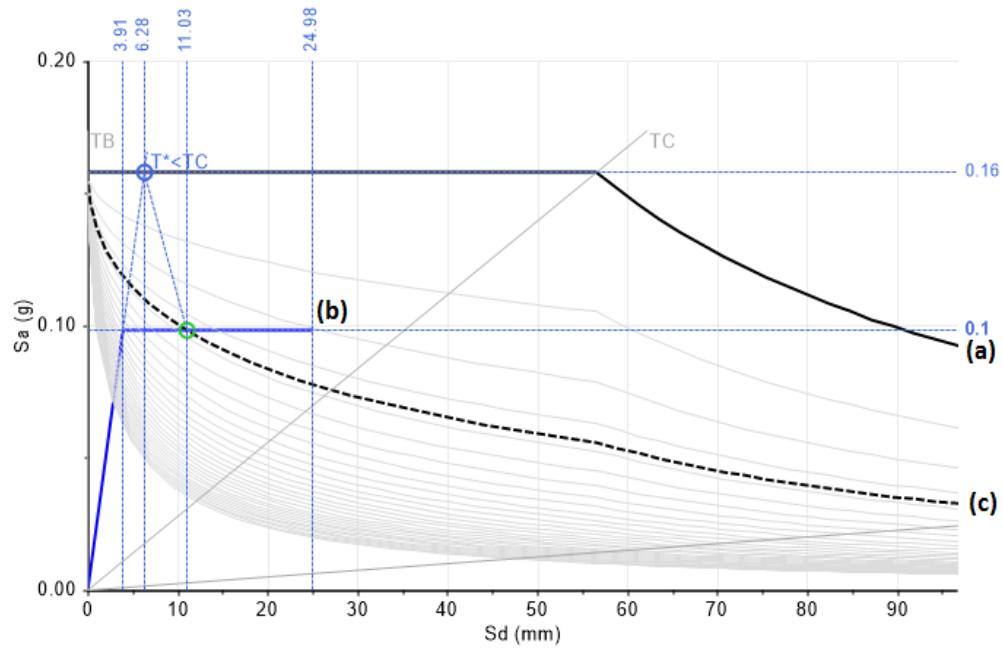
Figure 11: Bilinear capacity curve and target displacement for the seismic load for the combination Y-0.3X with the unimodal lateral load distribution. (a) 1985 [7] elastic spectrum; (b) bilinear capacity curve; (c) 1985 [7] non-linear spectrum.

In Figures 10-13 four bilinear capacity curves of the equivalent single-degree-of-freedom system are presented, out of the sixteen analysis performed in total. The seismic loading of this analysis is that of the seismic code 1985 [7]. The result is that the structure is sufficient for this level of seismic loading.
