## **DISCUSSION ON THE RESPONSE OF UNREINFORCED MASONRY TO LOW-AMPLITUDE RECURSIVE LOADS: CASE OF GRONINGEN GAS FIELD**

**Keywords:** unreinforced masonry, cyclic response, recursive loads, low-amplitude response

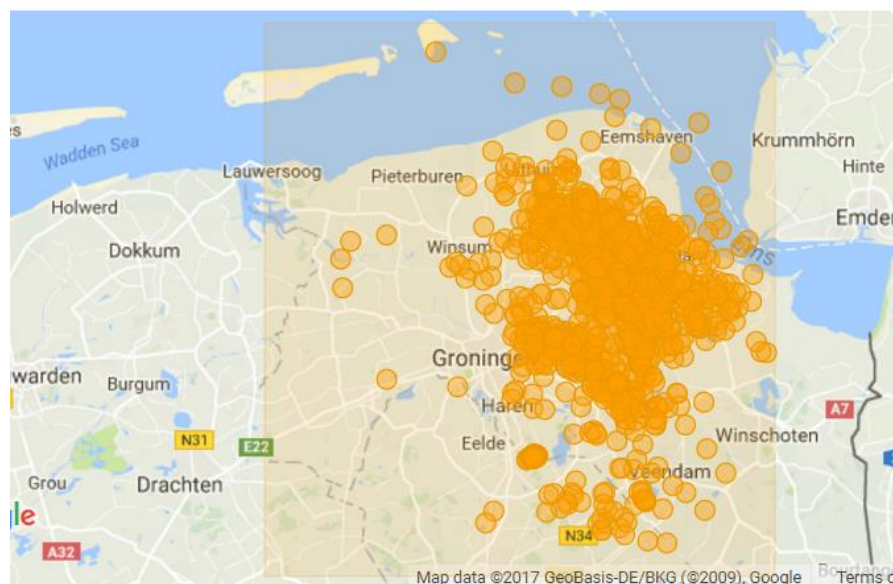
Figure 1: The seismic events obtained from the KNMI Seismic Database for the Groningen region for the time period between 2003 – 2016.

In Figure 1, the seismic events between 2003 and 2016 in the area can be seen. Distribution of the events in terms of magnitude ranges can be seen in Figure 2. The sudden increase in seismic events between 2011 and 2013 can clearly be observed in that figure.

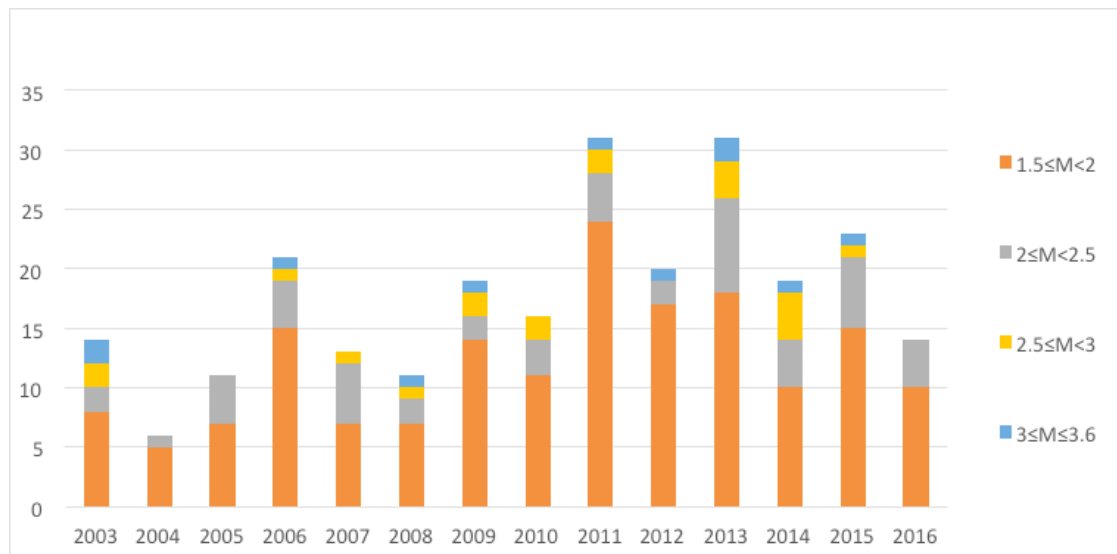
Figure 2: The distribution of the seismic events in a year basis for Magnitude 1.5+.

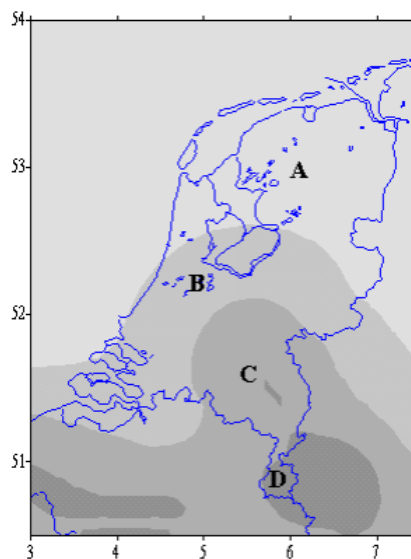
Figure 4: The seismic zonation map of the Netherlands is based on a seismic hazard study with a 10% of exceedance in 50 years (return period 475 years, and A means  $0.01 \text{ g}$  PGA).

In Figure 3, the seismic zonation map of the Netherlands is given in accordance with the Eurocode-8. Specifically, the region of Groningen is classified as Seismic Zone A, which corresponds to  $\text{PGA } 9.81 \text{ cm/s}^2$  ( $0.01 \text{ g}$ ). This value was exceeded by far during the strong ground motion that was recorded at the Huizinge event on the 16<sup>th</sup> of August 2012 (Middelstum station). More detailed research on the seismicity of the region, as well as the characteristics of the strong ground motion records can be found in Bommer et al (2015) [3].

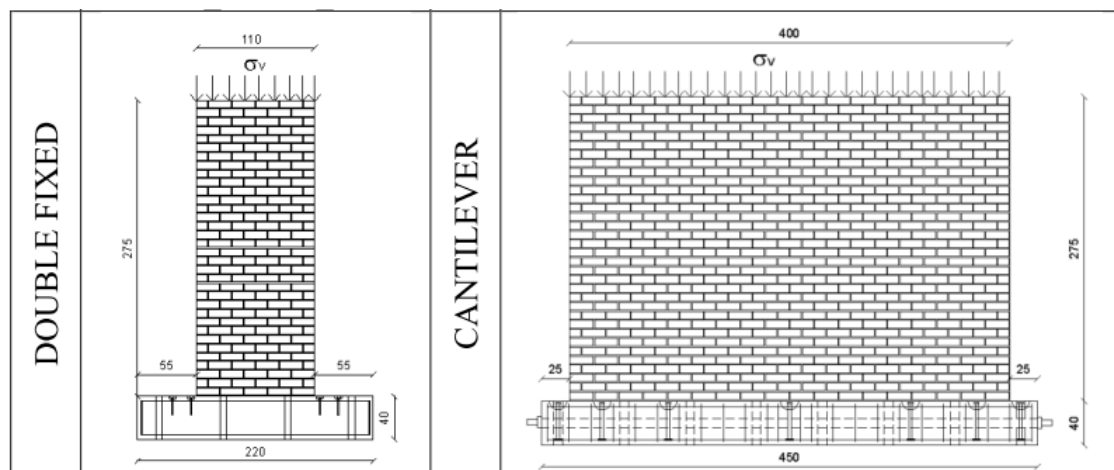
Figure 5: Experimental configurations considered, Slender Wall (left) and Squat Wall (right) (Pavese et al, 2015 [4]).

Experiments sponsored by NAM (Nederlandse Aardolie Maatschappij) and conducted by EUCENTRE (Pavia, Italy) were carried out on full-scale wall specimens resembling the typical calcium-silicate unreinforced masonry walls that can be found in the Groningen region. Specifically, two wall specimens representing a slender and a squat wall, correspondingly, were investigated under in-plane cyclic shear-compression tests. Their characteristic and dimensions are given in the Table 1, and their experimental configurations are shown in the Figure 4. These two specimens were chosen to account for different types of wall that can be traced in real structures are characterized by flexure or shear dominated type of failure.

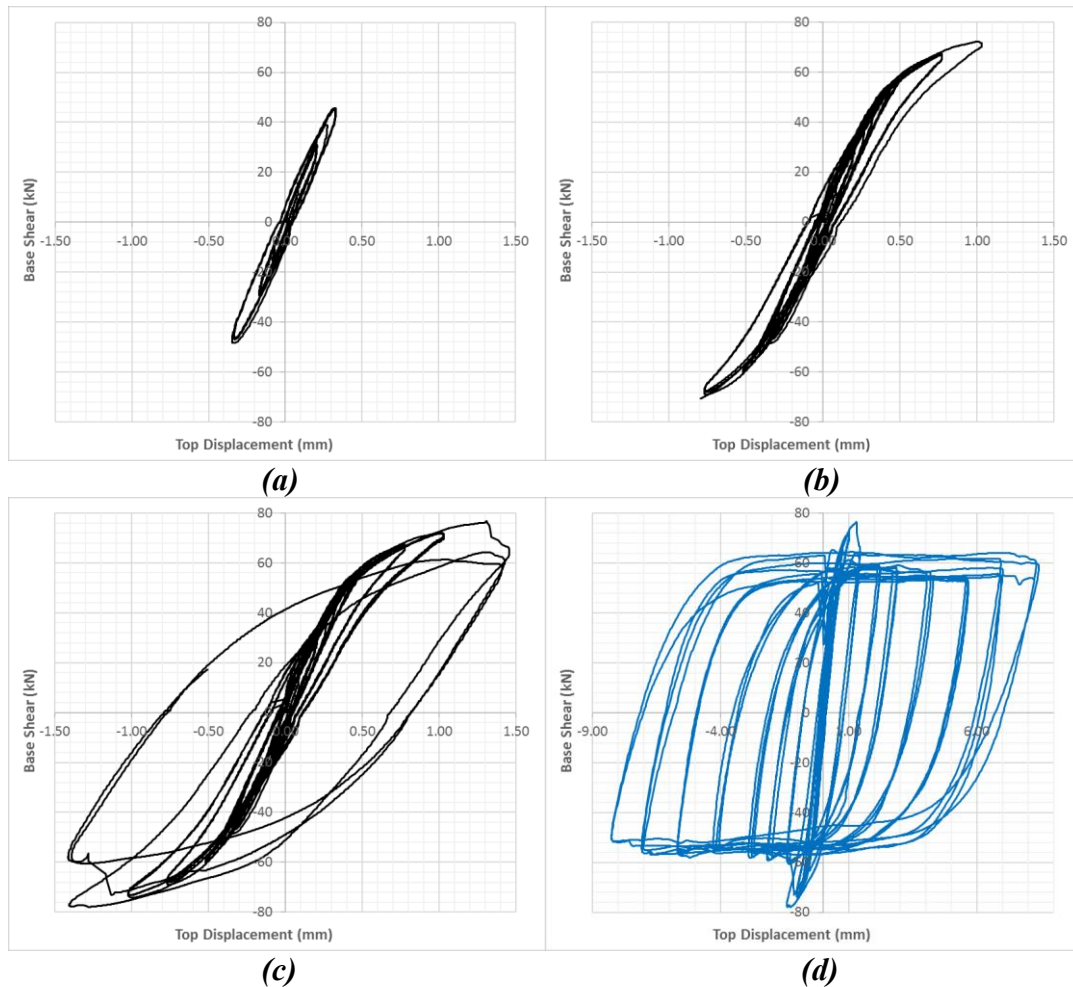
Figure 6: Experimental load deflection curve of the same EUCENTRE specimen (the squat wall specimen) focusing on different displacement ranges: (a) The first 3x3 cycles, up to 0.4mm top displacement, (b) The first 3x6 cycles up to 1mm top displacement, (c) The first 7x3 cycles up to 1.5mm top displacement, and (d) the full experimental hysteresis curve (modified from Pavese et al., 2015 report, and please note that the displacement scale of the first three plots is the same)

The test results presented herein are in terms of Horizontal Force – Drift/Horizontal Displacement (Figure 6 and Figure 7). More detailed results can be found in the aforementioned report (Pavese et al., 2015, [4]). As it can be inferred from their pseudo-dynamic characteristics derived from the cyclic tests, their strength should be considered adequate to withstand the frequent but mostly weak seismic events that occur in the Groningen region. As a matter of fact, this led to the necessity to further investigate the response of the tested specimens not in the range of their ultimate strength but in numerous cycles of low range of loading which may finally play an important role in the overall response during a relatively stronger event. Specifically, a thorough investigation of the tests results pointed out that nonlinear phenomena take place for very limited value of top displacements. In the Figure 6 and Figure 7, the first cycles of the conducted tests are presented for the squat wall – the results for the slender wall are equivalent and thus are not cited in this paper. It can be noticed that the unloading branches do not follow the loading one, leading thus to a small amount of residual displacements even for quite low loading. This type of response leads to an assumption that the frequent quakes that

In order to better understand the response of the Groningen-type URM to cyclic loads, focus on the load-deflection curves are presented here in Figure 6. In evaluating the load-deflection curves in earthquake engineering practice, it is more common to concentrate on the post-yield phase of the response. In the case presented here, however, the response in the very small cycles becomes important. It can be seen in Figure 6a that the very first cycles of the squat wall (see Figure 6 for the squat wall specimen), there is a considerable amount of hysteretic energy consumed, as well as residual displacements remained on the system. In this case, the top displacement is extremely small, in the range of 0.4mm, translating into 0.01% top drift. The response becomes slightly different in Figure 6b, where the top drift ratio goes up to 0.015%, and a pinching type response is observed. The reason for this response may be either rocking of the specimen as it is, or failure of bed joints and partial rocking of the wall on one or multiple bed joints. In Figure 6c, on the other hand, ductility starts to build up leading to fatter hysteresis

loops and obvious damage. When focused out to the overall response, as shown in Figure 6d, the response in the very first cycles gets invisible.

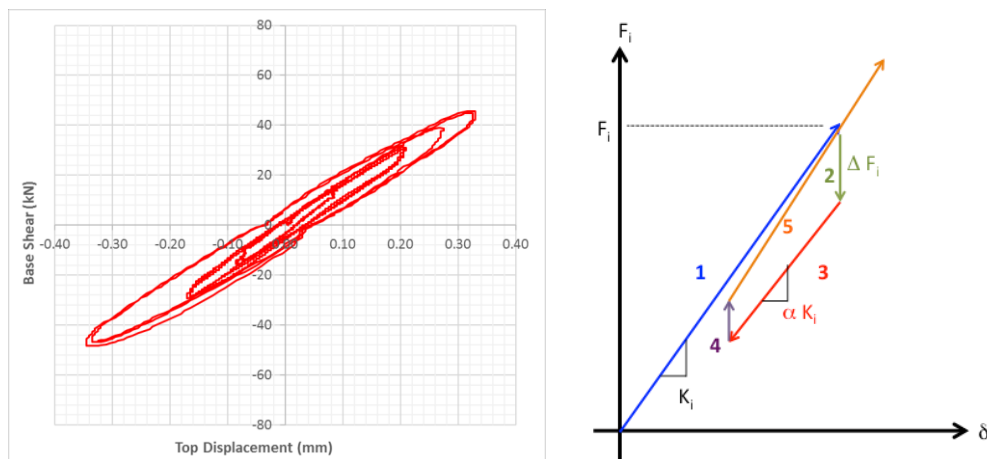
Figure 7: Focus on the experimental load deflection curve for the first 3x3 cycles (left) and an idealized hysteresis backbone (right)

Zoom into the very first 3x3 cycles, as shown in Figure 7 (left), provides insights regarding the extremely low amplitude response of the URM walls in question. The hysteresis loops of the first cycles is quite fat, leading to residual displacement and energy consumption, so damage, in the very beginning of their response. After analyzing several cycles in the experiments, the initial backbone curve suggested for the very low amplitudes can be seen in Figure 7b. It should be noted that the main issue in this behavior, at the very beginning of the response, is the force drop when the cycles reverse. As opposed to bi-linear response, for instance, the constant is the displacement but not the load. This created practical problems in modeling these URM walls since none of the available and suitable models can consider a strength drop under constant displacement, since the hysteresis loops are mostly set for large deformations and the case is the increasing displacement under constant or slightly increasing/decreasing loads. More insights are provided on this issue in the rest of the paper.

In Figure 7 (right), in line with the experimental results, there are two characteristic behaviors that need to be addressed in a suitable hysteresis loop, which are i) at the beginning of every unloading, there is a force drop of  $\Delta F_i$ , and ii) the unloading stiffness is always smaller than the initial loading stiffness, thus the initial stiffness  $K_i$  is multiplied with a coefficient  $\alpha$ , that is smaller than or equal to 1.0.

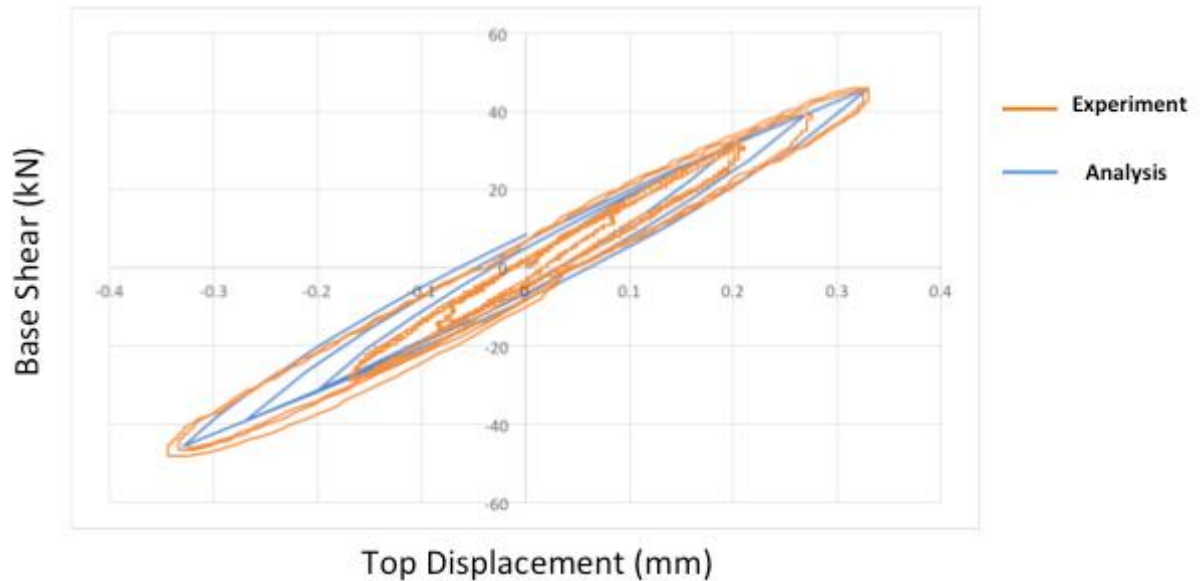
Figure 8: Calibration of the numerical model with the response of the tested specimen in terms of base shear versus top displacement for the first 3x3 cycles of the conducted experiment.

At this point, a simple numerical model was created in the SeismoStruct software to simulate the response of the tested specimens for the very first cycles of the conducted experiments which seem to be of major importance. The Ramberg–Osgood [5, 6] constitutive model was applied on a link element, taking into consideration also the physical characteristics of the tested specimens, such as the mass, stiffness, and strength. The response of the utilized numerical model is presented in the Figure 8, comparing with the response of the corresponding specimen. Their comparison yields to a reasonable match in terms of horizontal force – top displacement response.

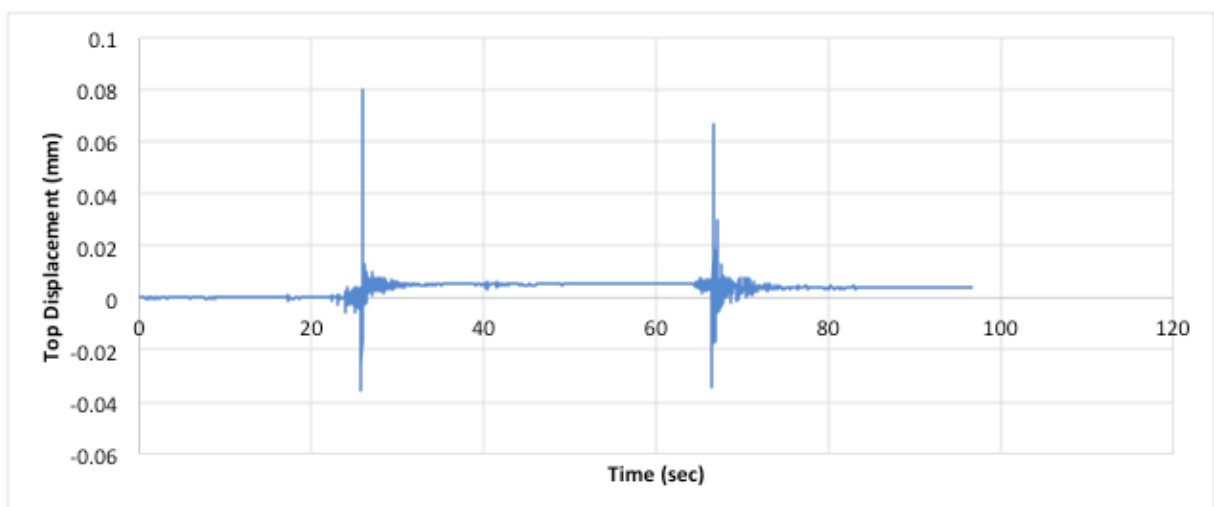
Figure 9: Top displacement time history of the squat specimen for scenario #2

In order to explain the findings, only the results of the scenario #2 is presented here (see Figure 9 and Figure 10).

By using the calibrated Ramberg-Osgood model, and by applying several recursive seismic actions, it was found that the residual top displacement is approximately 0.05mm after 2014 event, and it goes down to approximately 0.025mm after the 2012 Huizinge event. Repetition of the 2014 event for 5 or 10 times does not alter this response.

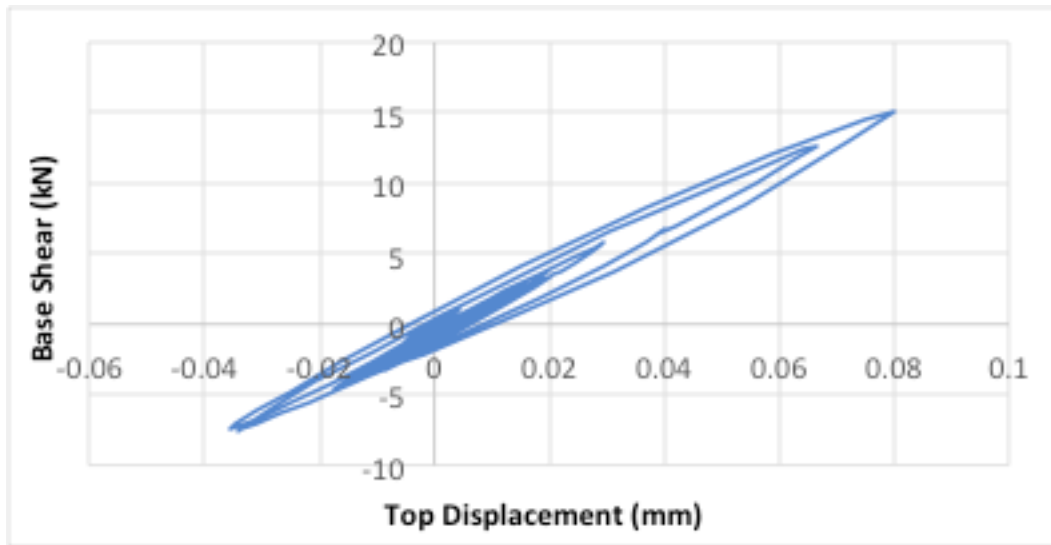
Figure 10: Top displacement versus base shear for the time history of the squat specimen for scenario #2
