## **EXPERIMENTAL ASSESSMENT OF STRENGTHENING STRATEGY TO IMPROVE THE MASONRY INFILLS OUT-OF-PLANE BEHAVIOUR THROUGH TEXTILE REINFORCED MORTAR**

The present work focusses in the assessment of the efficiency of a strengthening technique based on textile-reinforced mortar (TRM) to improve the OOP behavior of a full-scale infill panel. For this, two specimens tested to OOP loadings applied by pneumatic actuators. The first specimen is representative of the enclosure of a typical existing RC building in the Southern countries in its "as-built" condition. The second specimen was strengthened with textile-reinforced mortar using glass fiber mesh. Experimental results will be presented and detailed in terms of out-of-plane force-displacement responses and damage evolution. In the end, the results of the tests are compared to assess the effectiveness of the strengthening technique.

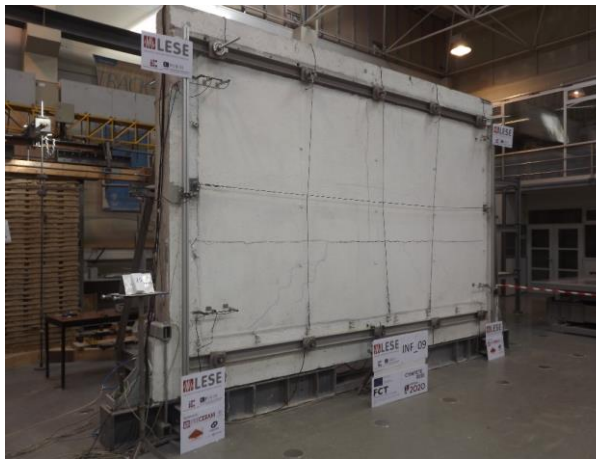
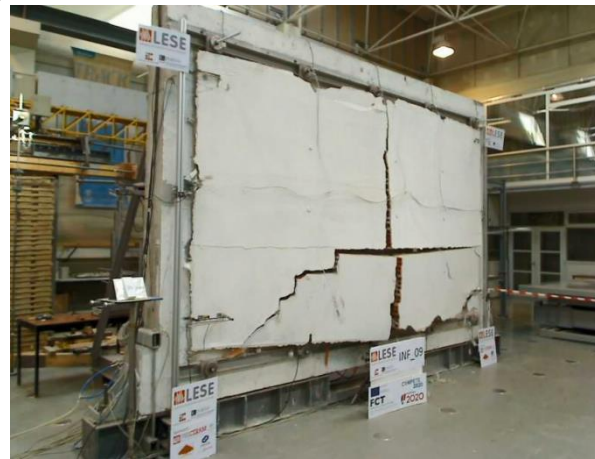
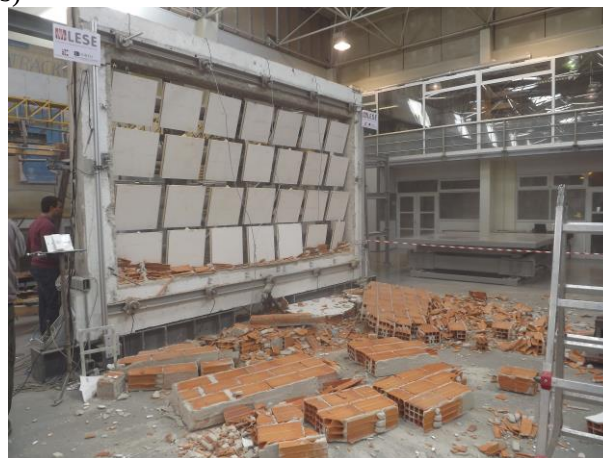
Figure 6: Specimen Inf\_09: a) Cracking pattern; b) Final damage before the panel collapse; c) Beginning of the panel collapse; d) Final damage after the panel collapse.

During the test, it was not detected any damage until an OOP displacement equal to 5mm. At this level of OOP displacement occurred the plaster detachment in some parts of the panel. After that, at the OOP displacement equal to 7.5mm it was observed the beginning of a horizontal cracking at 1/3 of the panel height. When the panel reached the OOP displacement equal to 15mm, the horizontal crack becomes more pronounced and at the same time appeared a vertical crack at the middle of the panel, from the top until the horizontal crack. Quite often, when the OOP displacement reached 25mm diagonal cracks were visible, which started in the same alignment of the horizontal crack until the bottom of the panel. At the end, at the OOP displace-

ment equal to 30mm it occurred the panel collapse. The cracking pattern was essentially trilinear as evidenced in Figure 6a. Figure 6b and 6c presents the panel immediately before and after the collapse.
