## **PREFABRICATED REINFORCED CONCRETE CLADDING PANELS SUPPORTS: DESIGN AND NUMERICAL MODELLING**

### **Abstract**

## 2 COOLING TOWER CLADDING PANEL COLLAPSE

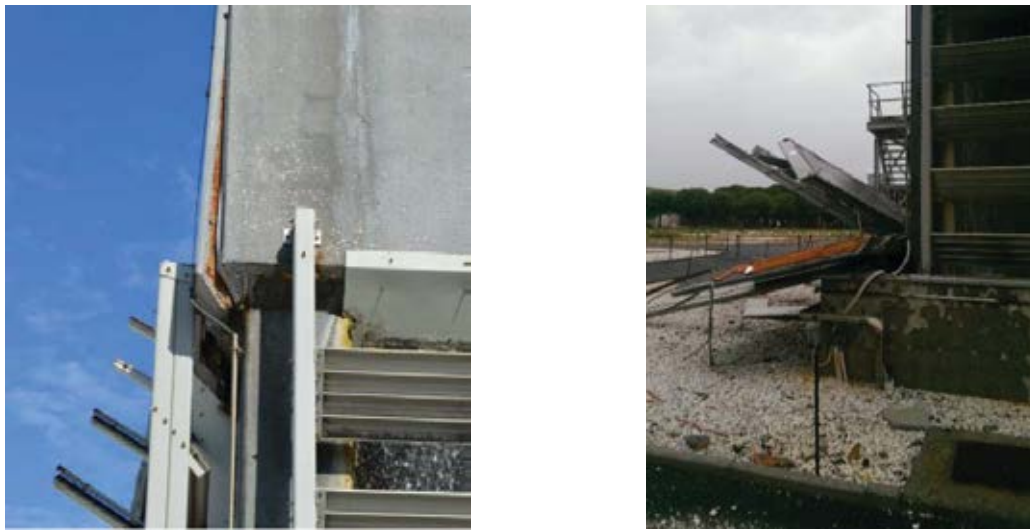
Figure 2: South-West corner before (left) and after (right) the collapse.

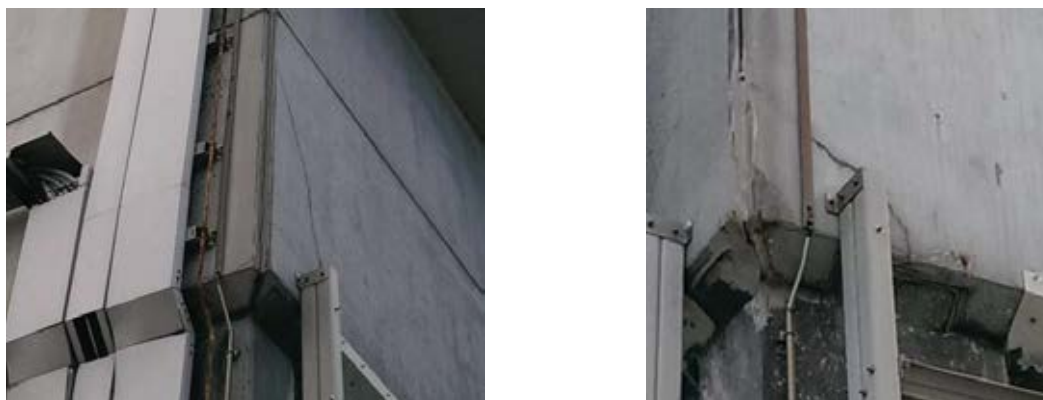
- mechanical characterization of the concrete of the various components (panels, columns, support);
- reinforcements emerging from the collapsed panels and cantilever;
- cracks on the lower edge panels still in position.

Figure 3: Cracks on the remaining panels.

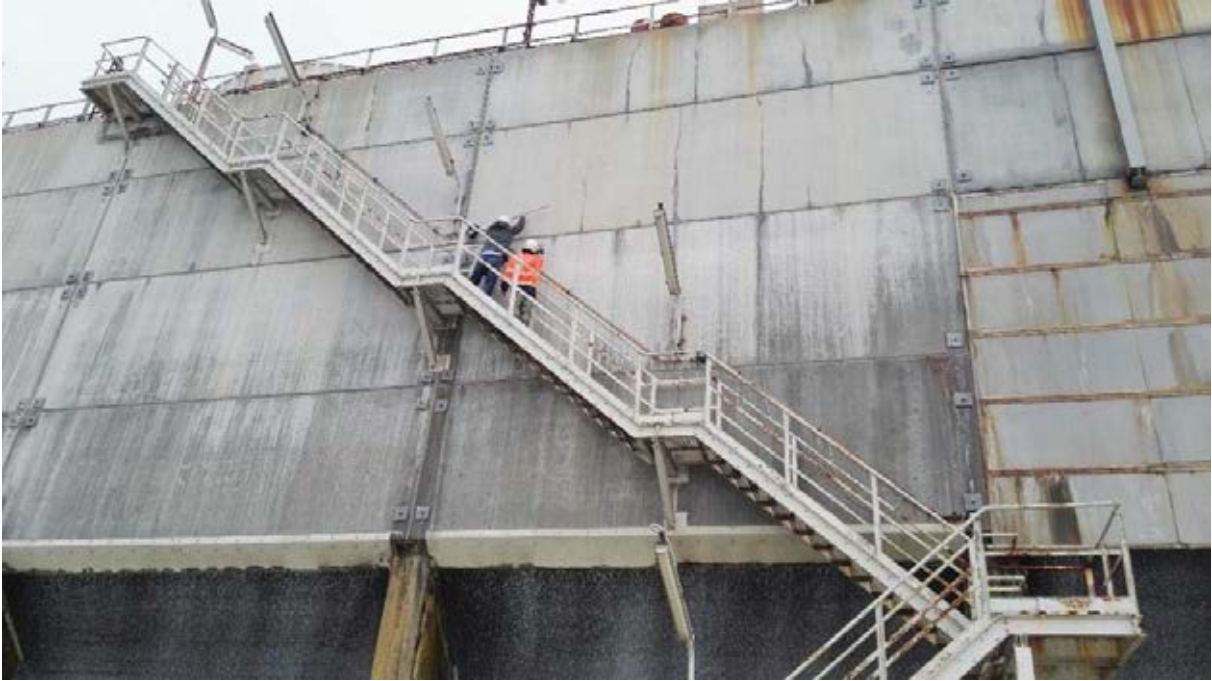
Figure 5: Details of on-site installation of the connectors.

To improve the safety of the other RC panels several additional connectors, realized with AISI 316 L steel ( $\phi 27$ mm,  $L=500$ mm), were applied throughout an injection with epoxy resins. These elements can guarantee structural integrity over time even in aggressive microclimatic conditions (Figure 4). Their external position (Figure 5) allows to carry out periodic maintenance inspections and to keep the support condition under control. The philosophy of intervention is to introduce redundancy in the system. Instead, the original detail did not have structural robustness, and, in case of material degradation, the failure is incipient.
