## **3D ADVANCED NUMERICAL MODELLING OF A CATALAN-LAYERED MASONRY VAULT UNREINFORCED AND REINFORCED WITH GLASS-TRM MATERIALS AND SUBJECTED TO VERTICAL SUPPORT MOVEMENTS**

**E. Bertolesi<sup>1</sup>, G. Milani<sup>2</sup>, J. Adam<sup>3</sup> and P. Calderón<sup>3</sup>**

### **Abstract**

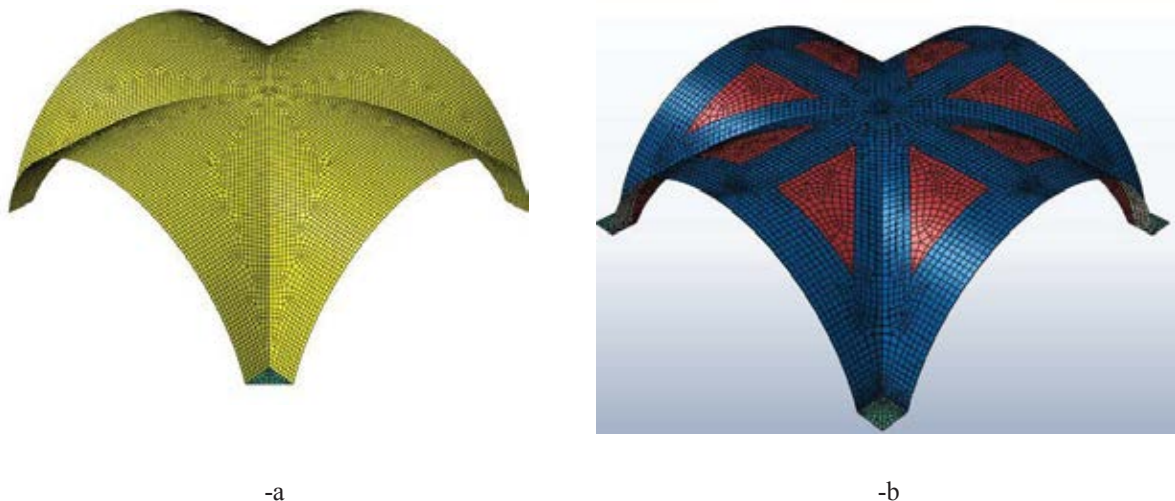
Figure 3: 3D models of the timbrel vault: unreinforced structure (-a) and TRM reinforced structure (-b).

The vault behavior was modeled using a 3D macro-modelling strategy using 4-noded shell elements representing the masonry support and strengthening material. The final models are depicted in Figure 3 -a and -b, respectively considering the unreinforced and TRM reinforced vaults.

In details, the thickness of the masonry supports was considered equal to 70.5 mm for the vault and 159.5 mm in the lateral arches while, the TRM thickness was set to 10 mm. In order to realistically study the effect of vertical settlements, the masonry support and TRM materials were simulated using a Concrete Damage Plasticity (CDP) model available in Abaqus. The elastic modulus of the masonry support was set to 1700 MPa, with tensile and compressive strengths equal to 0.23 MPa and 10 MPa, respectively. The TRM mechanical properties were deduced according to the data provided by the manufacturer when available. In details, the authors assumed an elastic modulus equal to 3179 MPa and compressive strength equal to 17 MPa.
