## **CORRELATION OF VULNERABILITY AND CONSERVATION BETWEEN ARTISTIC ASSETS AND STRUCTURAL ELEMENTS: CAMPAIGN OF THERMOGRAPHIC SURVEYS ON THE FRESCOES OF THE TEMPLAR CHURCH OF SAN BEVIGNATE**

**R. Liberotti, F. Cluni, F. Faralli and V. Gusella**

**Abstract.** *A museum, an art collection and a heritage architecture all in one the former Church of San Bevignate is a 39.5m long masonry building that overlooks the countryside of the Umbria Region in Italy. Part of a Templar complex of the 13th century located in Perugia, it holds within a precious series of frescoes, depicting the heroic deeds of the temple's knights across crossings and borders. The safeguard of historical buildings in seismic hazard-prone Regions, as in this case, needs specific measures due, amongst other reasons, to the presence of artistic assets unmovable precisely as frescoes, valuable plasters/stuccoes or in general wall decorations. Therefore, to define a correlation of the seismic risks between masonry structural systems and artworks is a mandatory condition in order to perform safety evaluation and to identify the proper conditions for possible interventions. The efforts made to increase the level of knowl

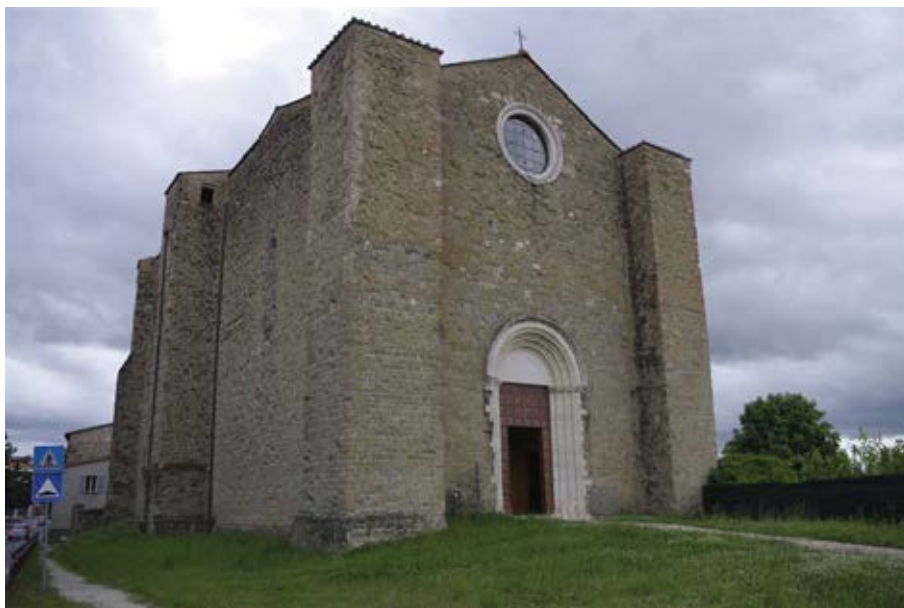
Figure 2: External view of San Bevignate. Image taken from <https://www.iluoghidelsilenzio.it/chiesa-di-san-bevignate-perugia/>.

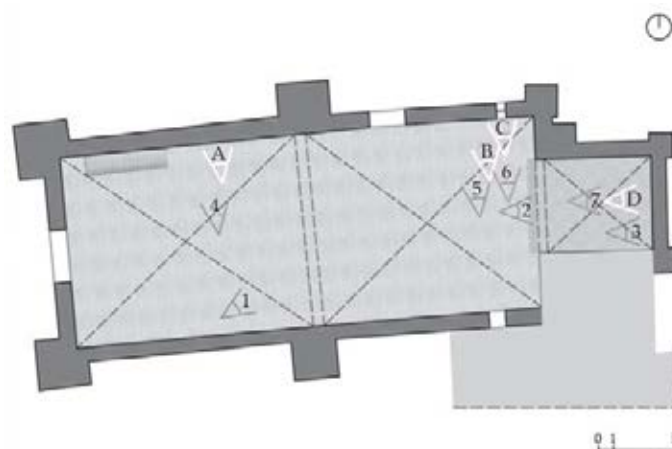
Figure 3: Schematization of the plan of the Church, inside the photographic cones of vision chosen for the survey: in white the settings of thermographic shootings, in grey the digital photography ones.

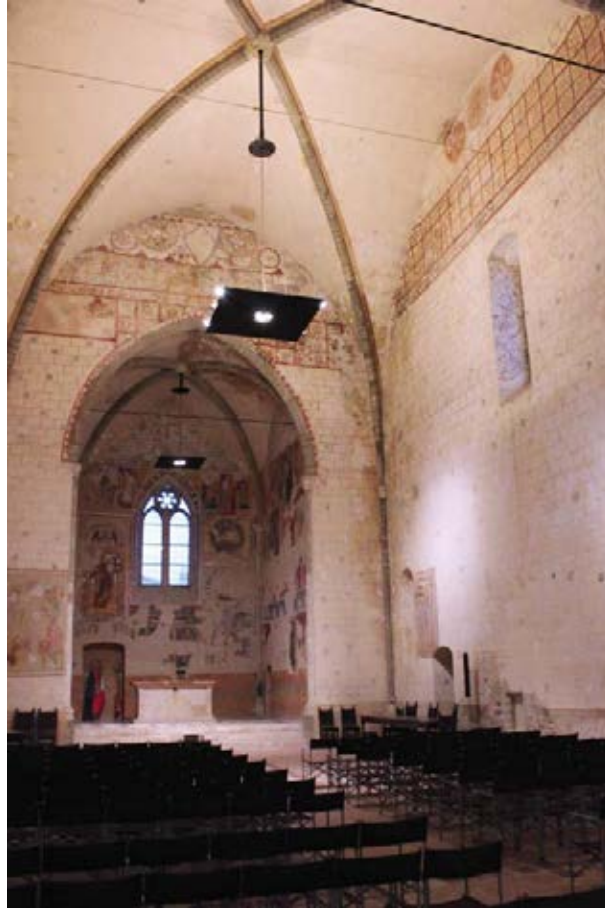
Figure 4: Inner view of the church of San Bevignate (see cone of vision 1 in Figure 3).

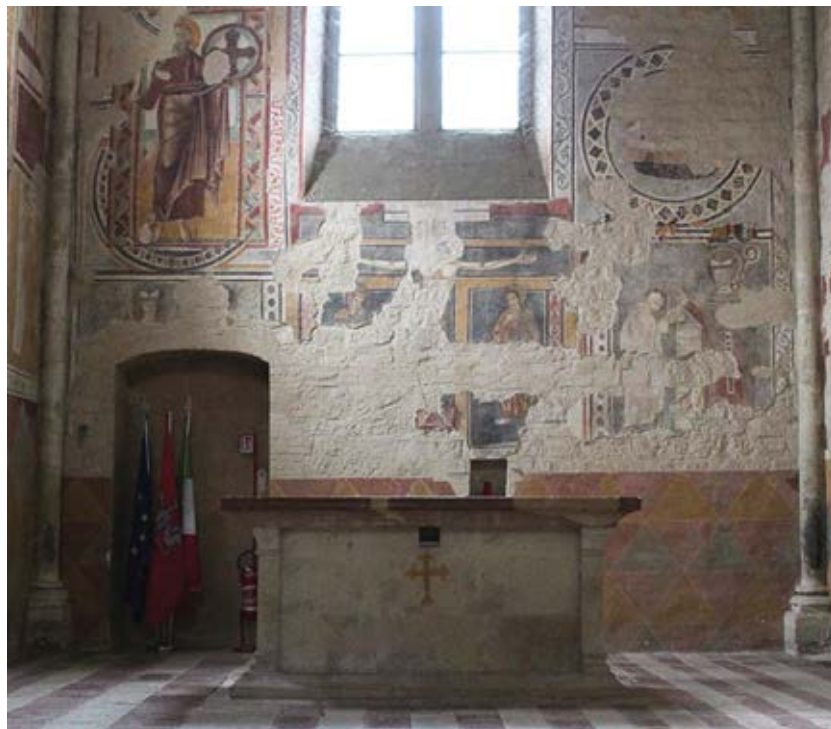
Figure 5: Picture of the altar, in background the lower register of the apse's frescoes (see cone of vision 2 in Figure 3).

A quasi-periodic texture made of stone blocks with different widths, ranging from 25 to 60 cm, but similar heights, of about 20 cm, has been observed; such results matches with what was surveyed in the apse, concerning the areas where the fresco peeled off (see Figure 5) and on the external façades.

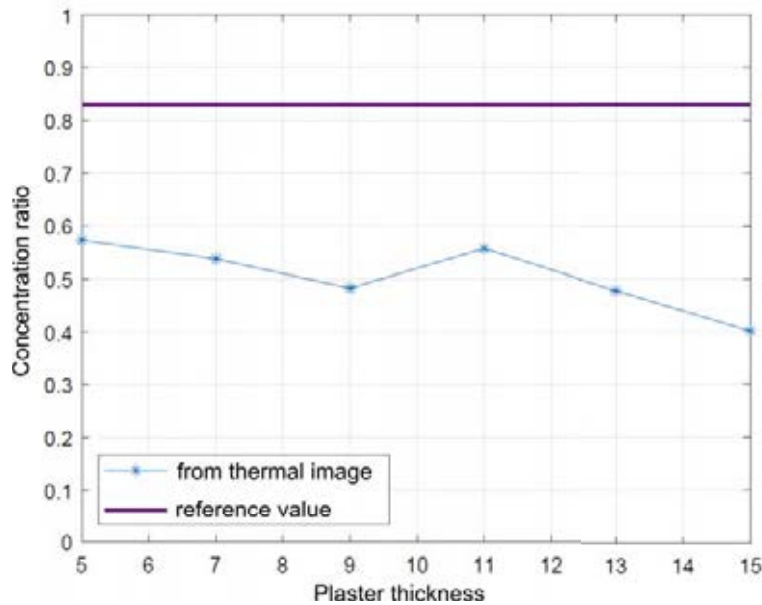
Figure 7: Concentration ratio of strong phase for various plaster thicknesses.

In Figure 7 the concentration ratio of the stone, which is the strong phase, is shown and compared with the reference value.

As can be appreciated, it seems that even small values of plaster thickness lead to a quite large decrement of the percentage estimated for the stones, and therefore further studies are necessary in order to fully assess the influence of plaster thickness when estimating the mechanical characteristics of the wall.

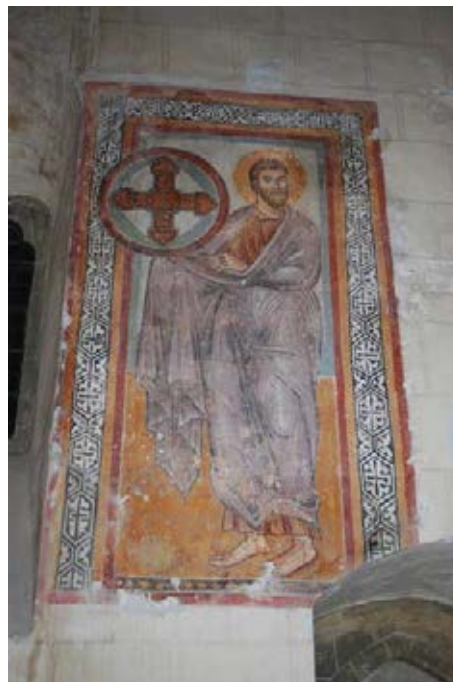
Figure 8: One of the frescoes under investigation, in particular one belonging to the apostle's cycle. 3.

Referring to the frescoes that decorate the examined wall, rows of overlapping ashlar are reproduced to imitate an austere wall face made of stone, this is a typical decoration of the Templar churches aimed to recall the poverty of the holy land. Moreover, the series of the twelve apostles stand out, distributed also on the other side wall, on the façade and the back walls of the apse; such pictorial cycles were superimposed on the original decoration during a second phase between 1283 and 1285. In particular, a first tranche of thermographic surveys covered the mural paintings concerning the apostle’s cycle, Figure 6.

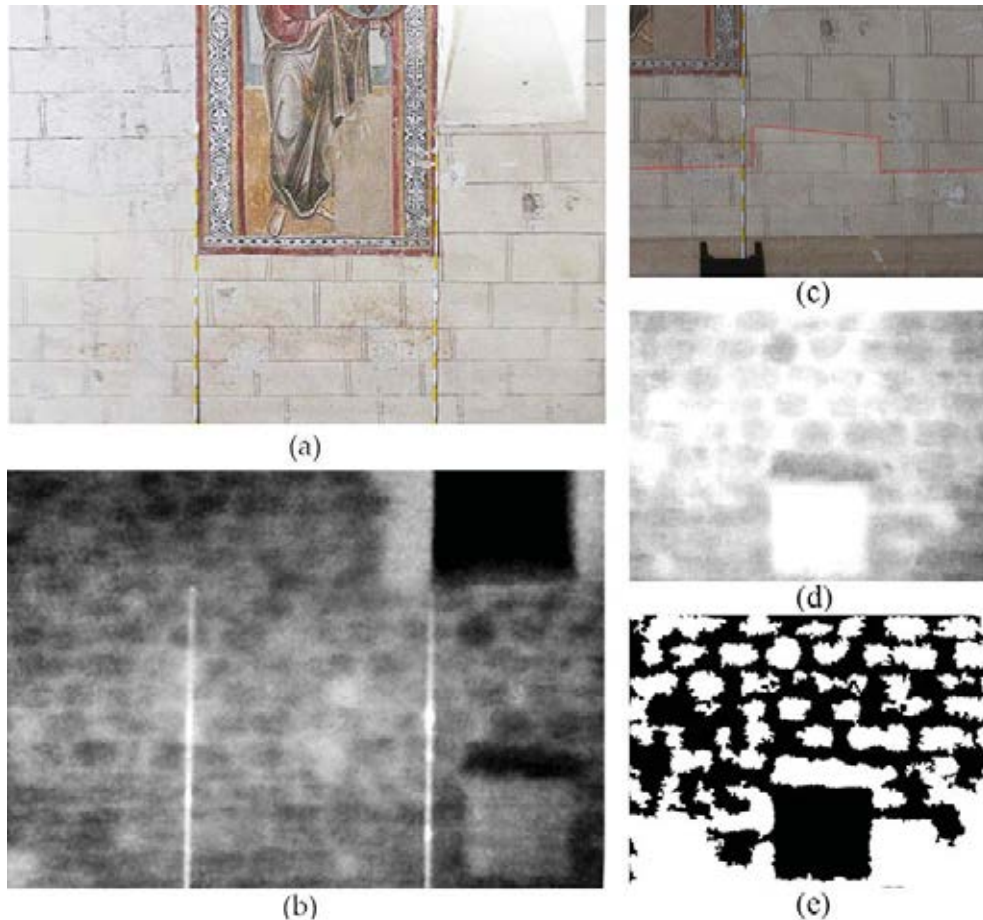
Figure 10: (a) Picture of a fresco near the apse. In the pictures, the reflective meter-sticks located as reference points for the subsequent post-processing are visible. (b) Thermal image with improved contrast in which are visible the structural peculiarities of the masonry wall, in the right corner is observable the former recess (see the cones of vision 5 and B in Figure 3). (c) Particular of the fresco under investigation, are observable colours of different gradation. (d) Thermal image with improved contrast. (e) Final binary image (see the cones of visions 6 and C in Figure 3).

The role of the latter approach in detection and qualification of deficiencies/discontinuities in the stonework is an important aspect [21, 22, 23, 24]. Through the analysis of another part of the same wall, located near the apse and in the proximity of a window, it was possible to discover the presence of a blind opening in the original masonry, which now is totally bricked up (Figure 10). In this second case the meter-sticks were placed at a distance of about 1.40 m leading to deduce a size of  $65 \times 75$  cm for the part walled up with a masonry typology different from sandstone. Additionally, there was pointed out the different emissivity and the presence of an architrave made of another material (possibly wood) of about 15 cm thick. Moreover, about the constructive phases and criteria, the peculiar workmanship, and the different material were also observable on the abutments of the window.

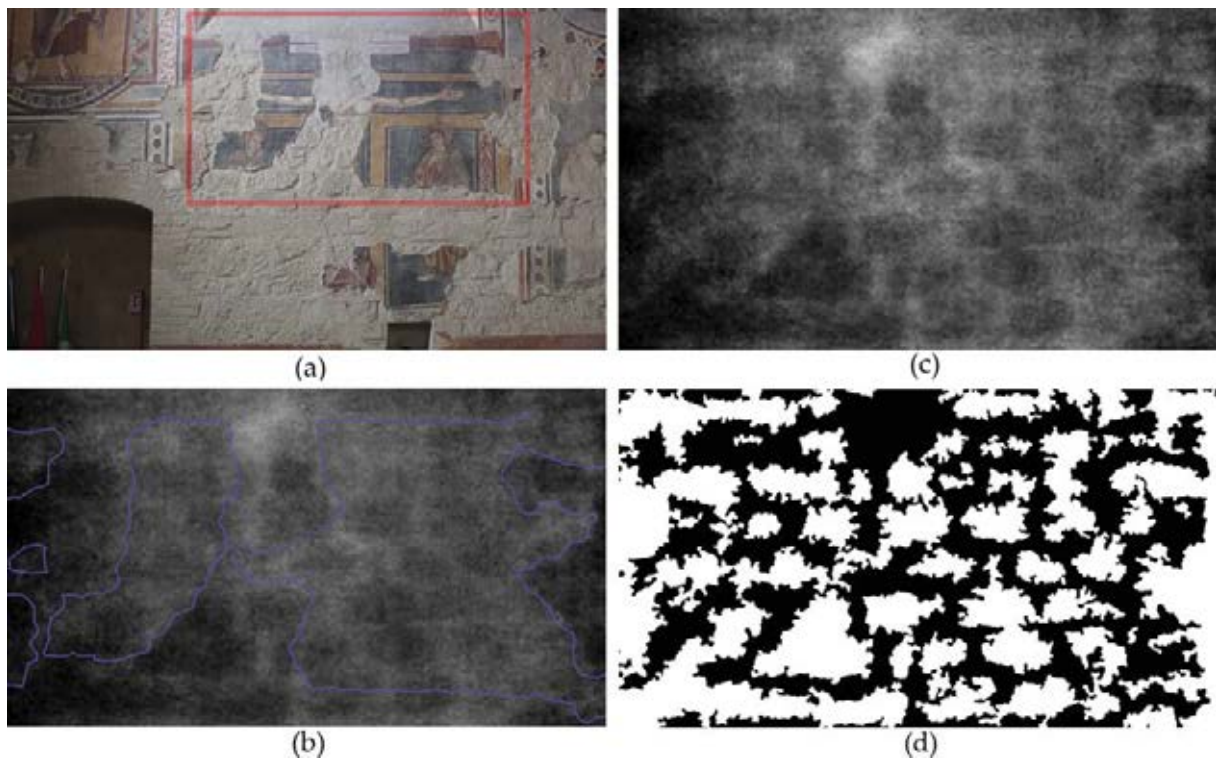
Figure 11: (a) Portion of the fresco under investigation, (b) thermal image where are highlighted in blue the edges of what remains of the frescoes, (c) thermal image with improved contrast, (d) final binary image (see the cones of vision 7 and D in Figure 3).

Indeed, a toothing masonry has been realized, characterized by the process of leaving alternate stone "teeths" for a better adjoining block or brick wall to be started from. Even nowadays, such technique is used when windows or door openings must be made from an existing wall, by demolition and cutting of masonry, allowing the adjoining wall to develop without having to adjust or cut bricks. It is also noteworthy to notice how, already with the naked eye - can be seen in Figure 10 - portions of the fresco with colours of different gradation are observable, probably due to varied breathability of the materials making up the masonry. This scenario is also confirmed by what emerged from a closer thermographic picture: assuming a stratigraphic interpretation of the wall, arise the construction phases of the ancient site executed by different bricklayers, made by lower rows of a type of stone (which appears darker) probably of superior quality compared to that of the band between the recess and the window where instead the masonry is composed of smaller elements thus making the presence of mortar predominant. Moreover, it is interesting to remark that the filling of the recess does not present any masonry texture as if it had been filled entirely with a concretion material. Finally, a thermographic investigation involved a part of the apse wall. This portion of the church was chosen because here can be found the coexistence of portions of plaster with parts of the masonry emerging, because of the detachments of the fresco that in past centuries were witnessed by the restorers. From the

thermographic images, one of them can be seen in Figure 11, it appears that to date there are no infiltrative nor detachment or disruptive phenomena of interest undermining the safeguard of the decorations under examination.
