“SCAGLIA ROSSA” EXPERIMENTAL CAMPAIGN AND MODEL UPDATING FOR NUMERICAL DAMAGE EVALUATION

G.P. Salachoris¹, E. Magagnini², and F. Clementi²

Abstract

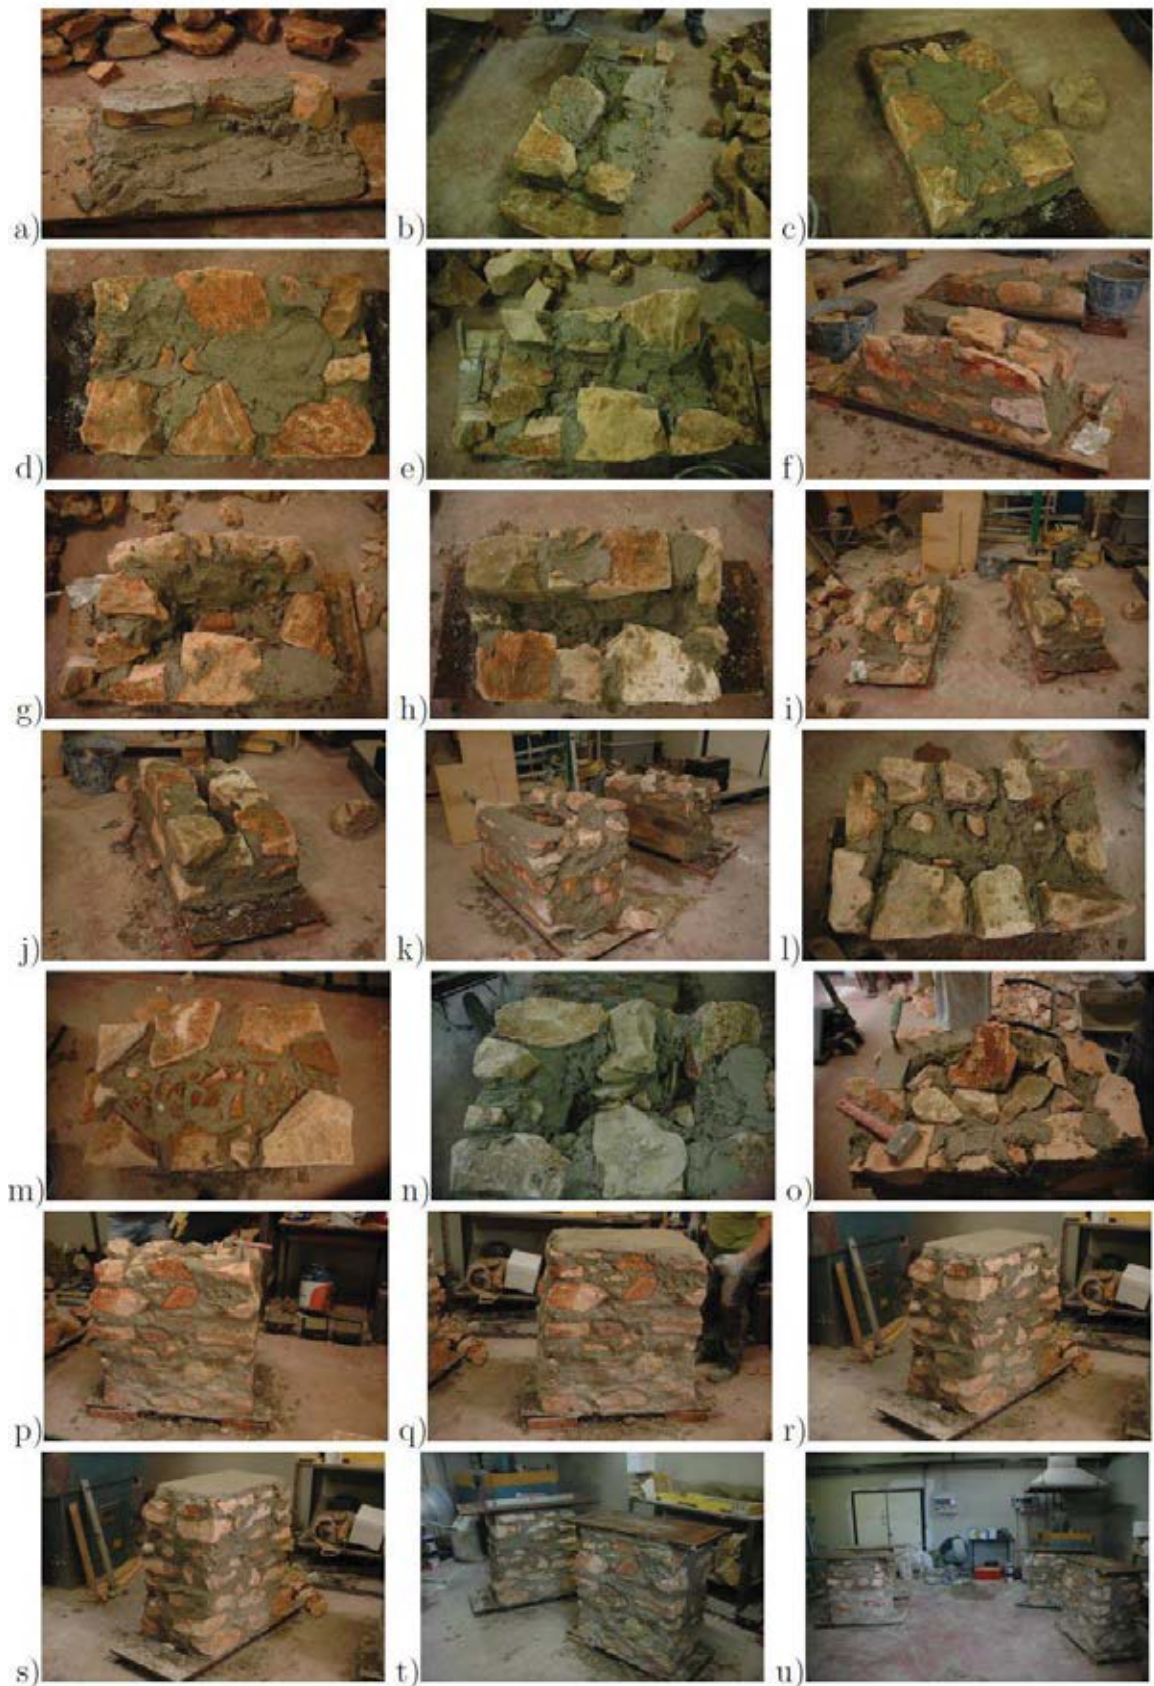
Figure 1: Construction process followed for the wall specimens with "Scaglia Rossa" limestone applying the double leaves technique.

The constructed walls for the masonry mechanical parameters evaluation are four in number and are made with samples of different sizes and shapes utilizing a double leaves technique (Figure 1). Two different kind of tests were performed: a load bearing test in order to establish the behavior under vertical static loads on one wall and load-bearing tests in order to establish the resistance to horizontal loads acting in the plane for all three walls. The dimensions of the four constructed walls are reported in Table 1.

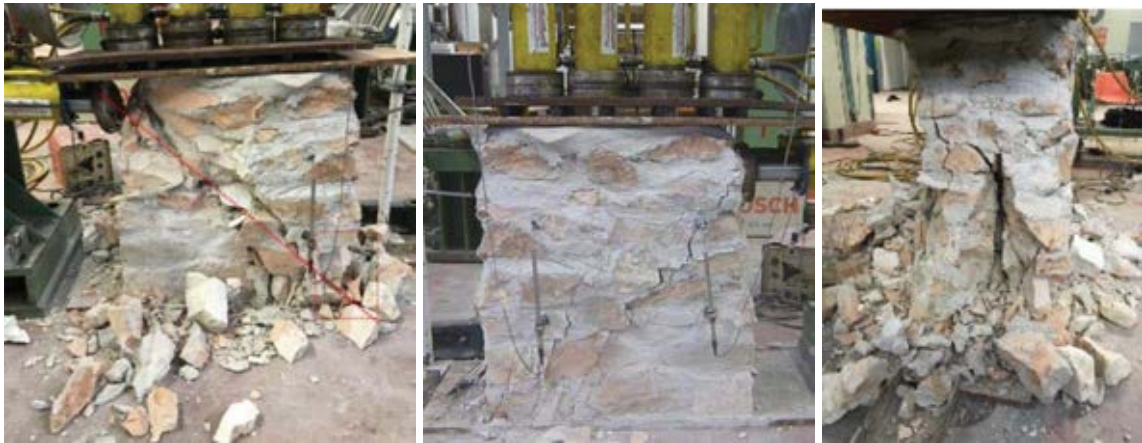
Figure 6: Damaged specimens at the end of the load-bearing-shear test for Wall#1, Wall#2 and Wall#3.

All the performed tests showed homogeneity in their behavior, with a maximum resistance standing above 500 kN except for local criticalities. In more detail, Wall#1 retains the maximum force applied at 580 kN with the displacement arriving at 2.6 mm or the drift is 0.31%. For Wall#2, the maximum force stands at 500kN for a drift of 0.18% and Wall#3 a maximum force of 580kN is observed for a drift of 0.22%. The drift values are comparable with values encountered in National Standards for nonlinear analysis of masonry's walls. The absence of plateau is given to the highly fragile behavior of the specimens once the maximum force is reached. The damage observed indicates in all the specimens a diagonal rupture due to compression and shearing and in some cases panel disintegration when the maximum force applied was reached (Figure 6).

The non-monolithic behavior of such matrix is well represented and does confirm the behavior found commonly in stone walls made by substantially joined faces with diatones providing connections transversally.
