## **OPTIMIZATION OF EMPIRICAL SEISMIC VULNERABILITY ASSESSMENT FOR MASONRY BUILDINGS FOLLOWING NONLINEAR ANALYSIS**

**E. Onescu<sup>1</sup>, I. Onescu<sup>2</sup>, and M. Mosoarca<sup>2</sup>**

### **Abstract**

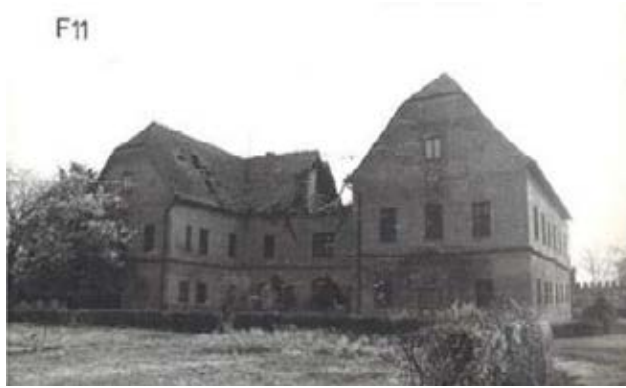
The strongest seismic event registered in Banat area was the earthquake from 1991, in Banloc city, at less than 40 km from Timisoara, with a magnitude  $M_w = 5.5$  and a focal depth of 11 km, followed by a strong aftershock of a magnitude  $M_w = 5.3$  and a focal depth of 5 km [7]. After the event, there were registered damages, especially to attics, arches, lintels, and chimneys, as presented in Figure 7 [3],[8].

Figure 7: Damages to masonry buildings in the epicenter after Banloc earthquake, 1991 [3], [8]

There were observed both in-plane and out-of-plane failure mechanisms. The in-plane mechanism that can be noticed is mostly the diagonal shear cracking, especially in the façade masonry walls. Also, the vertical cracks can be seen due to the presence of strong vertical forces and L and R surface waves. Following the on-site observation, there was defined a specific failure mechanism for historic masonry buildings located in the near-field areas, after earthquakes of crustal type, as illustrated in Figure 8 [9].

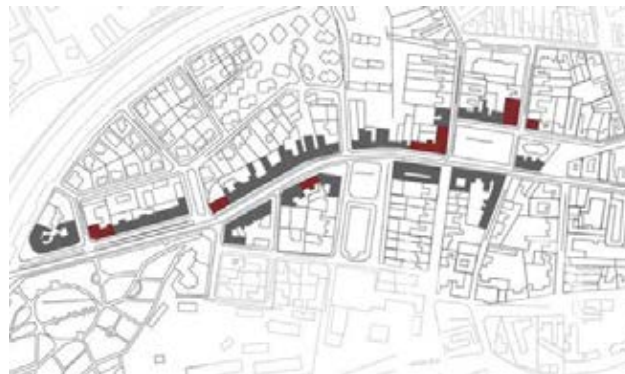
The investigated buildings are considered to be representative of the area, from all existing height regimes. Their location is presented in Figure 11 [13].

Figure 11: Location of the case study buildings [13]

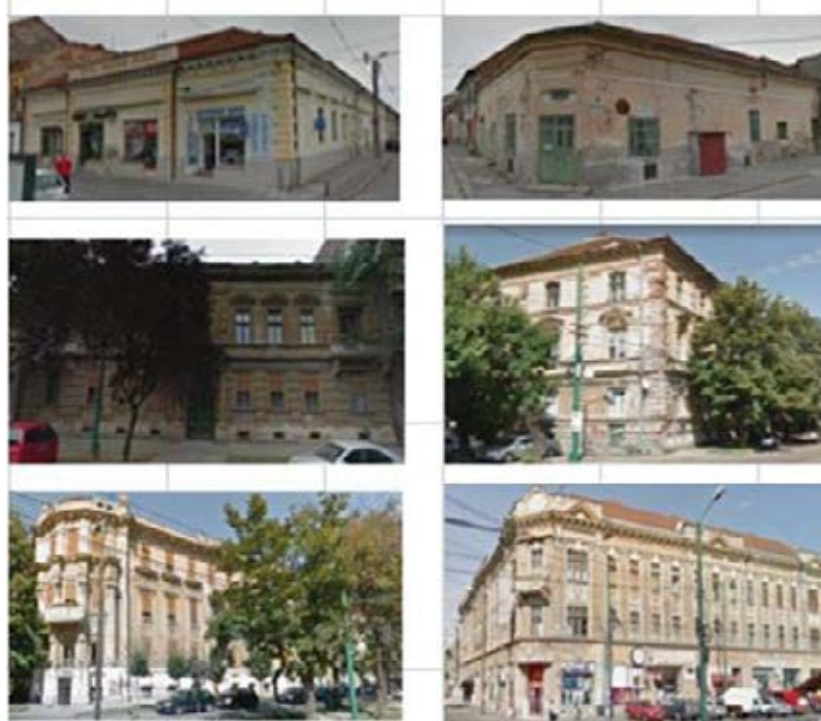
The six selected buildings for investigation are presented in Figure 12 [13].

Figure 12: The six selected buildings for further investigation [13]

In the area, there can be noticed that almost all buildings present the basement, while the minimum height regime is basement and ground floor, and the biggest is a basement, ground floor and two levels. The structural system of all investigated buildings is the masonry of burnt clay brick and lime. The buildings are located with the longest dimension along the main street, presenting massive façade and intermediate walls with thicknesses from 80 centimeters in the basement and 40 centimeters on the last floor. The transversal walls are not connected with the façade walls in most of the cases and are much thinner, around 15 centimeters [3], [14].

The horizontal structural systems are masonry vaults above the basement and sometimes ground floor and wooden floors for the other levels. There can be noticed, in many cases, a very tall complex wooden framework for the roof structure [3], [14].

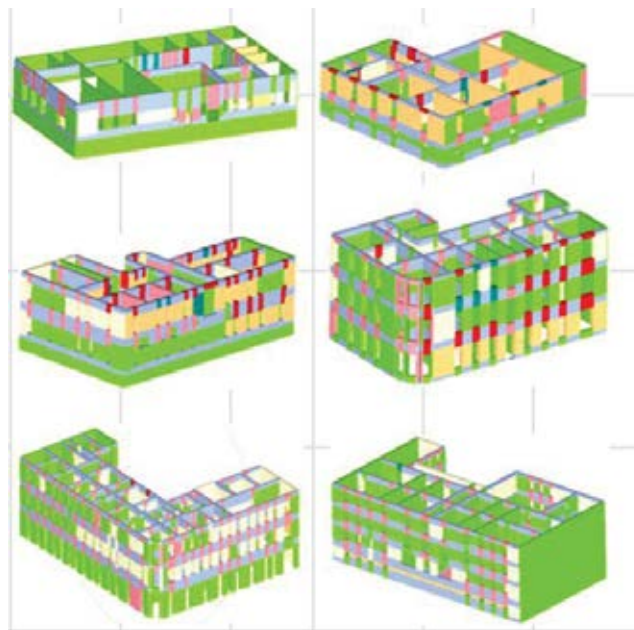
The analysis made with Tremuri is a simplified analysis, appropriate for the investigation of more than one building, and can be used for historical masonry buildings. It has revealed the expected cracks damage distribution, as presented in Figure 19 [13].

Figure 19: Cracks and failures to the six investigated buildings after pushover analysis [13]

The pushover analysis has revealed that the buildings would suffer both nonstructural and structural damages for the considered seismic scenario, around damage states D2-D3. In Table 3, there are presented the yielding and ultimate displacement and also the maximum shear forces [13].

The results indicated by the pushover analysis highlight the possibility of an appearance of cracks and failures due to bending forces, especially to the lintels at the upper part of the buildings. Also, there can be noticed, in some cases, cracks and failures due to shear forces at the spandrels also located on the top floors. These aspects indicate a general damage state of D2-D3 for all six investigated buildings.
