DIAGNOSTICS OF HISTORICAL STEEL BRIDGES: THE CASE OF THE VALENCIAN RAILROAD NETWORK

The proposed procedure is applied to a riveted steel bridges located in the Valencian railroad networks (Valencia region, Spain).

The proposed methodology to derive an analytical failure tree from a FEM model is applied to the “Quisi” riveted steel bridge located in the Valencian railroad networks (Valencia region, Spain). The “Quisi” bridge is a multi-span truss deck bridge connecting the towns of Alicante and Denia, built between 1913 and 1915, which currently is still in-service within the Spanish railway network.

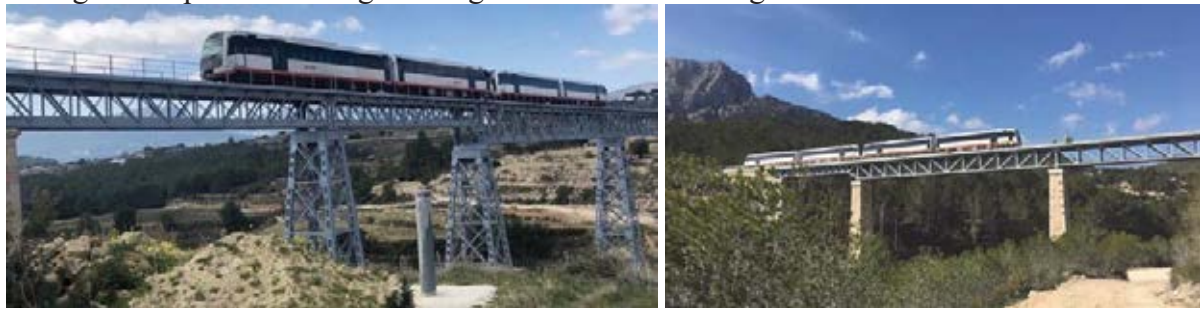
Figure 1. Two examples of old steel bridges in the Valencian railroad network: “Quisi” (left) and “Ferrandet” (right) bridges.

In *Valencian region* a large number of *riveted steel bridges* were built to create the railroad network from the middle of the 19th century to the first decades of the 20th century when the use of steel in bridge construction was widespread. After more than 100 years of existence of this railroad network, many bridges need repairing or strengthening interventions due to changes in service requirements or pathologies. In addition, since the steel bridges have been subjected over the years to an increasing number of train passages (which means a large number of load cycles from the beginning to nowadays), the *fatigue* phenomena could affect their remaining life. In particular, fatigue often leads to a brittle fracture that, joined with a typical low level of redundancy of these types of structures, produces a high risk of collapse. Figure 1 shows two examples of old steel bridges in the Valencian railroad network.

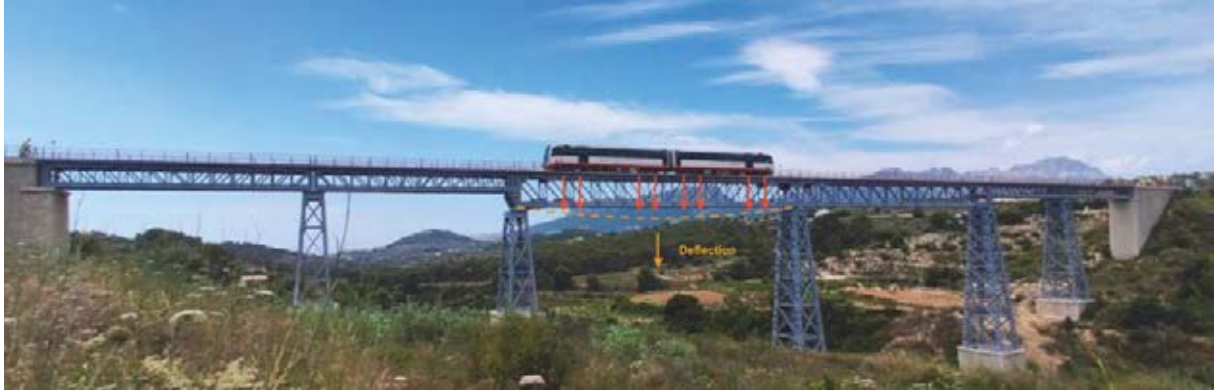
Figure 4: Static and load test on the bridge.

A *static load* test is performed: a train composed of two wagons, representative of the real service loads, is placed at the middle of each span and the stabilized *maximum deflection* of the truss is measured. Furthermore, the deformations in some significant truss components are registered thanks to the numerous strain and displacement sensors (Figure 4). In addition, a dynamic test is performed, in which a moving train travels on the bridge (speed of 30 km/h) and the strains and stresses of significant members are evaluated. This latter test allows for measuring bridge dynamic parameters such as the *modes of vibration* and *natural frequencies* by using a set of accelerometers during the same test.

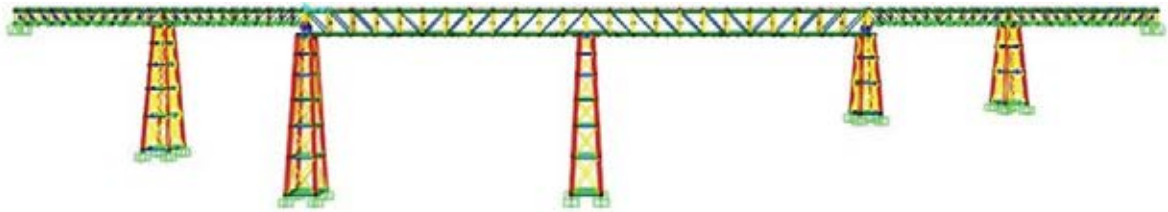
Figure 5: Structural Model of the investigated Bridge realised with SAP2000.

The FEM model is realized with the software SAP2000 (Computer and Structures INC (CSI). SAP2000 - Structural Analysis Program 2018) by exploiting the results of the described investigation plan. Figure 5 shows the structural model of the investigated Bridge. All the built-up members are modelled by single frame elements. The bearing devices connecting the trusses to the top beams of the towers are represented by linear *two-nodes links*. The elastic modulus of the steel is fixed at 210000 MPa and fully fixed foundations are considered. Rigid end zones are placed to model connection zones between the frame elements.

Some geometrical modelling assumption are necessary in order to reflect correctly the acquired information in the numerical model. In particular, the riveted connection beam-diagonal is modelled by using a fixed connection with rigid end offsets. Moreover, the isostatic span is assumed with the following external restraints: i) the fixed bearing modeled through pinned (i.e. fixed displacement) connection, ii) the movable bearing allowing a free longitudinal translation.

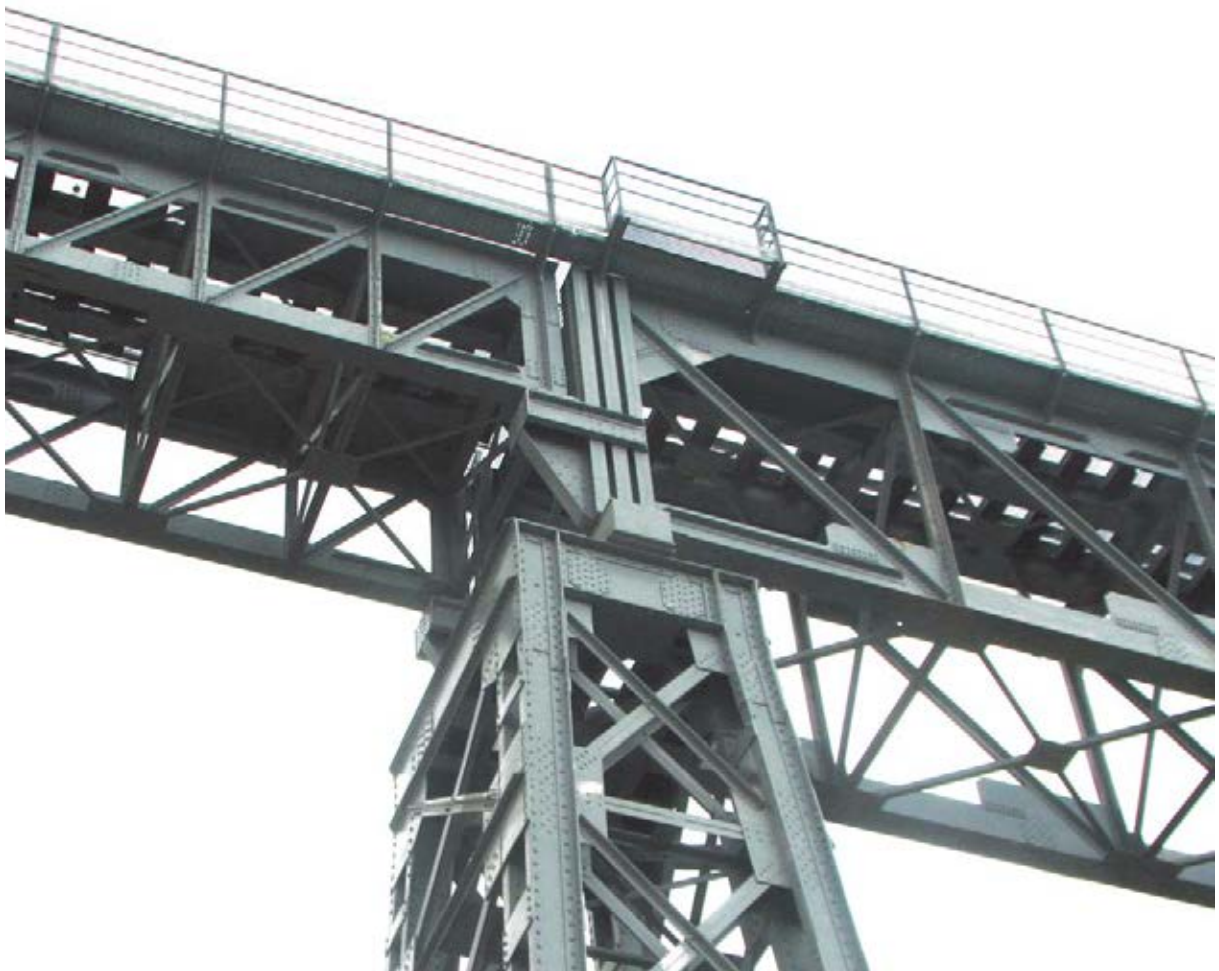
Figure 6: Connection between the isostatic span 2 (left), the hyperstatic span 3 (right) and the steel tower.

Figure 6 shows the connection between the isostatic span 2 (left), the hyperstatic span 3 (right) and the steel tower.
