## **SEISMIC VULNERABILITY OF MUSEUMS' COLLECTIONS: A CASE-STUDY**

**Silvia Lelli<sup>1</sup>, Maria Gatto<sup>2</sup>, Marco Tanganelli<sup>1</sup>, and Stefania Viti<sup>1</sup>**

### **Abstract**

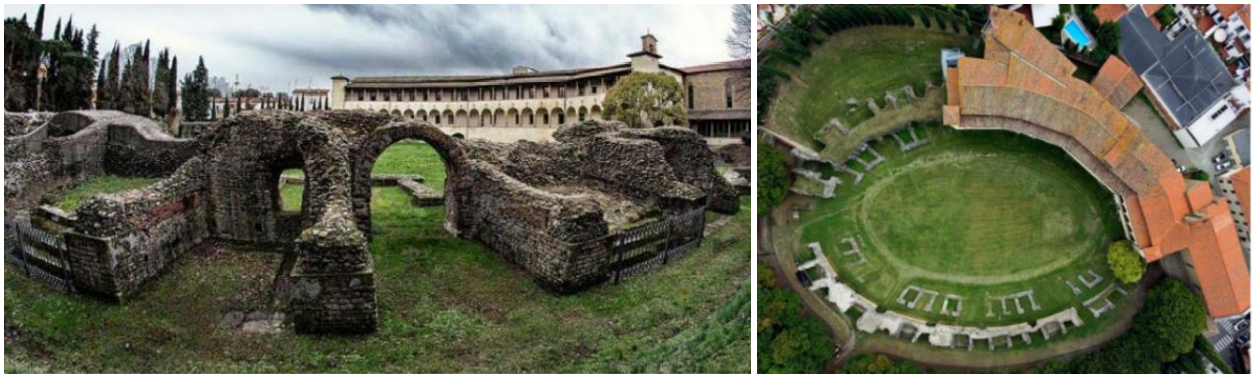
Figure 1. Views of the amphitheater and the Museum.

The National Archeological Museum “*Gaio Cilnio Mecenate*” (Figure 1) is placed in the old San Bernardo Monastery. The building is situated in Arezzo's historical down-town, next to the ancient Roman amphitheater.

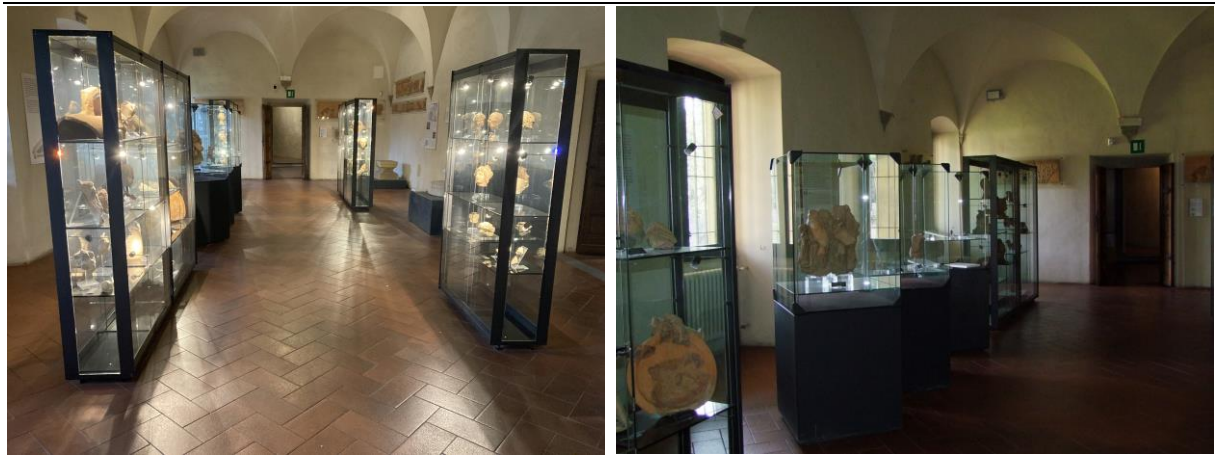
Figure 7. Views of the room “*Arezzo Etrusca*”.

**Room form.** The current arrangement of the room “*Arezzo Etrusca*” has been made in 2013 by Dr. Silvia Vilucchi. The room, shown in Figure 7, is placed in the central part of the ground floor of the Museum; it has a surface of 77.30 sqm, 4 windows and three doors. As it is shown in Figure 8, the room has some lighting and sensor devices fixed at the ceiling and the walls.

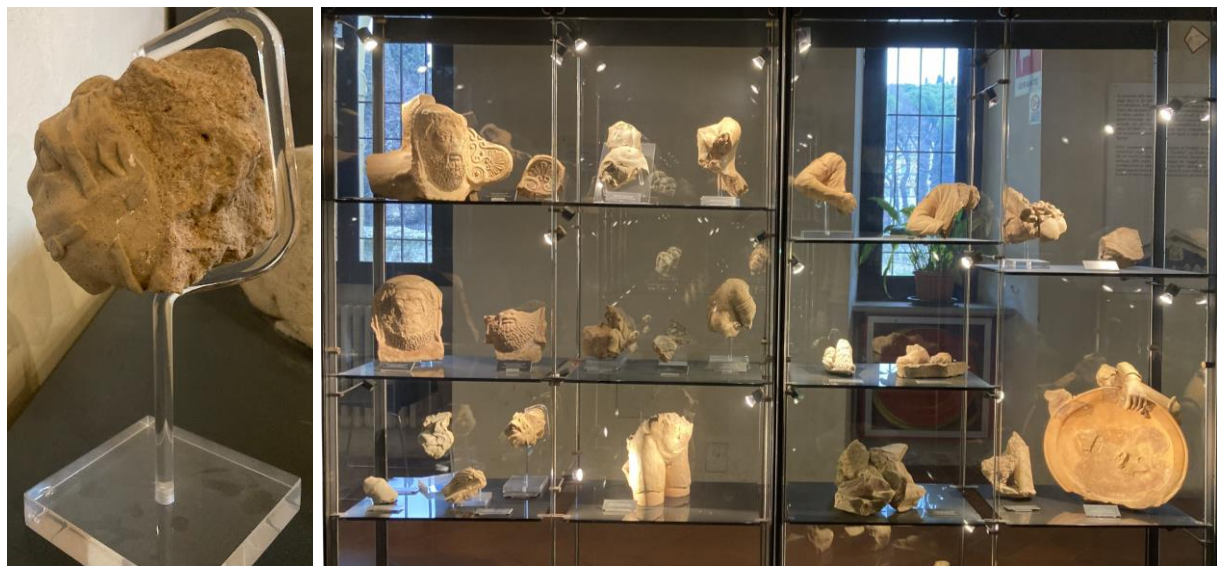
Figure 10. Display of the “Frammento di testa equina in terracotta”.

*Displayer form.* The displayer consists of a special pedestal, made in Plexiglas, which follows the shape of the item. It stands on the glass shelf of the window, laying, in turn, on the floor. The assessment of the seismic safety of the displayer, therefore, is not immediate, since it requires to analyze the stability of both the window, comprehensive of its shelves, and the Plexiglass device, beside the relationship between the floor and the window, and the window and the pedestal and the interaction between adjacent windows and adjacent pedestals. The possible interaction between the displayer system and the item will be face in the *vulnerability form*. Figure 10 shows two displayer images, together with the main information collected in this form. As can be seen, the window is placed next to another one, having the same dimensions, which can certainly interfere with its vulnerability in case of seismic excitation.

The dynamic response of the window could interfere even with the vulnerability of the item's pedestal.

system	material	dimension	shape	slenderness	weight	device interface	interference	interference' effects
windows	glass	medium	regular	medium	medium	no	yes	high
pedestal	Plexiglass	small	peculiar	high	low	no	yes	medium
