## **MECHANICAL-BASED SEISMIC FRAGILITY ASSESSMENT AND RETROFIT INTERVENTION OF CLUSTERED BUILDINGS**

*In this paper, the seismic behaviour assessment of a masonry building aggregate, one of the most widespread house typologies of historical centres, placed in a small burg in South Italy, is discussed through the definition of both capacity and fragility curves.*

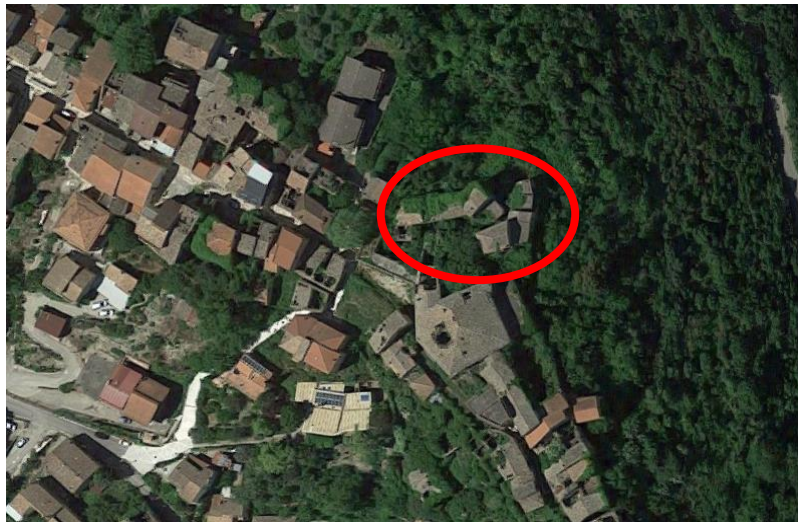
Figure 3: The investigated clustered buildings.

The examined structural aggregate is placed in Dietro La Torre street and it rises in a portion slightly detached from the ancient medieval nucleus. It is in the area where the current local administration wants to concentrate the economic resources in order to requalify the historical centre that, thanks to the presence of the old Castle, could have a tourist destination. Figure 3 displays the location of the case study aggregate.

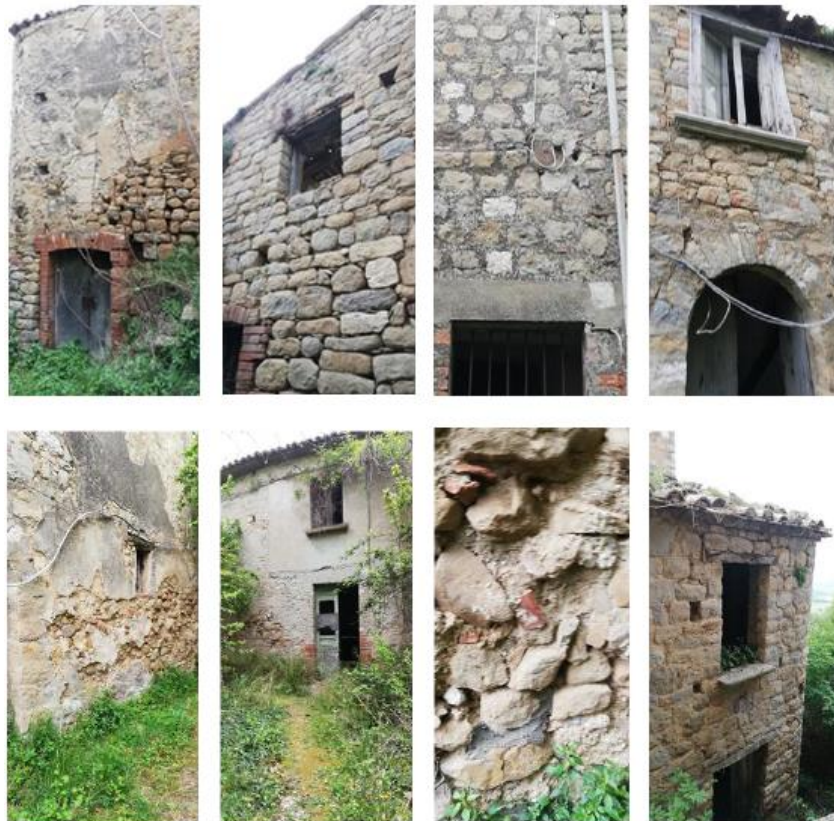
Figure 5: Crushing phenomena of vertical masonry walls.

The photographic documentation on the state of decay of the whole aggregate is herein reported. In particular, since all the masonry walls are not covered by plaster, it is possible to observe, as shown in Figure 5, the erosion phenomena due to environmental agents causing the pulverization of the mortar. In addition to the crushing of masonry walls, there are some partial collapses in correspondence of wooden beams of intermediate floors (Figure 6) and corrosion phenomena on steel beams within the units n. 2, 4 and 5 (Figure 7). Finally, Figure 8 points out the collapse of some parts of roofs.
