STRUCTURAL HEALTH MONITORING OF THE FATIGUE BEHAVIOR OF FRP STRENGTHENED RC BEAMS

**Barbara Charalambidi¹, Konstantinos Providakis¹, Konstantinos Katakalis² and
Alexandros Charalampidis²**

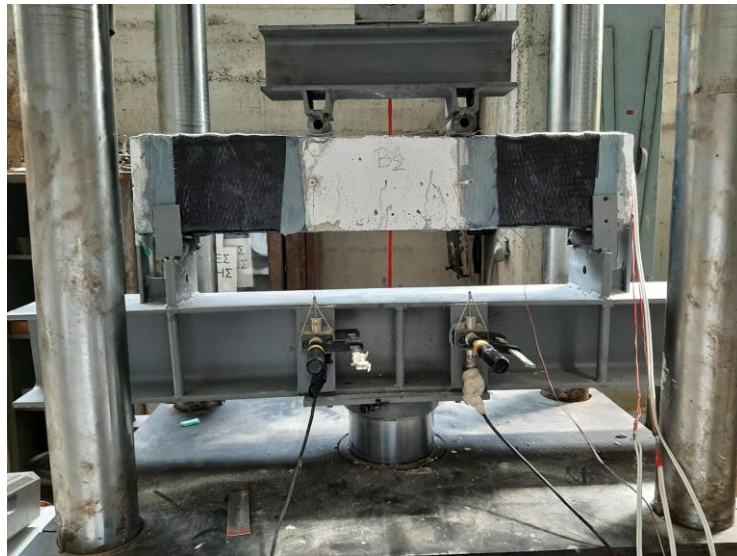
Figure 3: Crack pattern during testing of Beam B2 (no preloading, 20%-80%Py fatigue loading)

width was observed. During the last cycles, one particular crack was much wider than the rest of the recorded cracks. This main crack indicates the region where the steel fracture occurs [11]. Figures 3 and 4, illustrate the main crack in the case of beams B2 (beam with no preloading and 20%-80%Py fatigue load range) and A1 (beam with static preloading up to P_y and 20%-100% P_y fatigue load range). The fractured bar after fatigue failure of beam A1 is illustrated in Figure 5. The fracture of the steel bar was sudden, with no evident necking around the fractured region. Debonding of the externally bonded FRP laminate was a secondary failure mechanism of the strengthened beams. Debonding of the laminate occurred after the fatigue failure of the steel reinforcement of the beams and expanded towards almost the whole midspan of the beam.

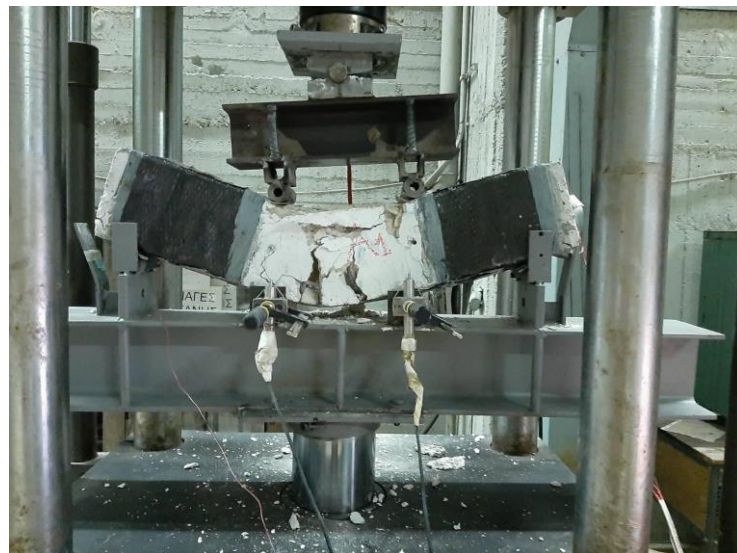
Figure 4: Crack pattern at failure of Beam A1 (P_y preloading, 20%-100%Py fatigue loading)

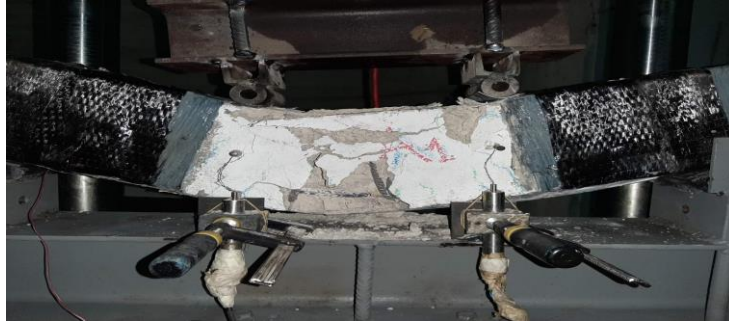
Figure 5: Steel fracture after fatigue testing of Beam B2 (Py preloading, 20%-100%Py fatigue loading)

All beams failed due to fatigue loading. Failure was due to tensile fracture of the steel reinforcement. No prior fatigue failure of the concrete cover in between the steel bar and the FRP strengthening was recorded in any case. The concrete cover of the beams varied from 10 mm to 15 mm. No prior FRP debonding failure was recorded. In each specimen, one main crack was formed at the midspan region of the beam, between the two vertical loads. As the number of fatigue loading cycles was increased, an increase in the total number of cracks and in their
