SEISMIC VULNERABILITY ASSESSMENT OF VAULTED MAYA CONCRETE TEMPLES IN BONAMPAK, CHIAPAS, MÉXICO

Abstract

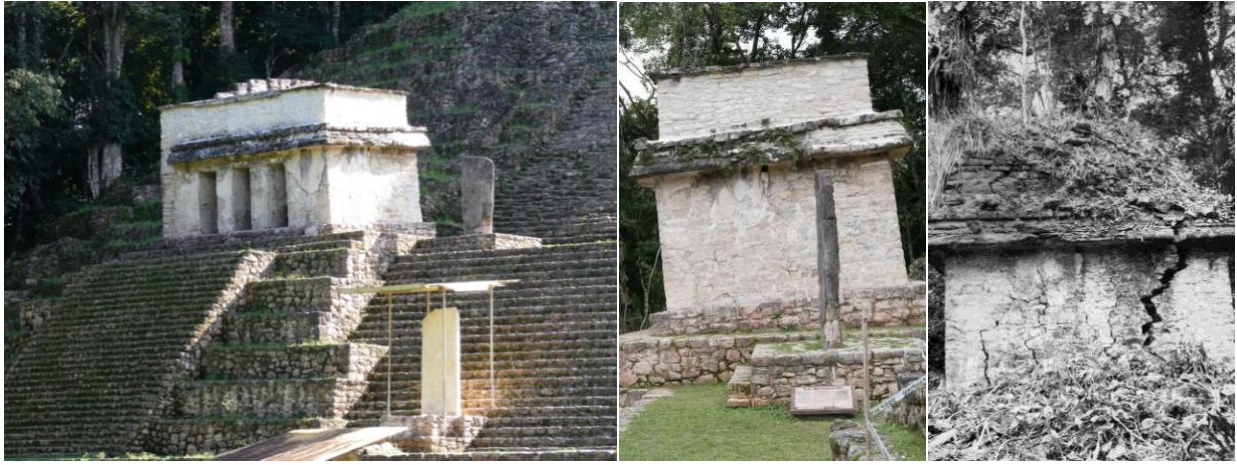
protrusions (Figure 3, left), suggesting that the temple was adorned with a feature called *crestería*, or “roof comb.” This ornamental structure is common in Maya architecture [3].

Figure 3: Inclined base of Structure 3 puts this and other buildings at the complex at higher risk [4],[5].
